# CULTURAL LANDSCAPE REPORT

## FOR SAGAMORE HILL

### NATIONAL HISTORIC SITE

Site History, Existing Conditions, and Analysis

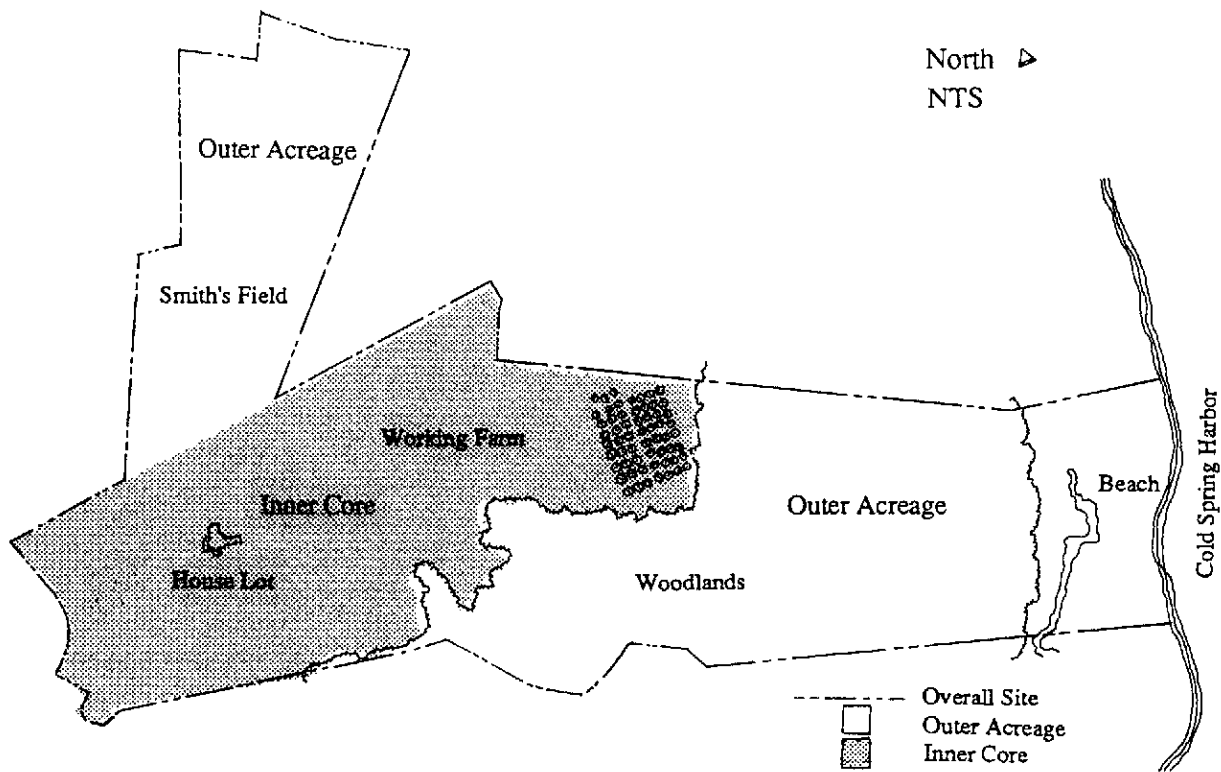
FIGURE 0.3: Map showing overall site, outer acreage, and inner core. (Bellavia, 1993. SUNY CESF).

The site was divided into three sections so that the features of the property could be researched and analyzed comprehensively and presented graphically in complete detail (see figure 0.3). The three sections were: (1) The overall site consisting of approximately eighty-seven acres; (2) the outer acreage consisting of the woodlands, beach, and "Smith's Field"; (3) the inner core consisting of the house lot and working farm. The "overall site" section is a general discussion of the landscape features with relation to the site as a whole. Sections two and three, "outer acreage", and "inner core", provide detailed discussion and documentation of the landscape features located in these areas of the site. The decision to present the inner core at a larger, more detailed scale was based on the intensity of use in that area and the amount of documentation available.

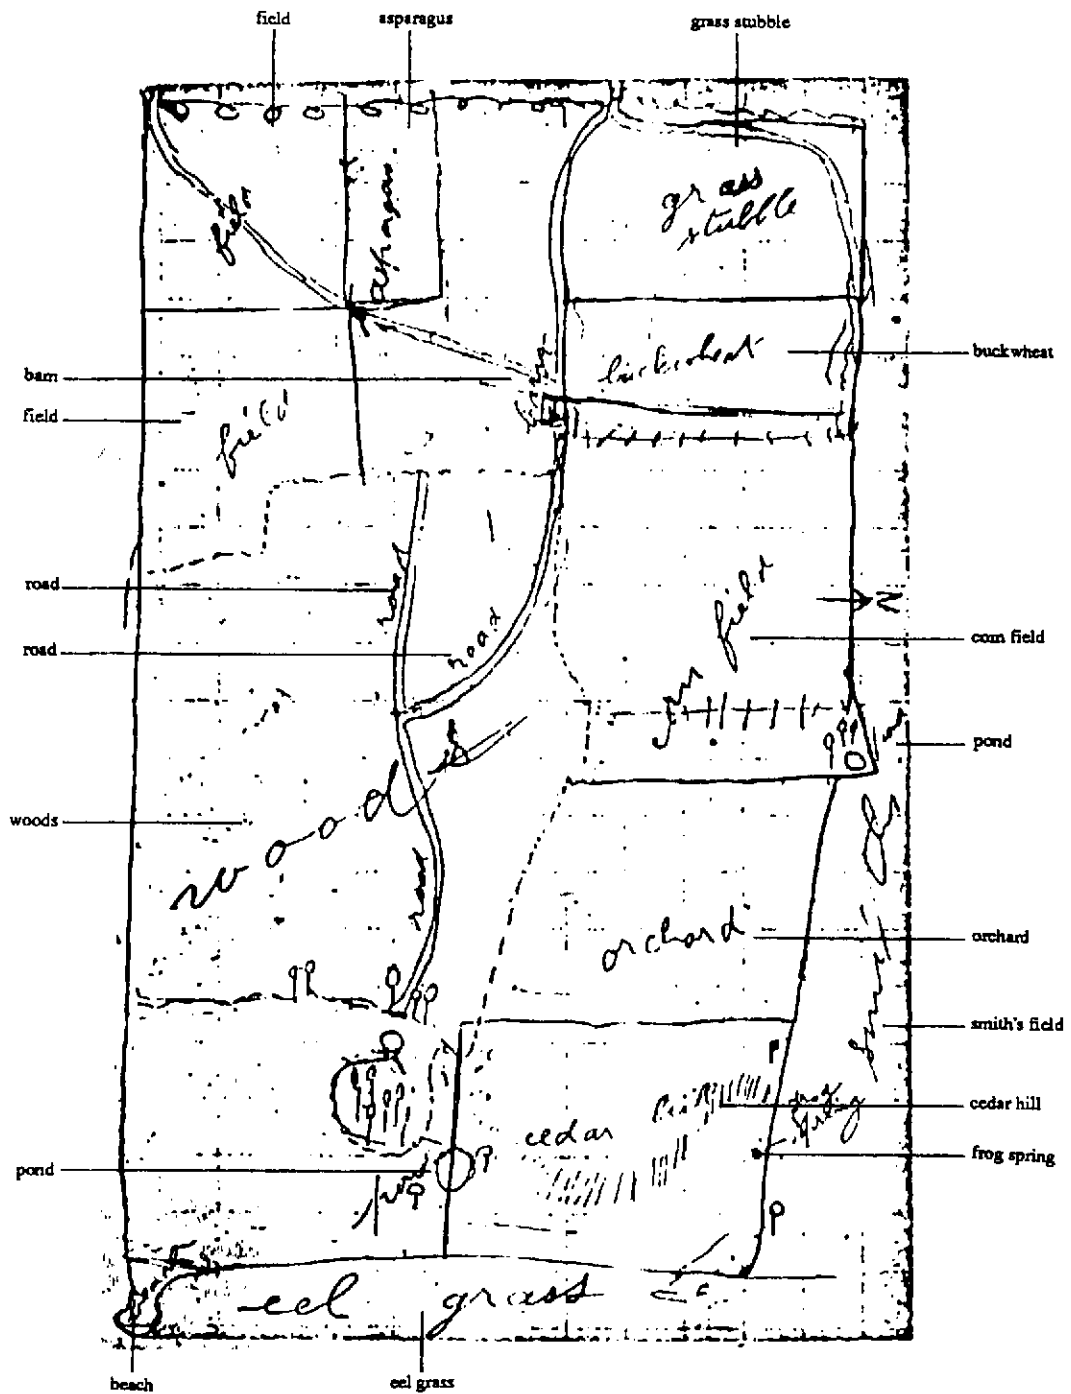
FIGURE 1.3: Theodore Roosevelt's sketch of his property, c. 1880. (SAHINHS Archives).

Roosevelt also noted a spring on the property in the woods west of Cold Spring Harbor (see figure 1.3). According to the sketch, the spring was very close to the north property limit.<sup>44</sup>

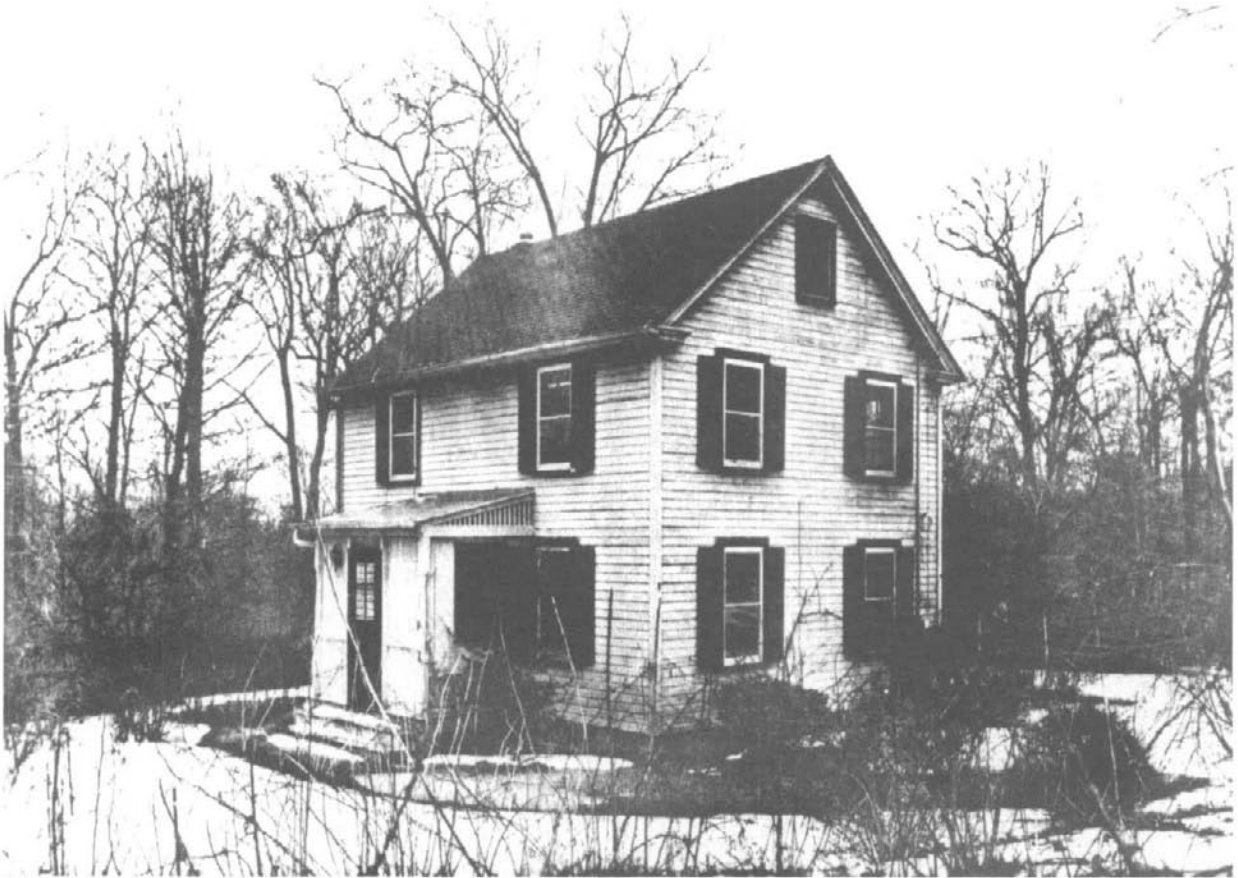
FIGURE 1.8: The Gray Cottage, 1964. (Courtesy of the Library of Congress).

The Gray Cottage – The Gray Cottage was constructed in 1910 for Theodore Roosevelt's valet and coachman (James Amos and Charlie Lee) and their families. The Gray Cottage was located on the edge of the woodlands east of the ravine (see figure 1.8, Overall Site: Theodore Roosevelt Stewardship). This rectangular 26' x 20', two and one-half story wood frame clapboard building was divided into two apartments and had a small enclosed one-story front porch. "While the porch may not have been enclosed originally, there is evidence that it was done at a very early stage in the history of the house."<sup>53</sup> There was also a one-story, enclosed porch in the back, on the south side of the house. The cottage had an attic and a full basement. The building was symmetrical and had four windows with shutters on the north and south facades, and four windows and one attic window on the east and west facades. The roof was wood shingles. The building was gray.

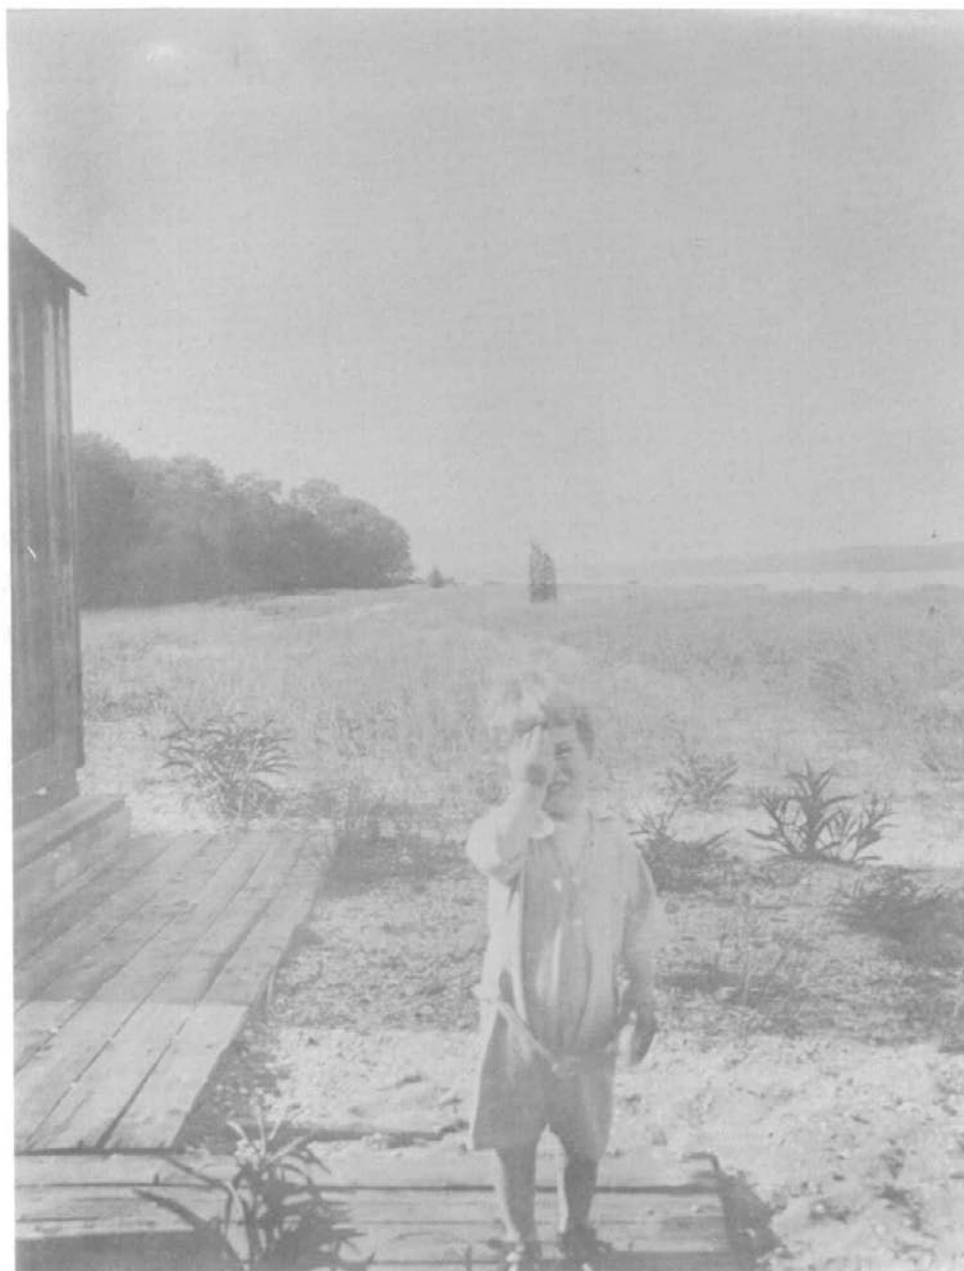
**FIGURE 1.10:** Bathhouse at C.S.H. Beach, c.1917. (SAHINHS, Family Photo Album no. 7644).

The Bathhouse and Boathouse – Two or more bathhouses were located on the shore of Cold Spring Harbor as early as 1888. Theodore Roosevelt referred to them in a letter to his sister Anna Roosevelt (Bamie) in August of that year. He wrote, "We had a terrible storm a couple of days ago, and among other feats it took the roof clean off the bathing houses."<sup>54</sup> In 1900, a reporter for the *New York Tribune* wrote, "On Oyster Bay the Colonel [Roosevelt] has a boathouse and a bathing-house..."<sup>55</sup> It seems that the writer was mistaken and the boathouse and bathing house were located on Cold Spring Harbor, not Oyster Bay Harbor, since there is no evidence to suggest he owned property bordering Oyster Bay in 1900. In 1906, Theodore wrote in a letter to his sister (Anna Roosevelt Cowles, "Bamie"), "...I have agreed to get from Emlen in lieu of this a right of way and a right to build a boathouse, bath house [sic] and a dock on the southernmost portion of his beach, about one hundred yards south of the present location, as this will not break up the continuity of his beach...."<sup>56</sup> It is unclear what happened to the original boathouse and bathhouse that was mentioned in the 1900 newspaper article. Photos from the early 1900's verify that Roosevelt did build at least the boathouse and bathhouse he discussed in his letter to his sister (see figures 1.9, 1.10) The bathhouse was a wood frame building that had two doors on the east facade. The exterior was clad with vertical boards; the gable ends had horizontal slats. The construction date, dimensions, and materials of the boathouse are unknown.

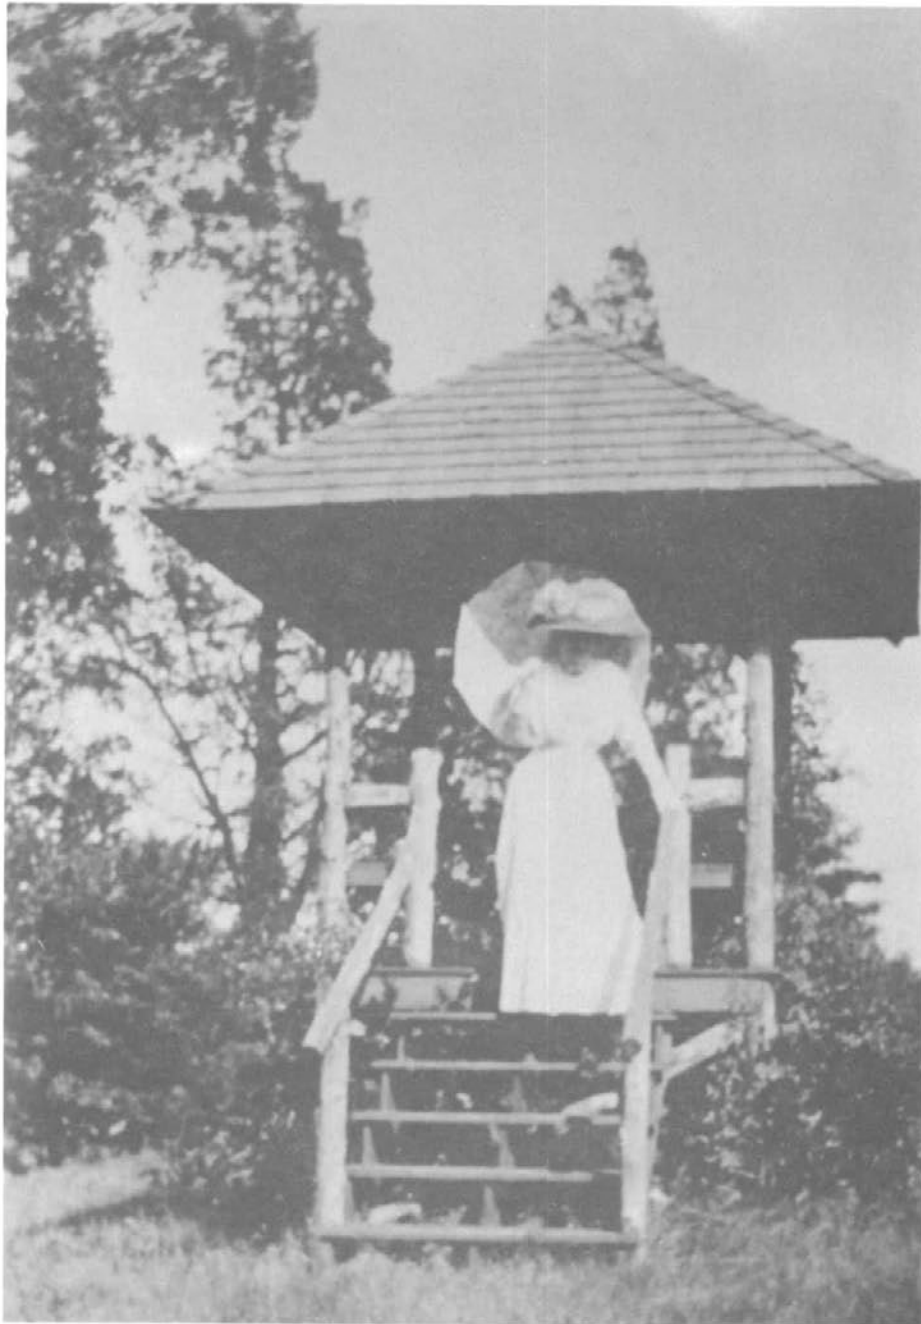
**FIGURE 1.11:** Mrs. Roosevelt in the "Nest" at Sagamore Hill, n.d. (SAHINHS, no. 9002, Box 13).

The Nest – The "Nest" was a small structure used as a quiet sitting and reading area by Mrs. Roosevelt located on a high point in the southern half of "Smith's Field" near the west property boundary (see figure 1.11, Overall Site: Theodore Roosevelt Stewardship, Appendix G: Aerial Photographs).<sup>57</sup> It was raised on cedar posts with six risers up to the platform. There was a hip roof covered with wood shingles and a timber railing, with posts and two rails, around the sides and along the stairs. Benches were located on three sides of the structure. The date of construction is unknown; however on June 12, 1906 Mrs. Roosevelt wrote a letter to her daughter Ethel from Washington concerning its construction. She wrote:

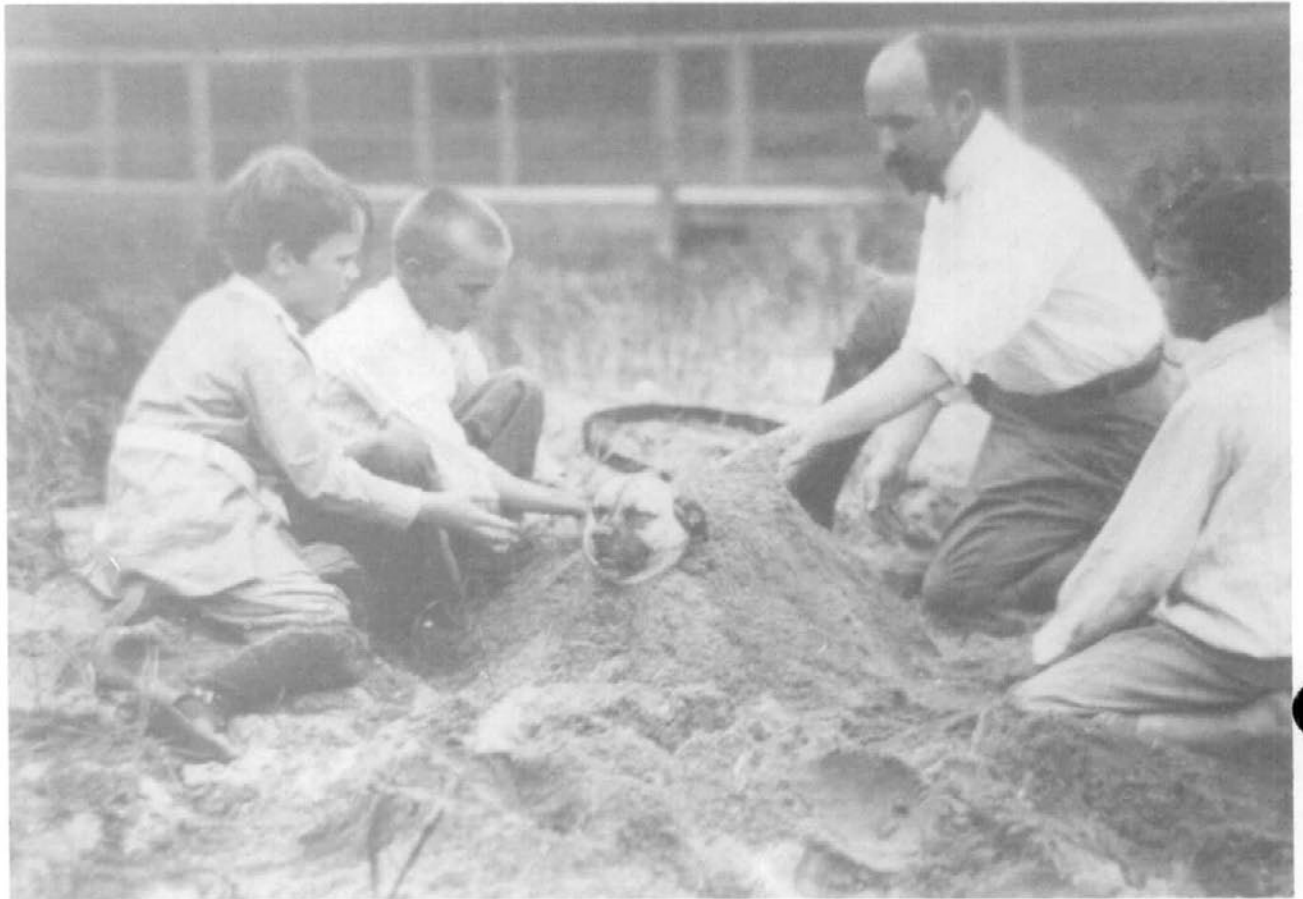
**FIGURE 1.12:** "Playing in the Sand" at Sagamore Hill, bridge in middle ground, c. 1904. (Courtesy of the Library of Congress).

The Bridge – A bridge crossed Eel Creek and connected the Roosevelt's woodlands with their beach at Cold Spring Harbor (see figure 1.12). It was constructed of wood decking and wood handrails; the vertical posts were 8–10' apart and had a horizontal top rail.

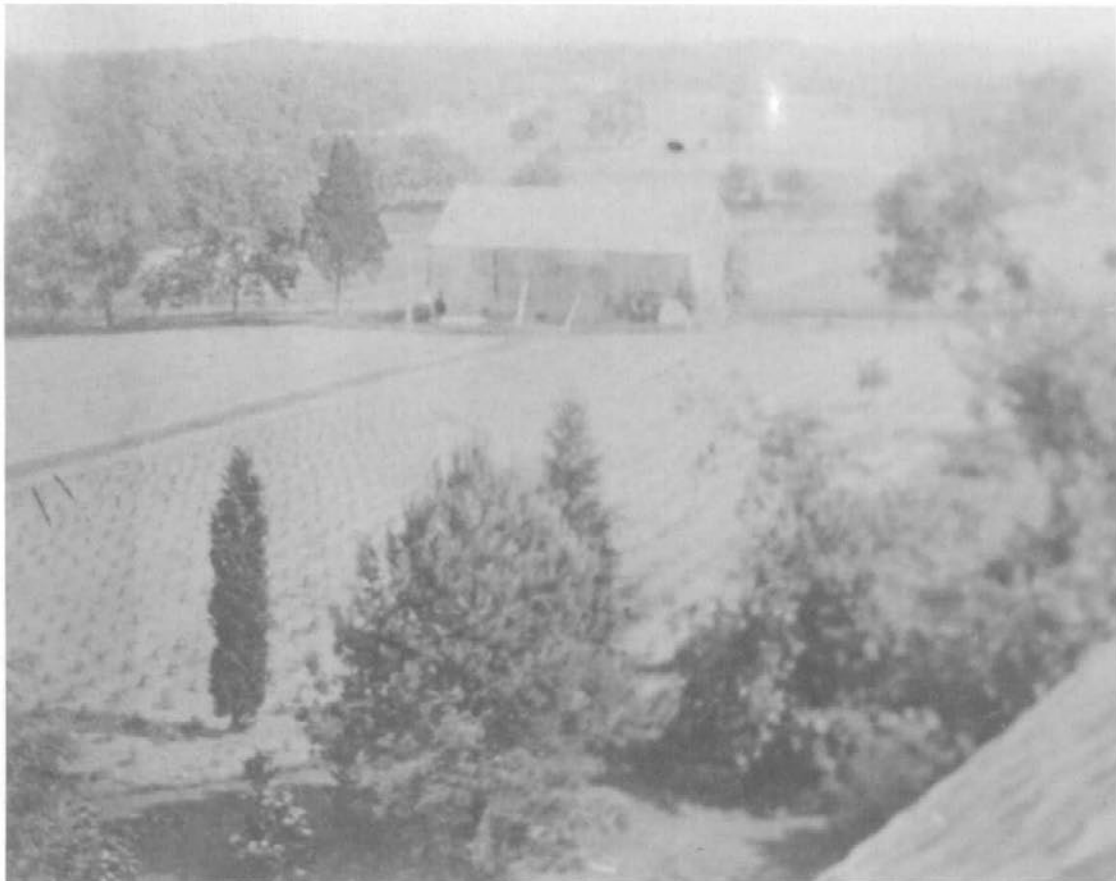
**FIGURE 1.14:** The "farm barn", prior to 1904. (SAHINHS, no. 1132, Box 6).

The "meeting spot of three fences" where the old barn stood was on the southern boundary of Roosevelt's property approximately 400' southeast of the house (see figure 1.14, Inner Core: Theodore Roosevelt Stewardship). The barn was a wood frame building whose dimensions are unknown.

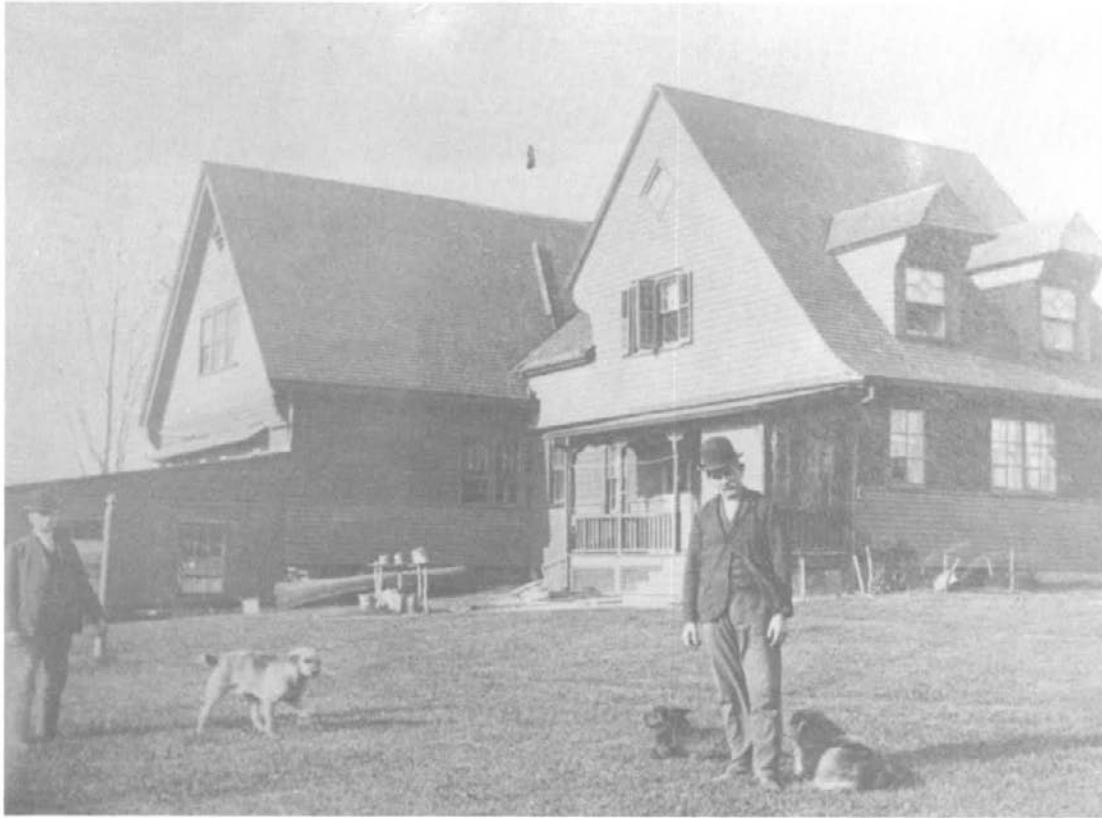
**FIGURE 1.15:** View of stable and lodge from the northeast, n.d. (SAHINHS, no. 1115, Box 6).

The Stable and Lodge – The first building that Theodore Roosevelt had constructed in circa 1883 was the stable and lodge, designed by the architectural firm of Lamb & Rich (Ethel Roosevelt Derby later referred to the building as the "stable and farm house"). The carpenters, John A. Wood & Son, agreed to completing the excavation, masonry, carpentry, and painting for \$5,160.00, on or before the 1st of February, 1884.<sup>65</sup> The stable and lodge was one building, located several hundred feet to the northeast of the hill, that served two functions (see figure 1.15, Inner Core: Theodore Roosevelt Stewardship). The stable portion was used to provide shelter for the cows and horses, as well as provide storage for hay and grain.<sup>66</sup> The lodge portion was the home of the caretaker, Noah Seaman.

The front of the building faced west. There were two ramps into the stable, one on the west facade and the other on the south.<sup>67</sup> The entire building had a stone foundation and was approximately 65' by 75', somewhat of an L-shape structure (see *Inner Core: Theodore Roosevelt Stewardship*).<sup>68</sup> The exterior cladding consisted of shake shingles on the upper wall (from approximately 6' above ground to the roof). The building's three dormers were clad in shake shingles. The bottom portion (from the ground to approximately 6') was clapboard. There was a small covered porch on the front with a simple railing of a sill and plate with an x-pattern in between (see figure 1.16).

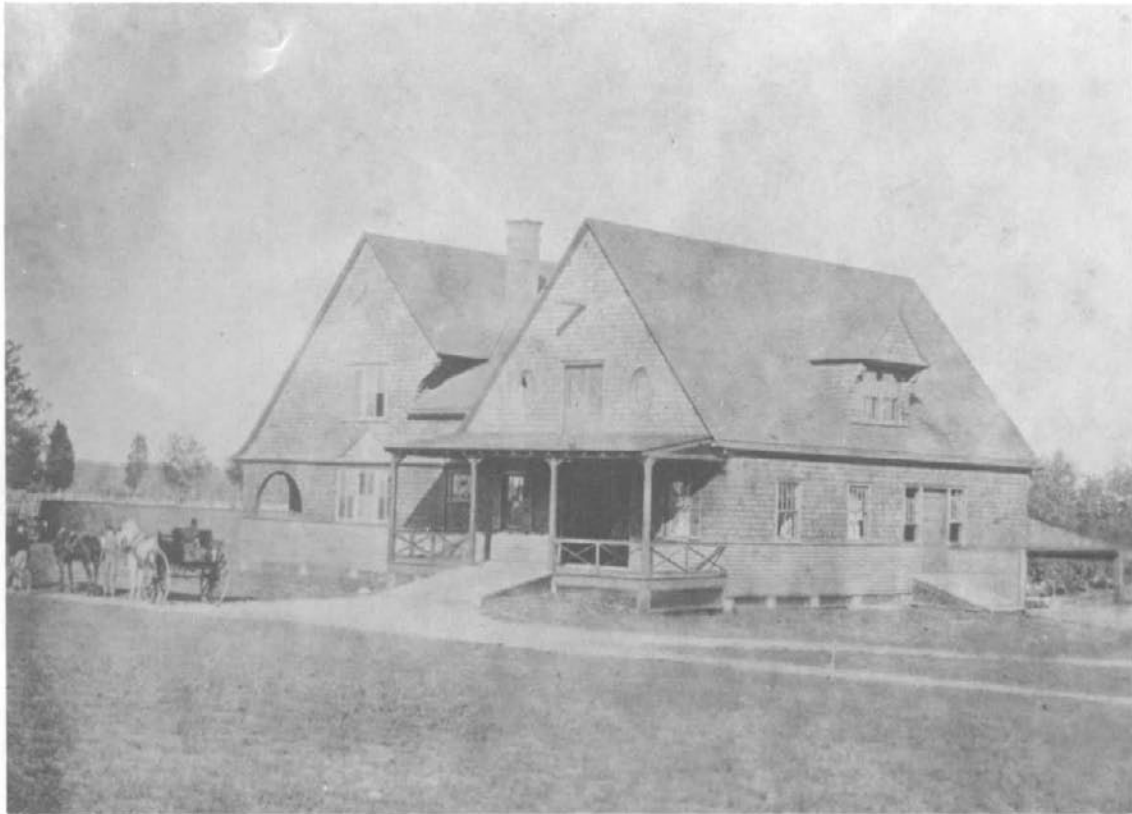
**FIGURE 1.16:** The west facade of the stable and lodge at Sagamore Hill, 1905. (SAHINHS, no. 1112, Box 6).

The ground floor consisted of a carriage room, stalls for five horses, a storage closet, and a harness room. The east facade of the stable had a shed roofed addition, presumably used for storage. The building had a basement, except under the carriage room. The stable basement was used to store grain and hay, and also had room to house four to six cows, and two horses. The lodge was separated from the stable by a brick firewall; the interior layout of the lodge is unknown.<sup>69</sup> The color of the stable and lodge is unknown.

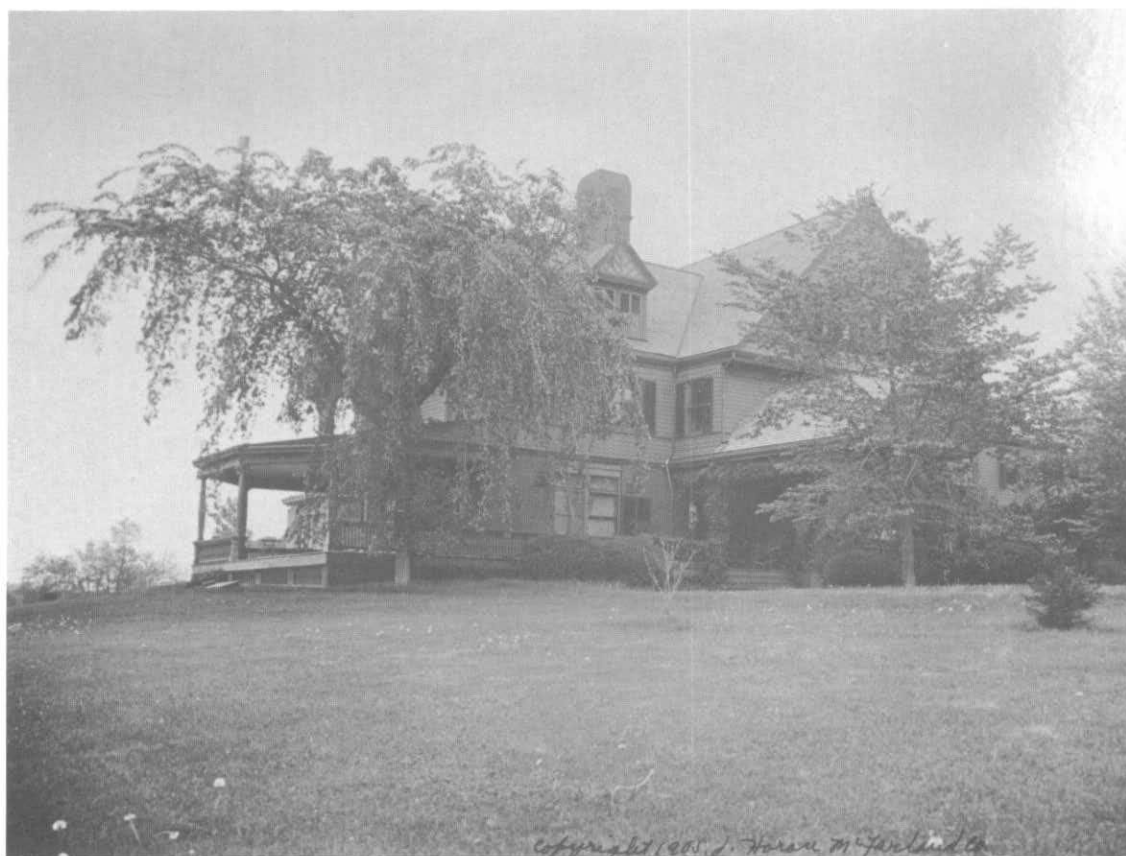
FIGURE 1.18: Sagamore Hill, 1905. (SAHINHS, no. 1117, Box 6).

The massing and the exterior details of the house reflect the latter portion of the Victorian period and Queen Anne style, as evident in the huge chimneys, large verandah, brick faced first floor, decorative shingles on the second floor, and gabled ends with stylized decoration.<sup>72</sup> The first floor was covered with common bond red brick and the upper portions of the building with a combination of clapboard siding and scalloped wood shingles (see figure 1.18).

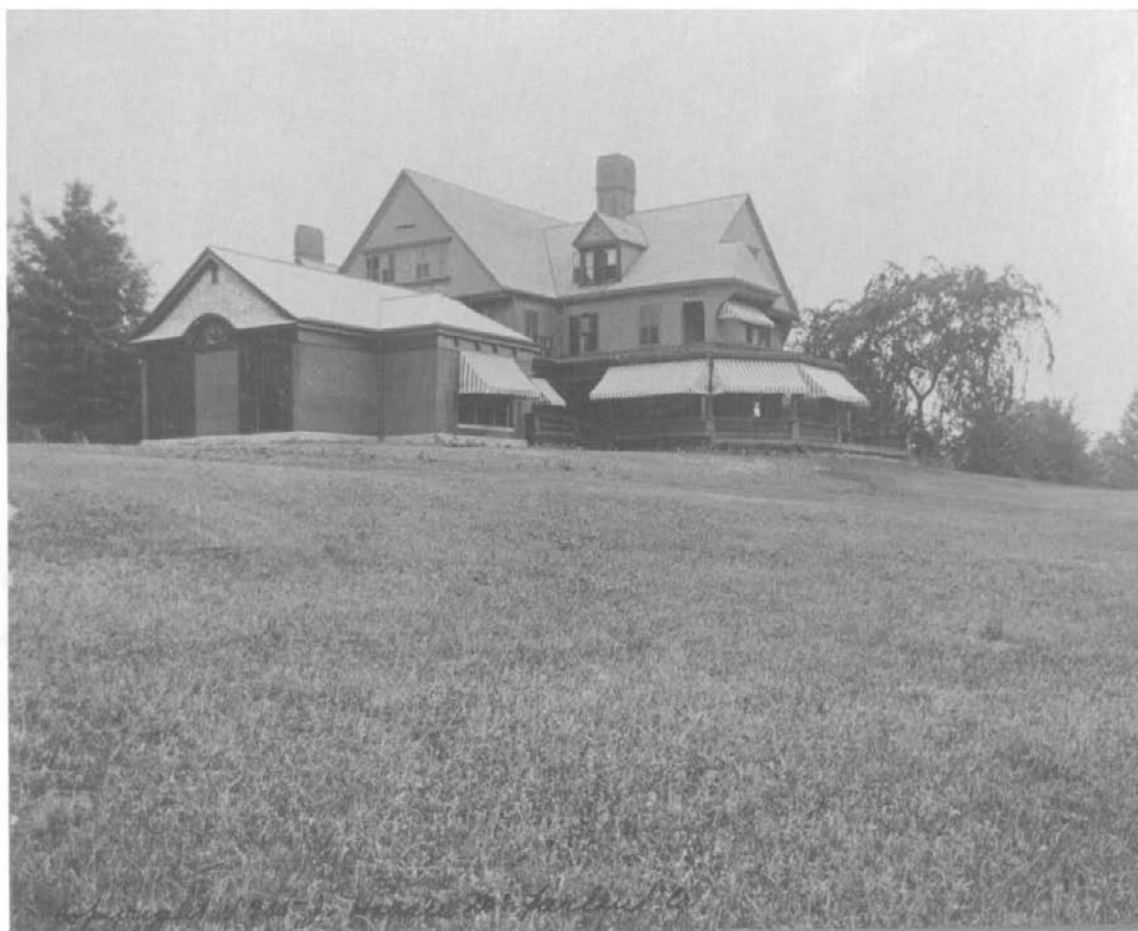
FIGURE 1.19: The North Room addition, 1905. (SAHINHS, no. 1119, Box 6).

In 1905 Theodore decided he needed a more spacious and dignified room than the library in which to meet his distinguished guests when conducting Presidential affairs. He commissioned his friend C. Grant LaFarge to design a 40' by 30' room on the north side of the house (see figure 1.19). It was two steps lower than the level of the first floor of the house; the outside was brick to match the rest of the first floor exterior; and the inside walls were heavy timber. Roosevelt hung his most prized trophies from his hunting expeditions on the walls of this room. As a result, this room soon became known as the Trophy Room, or North Room because of its location (and is referred to hereafter as the North Room).

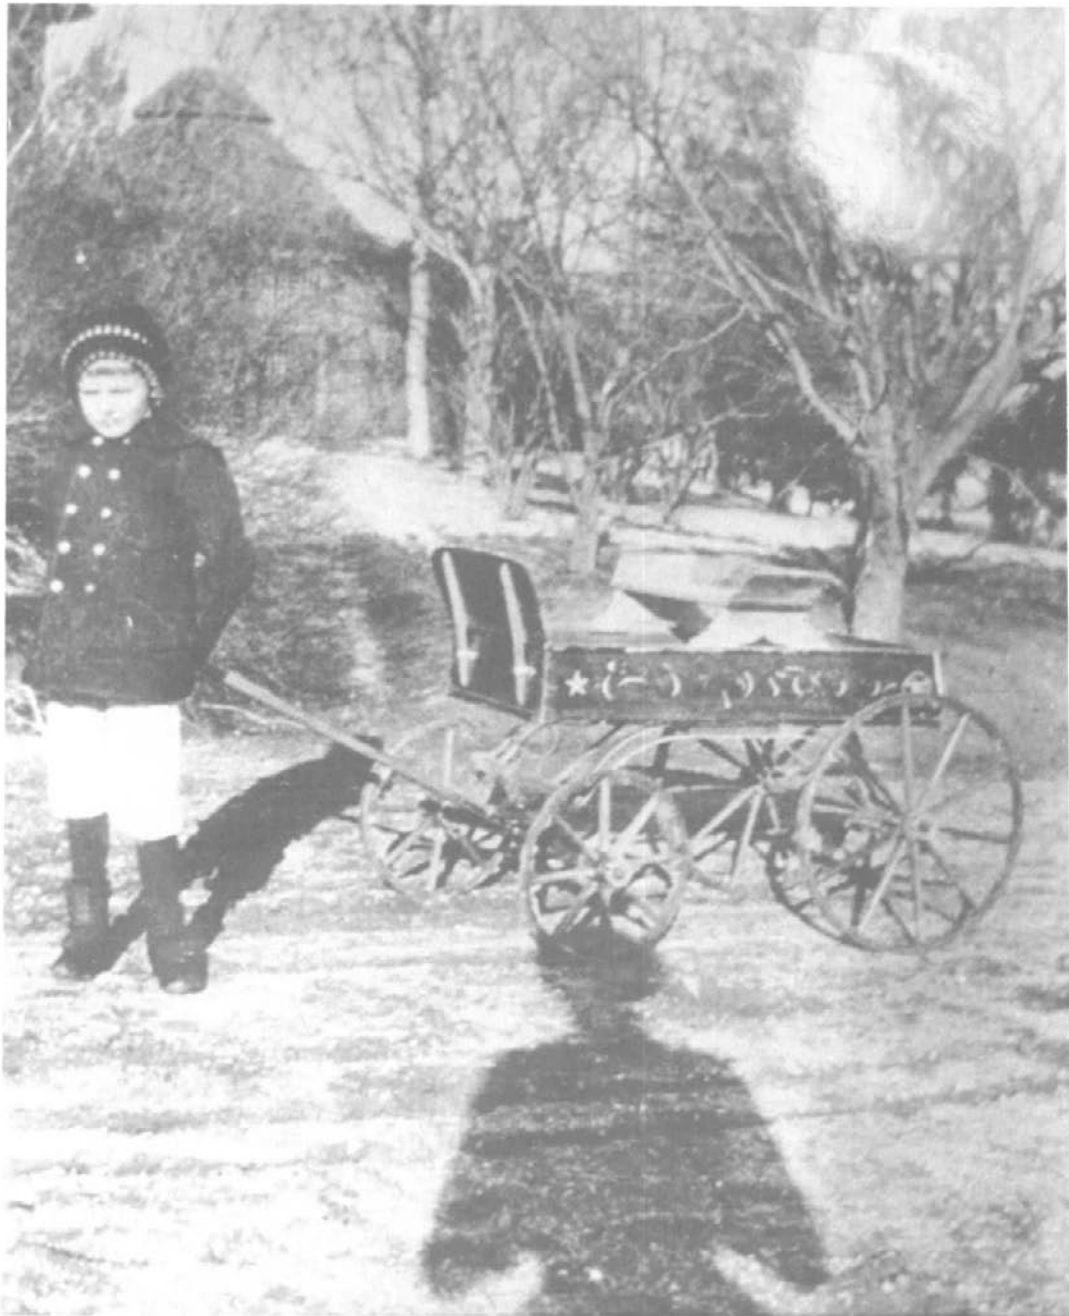
**FIGURE 1.20:** Archie Roosevelt with his wagon, ice house in background on left side of photo, c. 1901. (SAHINHS, no. 9021, Box 13).

The ice house had 6" thick, 5' high brick walls and a steep, wood-shingled gable roof. In the early 1900's some type of lattice was on the south side of the building (see figure 1.20). The function and the duration of this lattice is unknown.

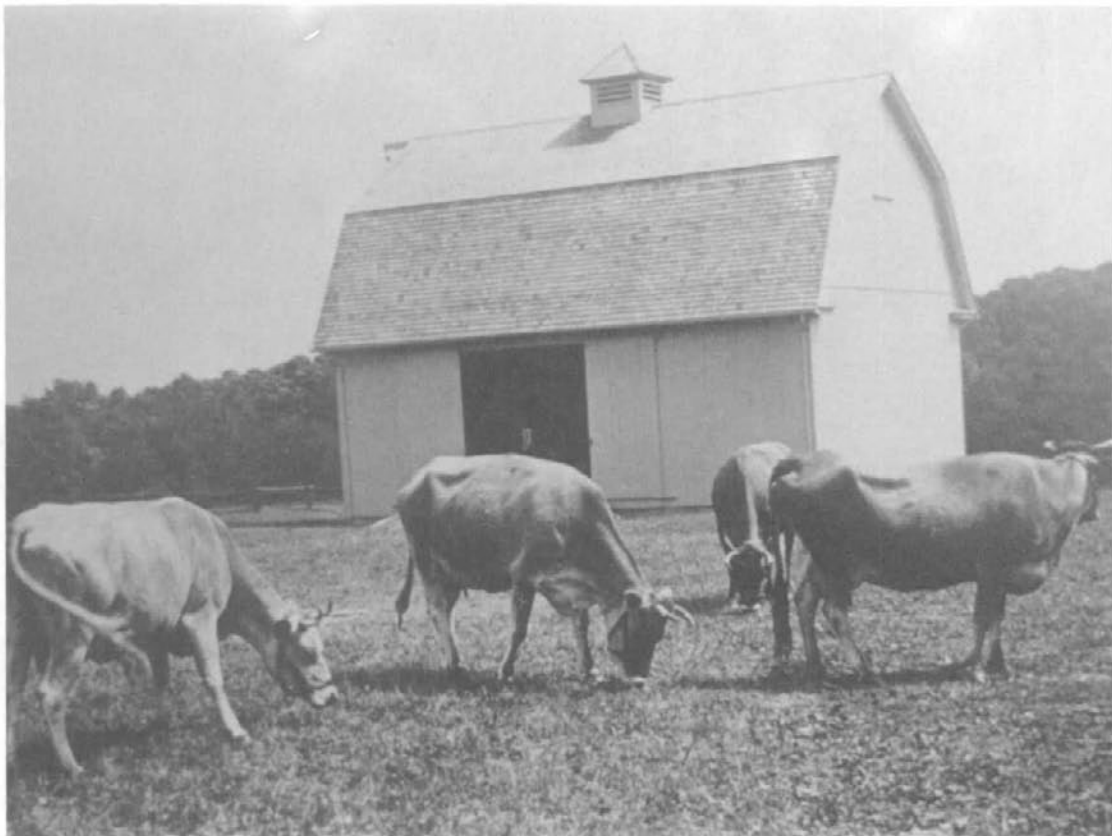
**FIGURE 1.21:** The new barn, 1907. (SAHINHS, no. 1113, Box 6)

The New Barn – The new barn was built in 1907, three years after the old farm barn collapsed. It was located in the pasture southeast of the stable and lodge (see Inner Core: Theodore Roosevelt Stewardship). It was a large wood frame building with a wood-shingled gambrel roof (see figure 1.21). "It had a large central opening, sliding doors and a cupola atop to provide ventilation."<sup>77</sup> The barn apparently was painted shortly after construction. A writer for *Broadway Magazine* wrote, "To the right of you as you drive around the rear of the house is a freshly painted gray and green barn."<sup>78</sup> The new barn was used for storage of farm equipment and crops, and to shelter livestock.

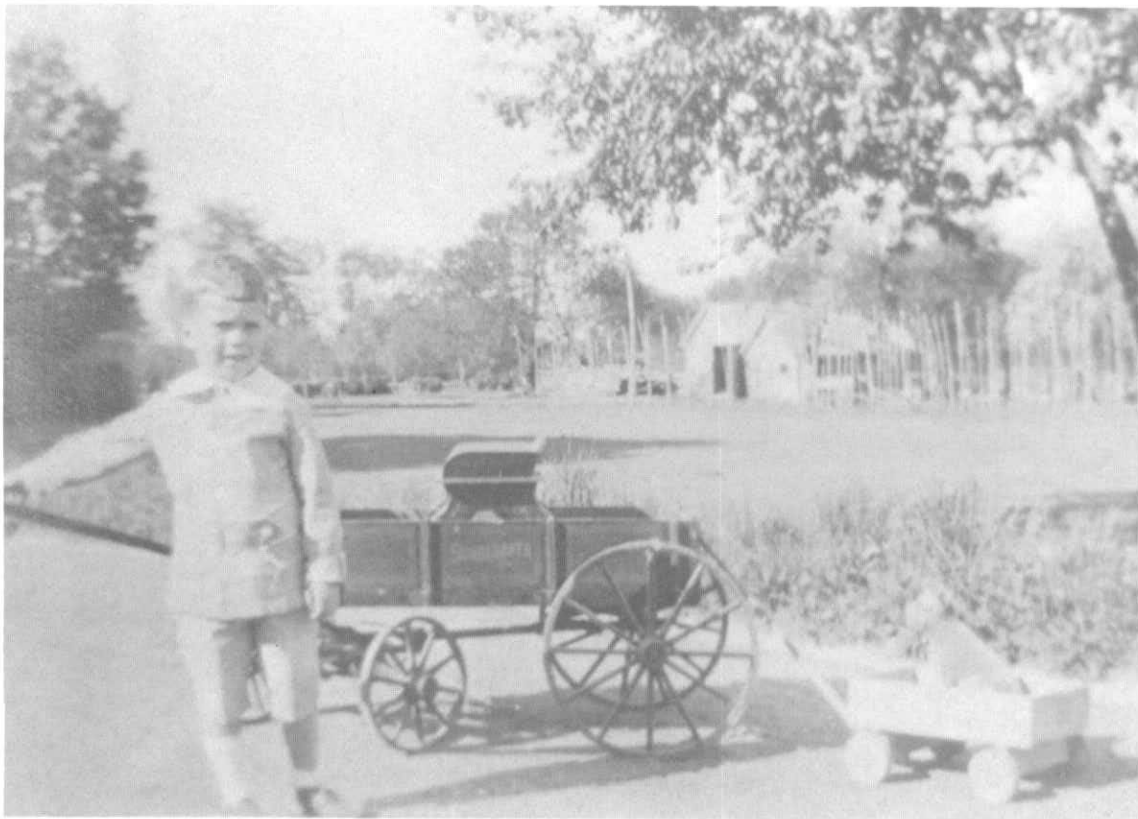
**FIGURE 1.22:** Chicken coop and Tool shed, middle background on right side (south), carriage house on left (north) of chicken coop, 1918. (SAHINHS, Family photo album no. 7644).

The Chicken Coop and Tool Shed – The chicken coop and tool shed, construction date unknown, was located, among other small structures, about 50' southeast of the stable and lodge (see Inner Core: Theodore Roosevelt Stewardship). It was a frame building, 40' x 14' x 9' high, with a dirt floor and clapboard siding (see figure 1.22). The west portion of the building was a shed used to store tools and equipment; the east portion was a chicken coop which housed approximately one hundred chickens.<sup>79</sup> The color of the building is unknown.

The Carriage House – The carriage house, construction date unknown, also was a wood frame building with clapboard siding, located north of and adjacent to the chicken coop (see Inner Core: Theodore Roosevelt Stewardship).<sup>80</sup> It was one and one-half stories and had two large access doors with

crossbracing. It had a dirt floor and was approximately 12' x 18' x 13' high (see figure 1.22). The color of the carriage house is unknown.

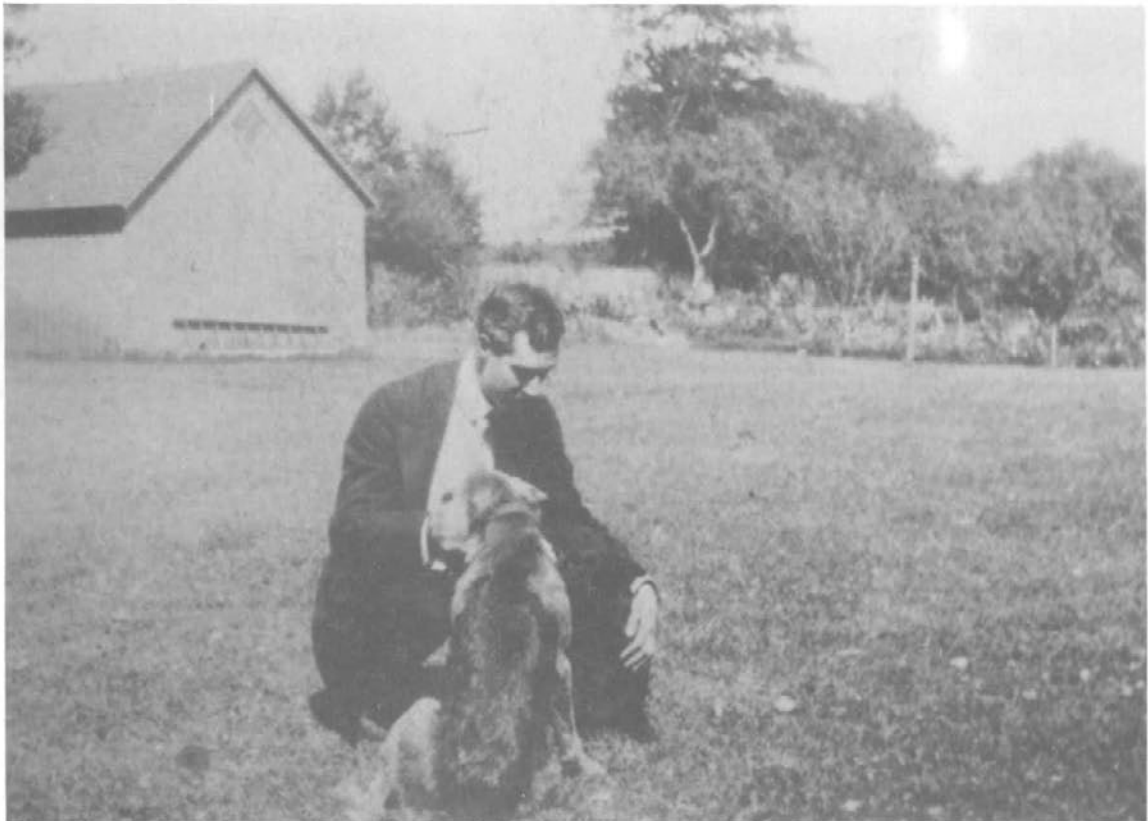
**FIGURE 1.23:** Bob Fergusen with dog, gardener's shed in background, n.d. (SAHINHS, no. 7095, Box 12)

The Gardener's Shed – The gardener's shed, construction date unknown, located in the northwest corner of the garden, was a simple one story, wood frame building with board-and-batten siding and a large sliding door on the east facade (see Inner Core: Theodore Roosevelt Stewardship). Diamond-shaped windows were located in the top corner of the gable ends (see figure 1.23). The color of the shed is unknown.

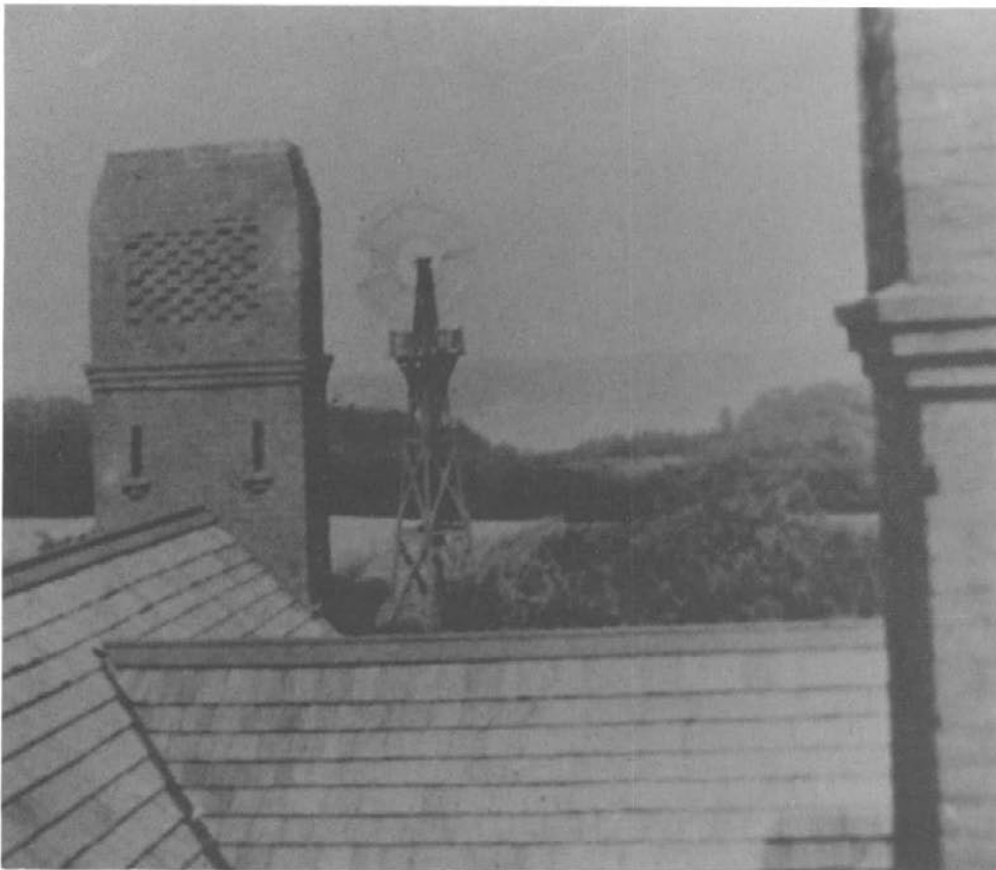
FIGURE 1.24: Windmill at Sagamore Hill, pre-1907. (SAHINHS, no. 1125, Box 6).

The Windmill – Between 1884 and 1886 a windmill was constructed on the site in association with the estate's water system (see figures 1.24 and 1.25). It was located approximately 100' northeast of the ice house (see Inner Core: Theodore Roosevelt Stewardship). This windmill was replaced in 1905 with a new, improved wheel, measuring 22'6", and a new tower. Corcoran, the contractor, proposed a new tower 42' high from the ground to the tank platform and made of Georgia yellow pine.<sup>82</sup>

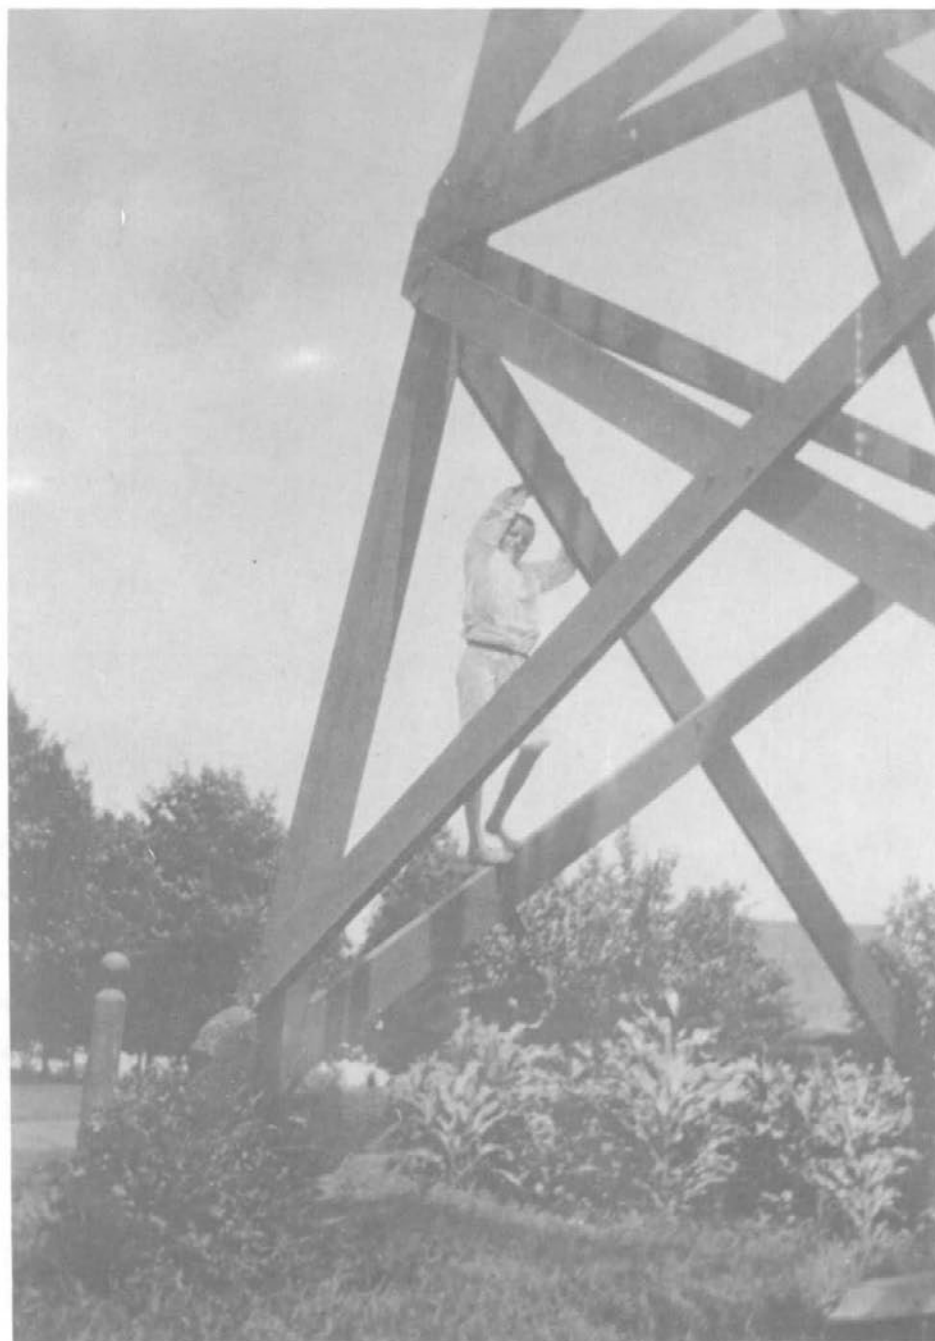
**FIGURE 1.25:** Archie Roosevelt on windmill, c. 1907. (SAHINHS no. 1127, Box 6).
