# CULTURAL LANDSCAPE REPORT

## FOR SAGAMORE HILL

### NATIONAL HISTORIC SITE

Site History, Existing Conditions, and Analysis

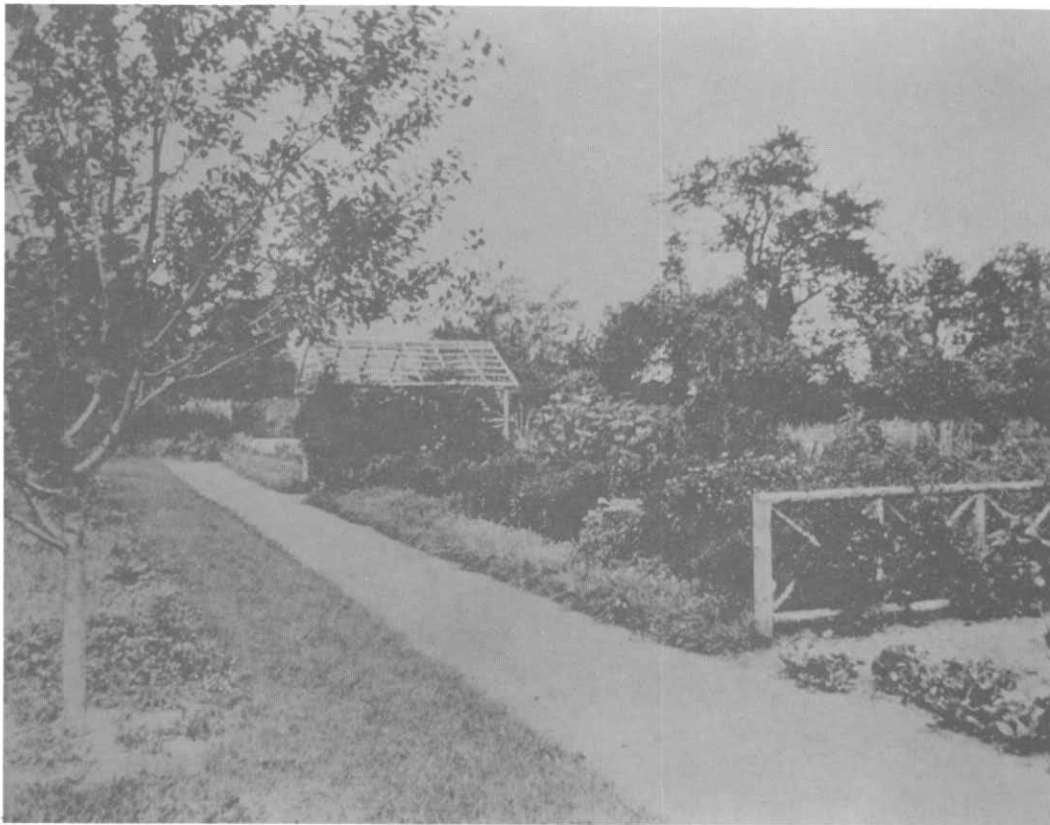
FIGURE 1.26: The garden arbor at Sagamore Hill, 1905. (SAHINHS, no. 1156, Box 6).

Garden Arbor – The garden arbor was a wooden structure 10' x 12', with benches on both sides, located at the west end of the garden's main path (see figures, 1.26, 1.27).<sup>84</sup> The walls consisted of three vertical posts approximately 8' high and 6' apart, and one horizontal cross member, approximately 4' above the ground. This configuration created four squares, each having an "x" design. The roof was a wood gable form with six horizontal members on either side of the ridge and seven vertical members including the ends. The gable ends were five to six horizontal support members that decreased in size from the plate to the ridge (see figure 1.27). The construction date and color of the arbor are unknown.

Flowers grew in planting beds on either side of the arbor that covered the central path of the garden. Although all species can not be identified, they likely were tall flowers used for cutting (see figure 1.26). Two perennials identified were Black-eyed Susan (*Rudbeckia hirta*), and bellflower (*Campanula* sp.) (see figure 1.47).<sup>135</sup> In addition, fruit trees bordered the western edge of the garden. Sunflowers (*Helianthus* sp.) grew along the fence on the north boundary of the garden (see figure 1.30). The arbor itself was laced with flowers. A reporter, Walter E. Andrews, commented on these flowers in detail.

The planting bed south of the arbor included cut flowers, the Lincoln boxwood (one of two plants established from cuttings of a boxwood at the Lincoln Birthplace), the "children's garden", and yellow roses. The "children's garden" contained a small section for each child to plant what they wished.<sup>137</sup> The planting bed west of the Lincoln box, and in direct line with it, also was planted with roses (see figure 1.26 , 1.50).<sup>138</sup>

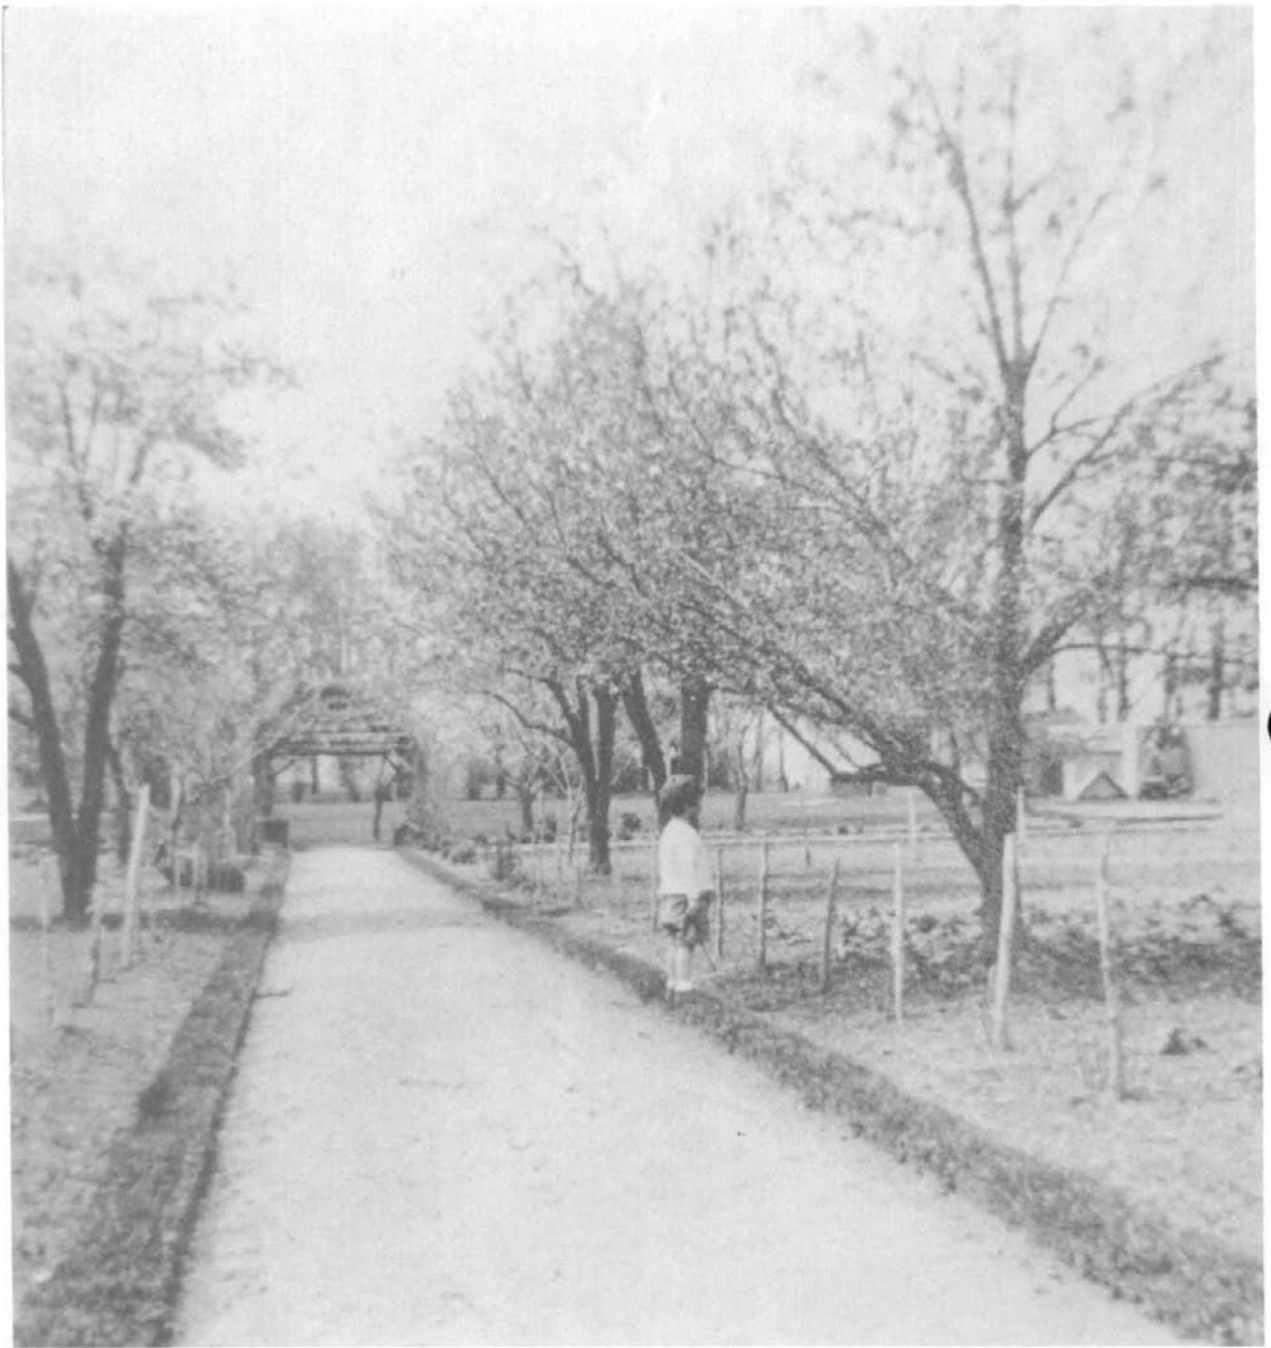
**FIGURE 1.27:** Richard Derby Jr. in garden at Sagamore Hill, c.1918. Garden arbor in background on left side of photo. (SAHINHS, Family photo album, no. 7644).

Trees lined the central walkway, spaced evenly at approximately 10' apart. They were not all the same species. At least one of these trees was a flowering cherry (*Prunus* sp.) (see figure 1.27).<sup>134</sup>

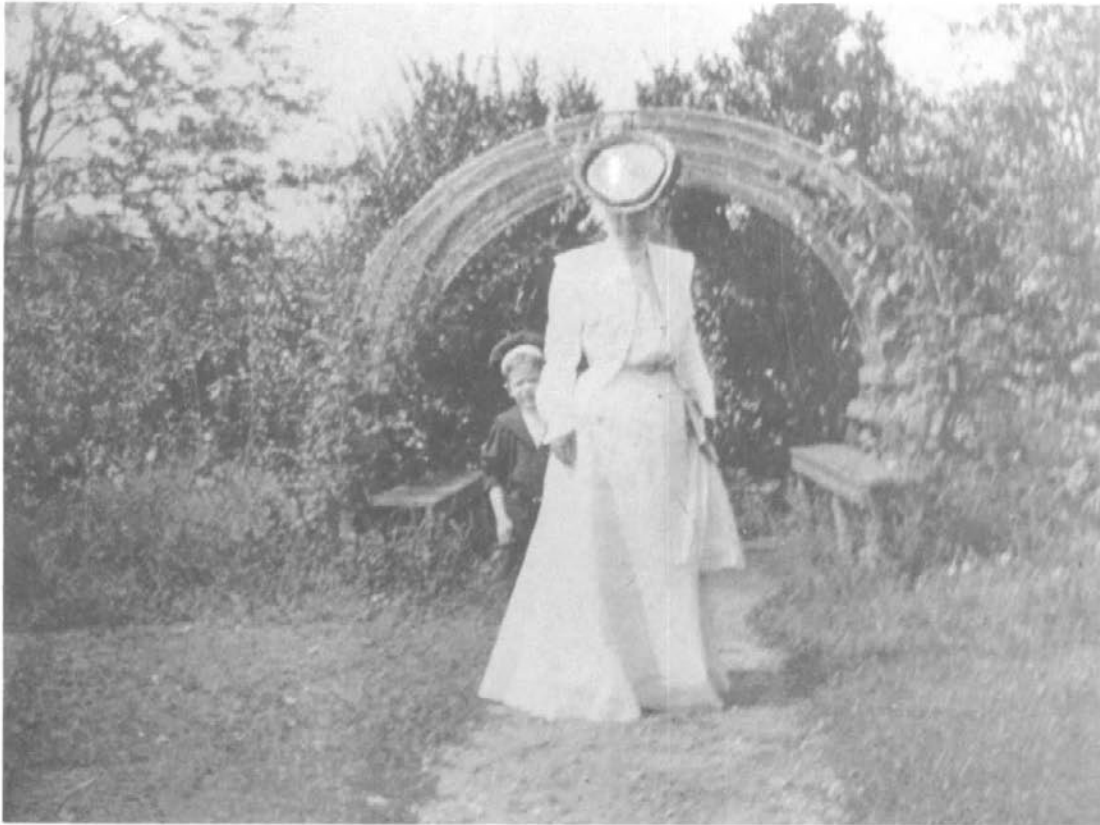
**FIGURE 1.28:** Mrs. Roosevelt and Quentin near Pet Cemetery, arched arbor in background, c. 1901. (SAHINHS, no. 1131, Box 6).

Pet Cemetery Arbor – Another arbor was located approximately 250' north of the house near the pet cemetery stone (discussed later, see Inner Core: Theodore Roosevelt Stewardship).<sup>85</sup> It was an arched arbor with two benches underneath (see figure 1.28). The benches appeared to be wood; the material of the arbor and its construction date are unknown.

Rambler roses (*Rosa* sp.) grew on the arched arbor located near the pet cemetery (see figure 1.28).<sup>129</sup> Sweet Autumn Clematis (*Clematis paniculata*) grew on the garden arbor.

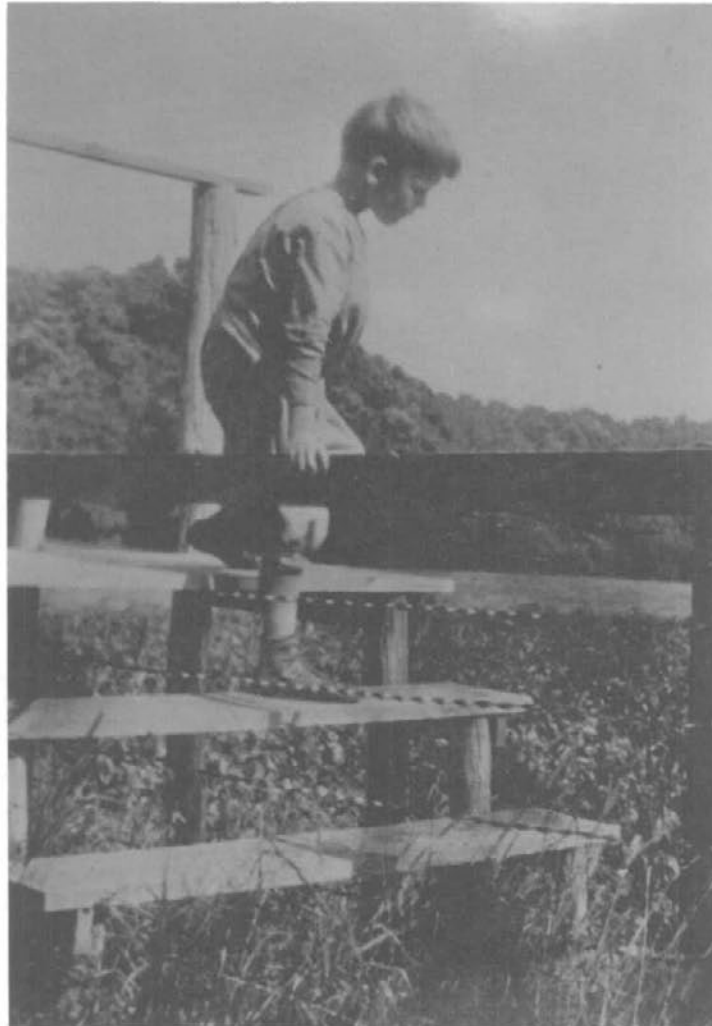
**FIGURE 1.29:** Quentin on stile at Sagamore Hill c. 1905. (SAHINHS, no. 1130, Box 6).

Stiles – Stiles, used to climb over fences or to ascend steep slopes, were purported to exist on the property (see Inner Core: Theodore Roosevelt Stewardship).<sup>86</sup> The only photo documentation of a stile, construction date and location unknown, indicates that the stiles likely were constructed of wood, having steps, platform and handrail (see figure 1.29).

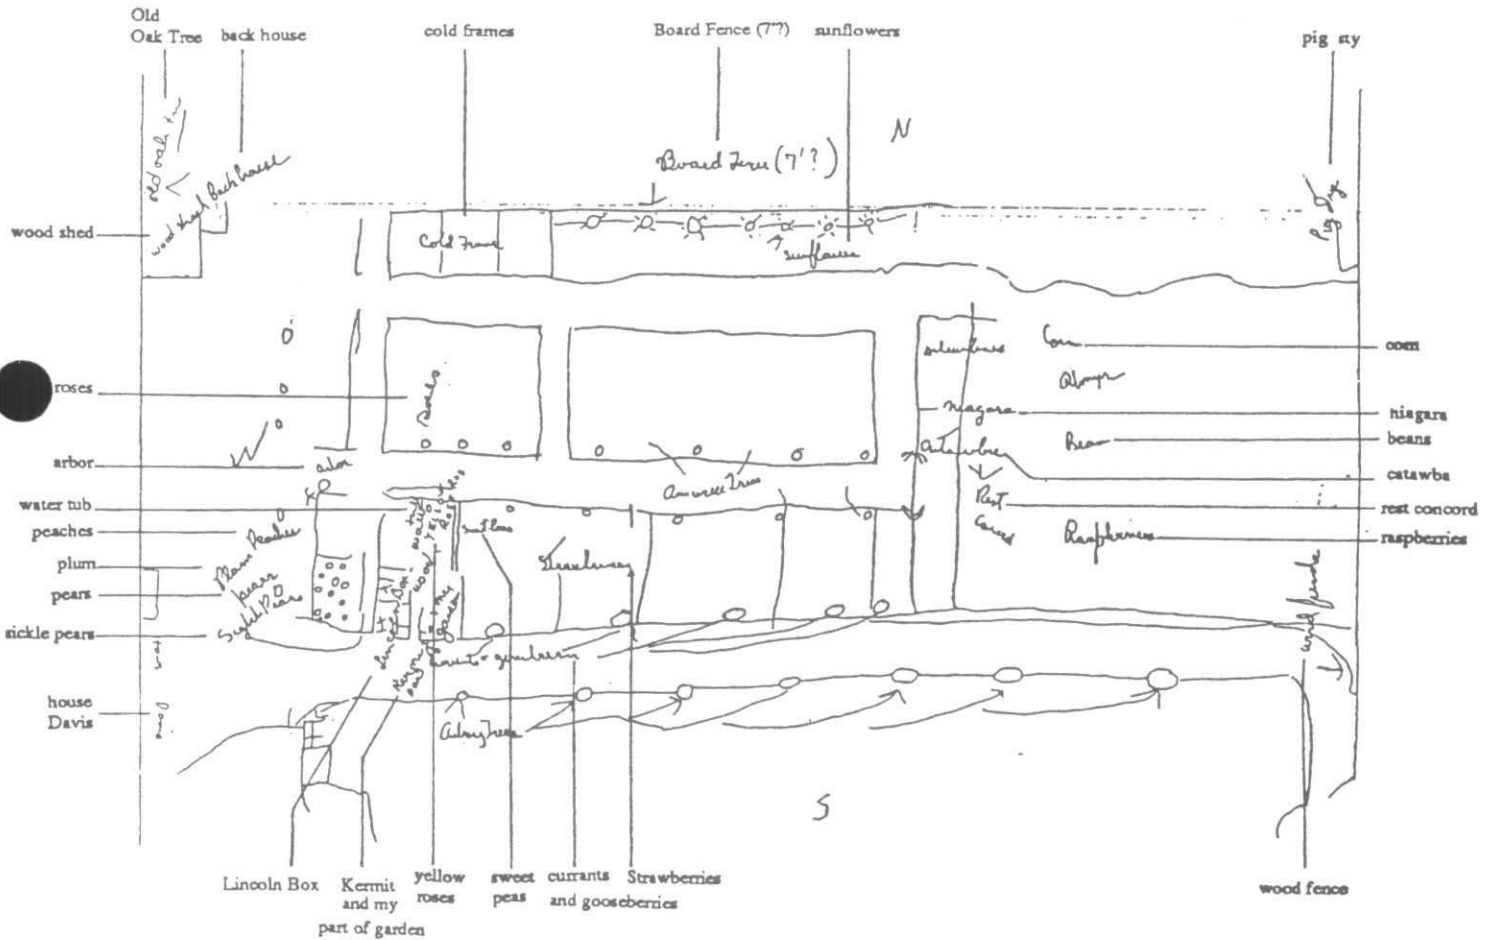
FIGURE 1.30: Archibald Roosevelt's sketch of flower and vegetable garden, n.d. (SAHINHS Archives).

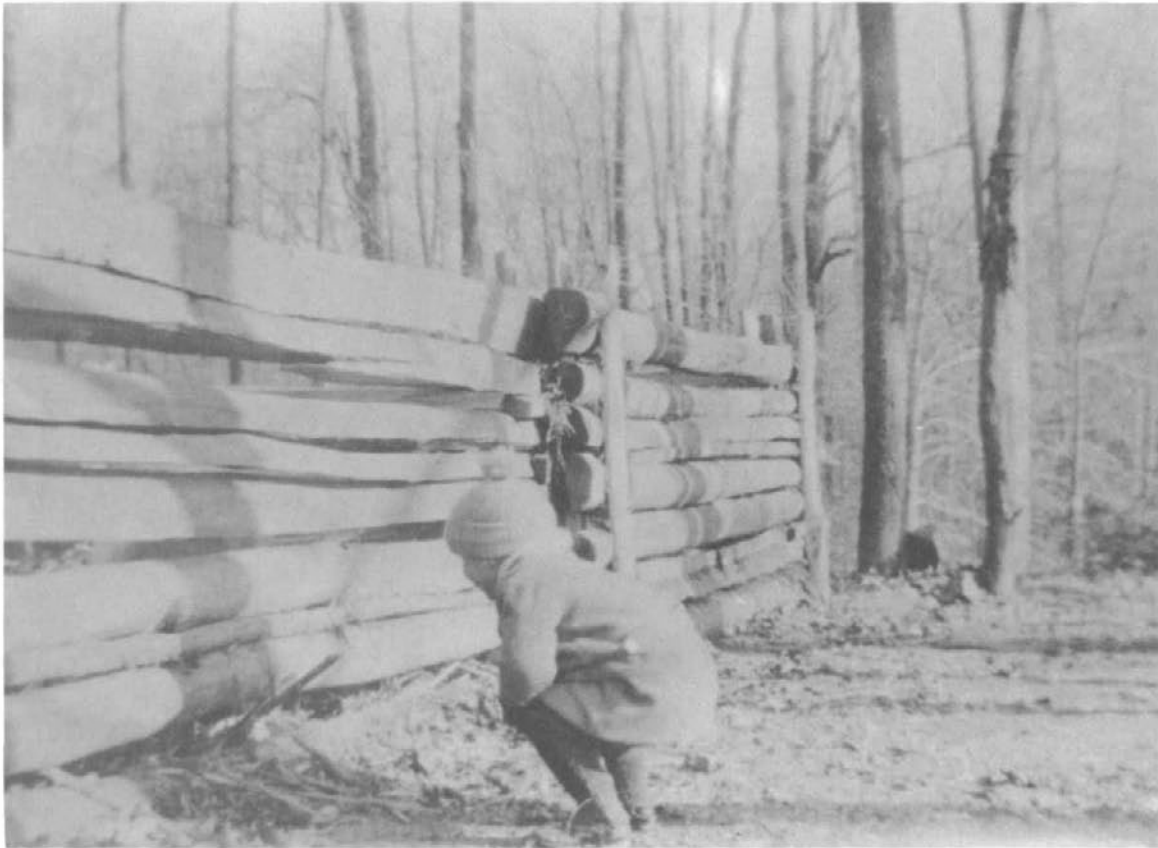
**FIGURE 1.31:** Richard Derby Jr. near pig pen at Sagamore Hill, c. 1918. (SAHINHS, no. 5553, Box 10).

Pig Sty – The pig sty, located in the northeast corner of the garden, was a square wooden pen approximately 20' on a side (see Inner Core: Theodore Roosevelt Stewardship). The pen walls were rails similar to those used for fencing throughout the farm, and placed roughly 2–4" apart. Vertical posts were located on both sides of the rails; the posts were at the corners and midpoints of each wall (see figure 1.31). The pig pen drained into Woodpile Pond; the method of drainage is unknown. The construction date and color of the pig sty are unknown.

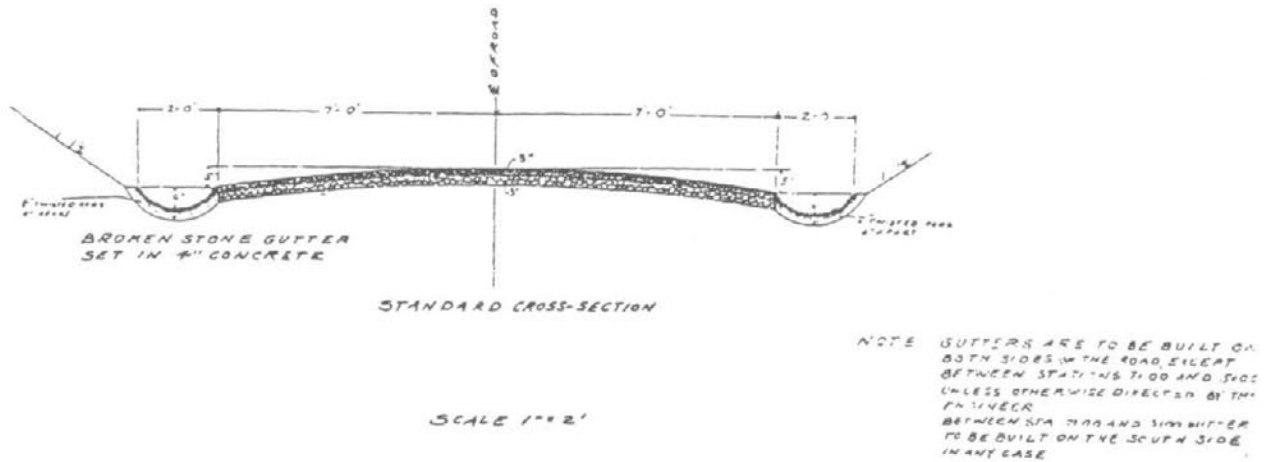
**FIGURE 1.32:** Gutter detail. Redrawn from Hans Rude Jacobsen, *Improvements on the Estate of Theodore Roosevelt, Esquire, Town of Oyster Bay, August, 1911*. (Bellavia, 1993. SUNY CESF).

Drainage gutters were installed in 1911 on both sides of the new entrance road constructed by Hans Rude Jacobsen (see figure 1.32). The gutters were made of broken stone set in 4" of concrete with 1/4" twisted rods 4" on center.

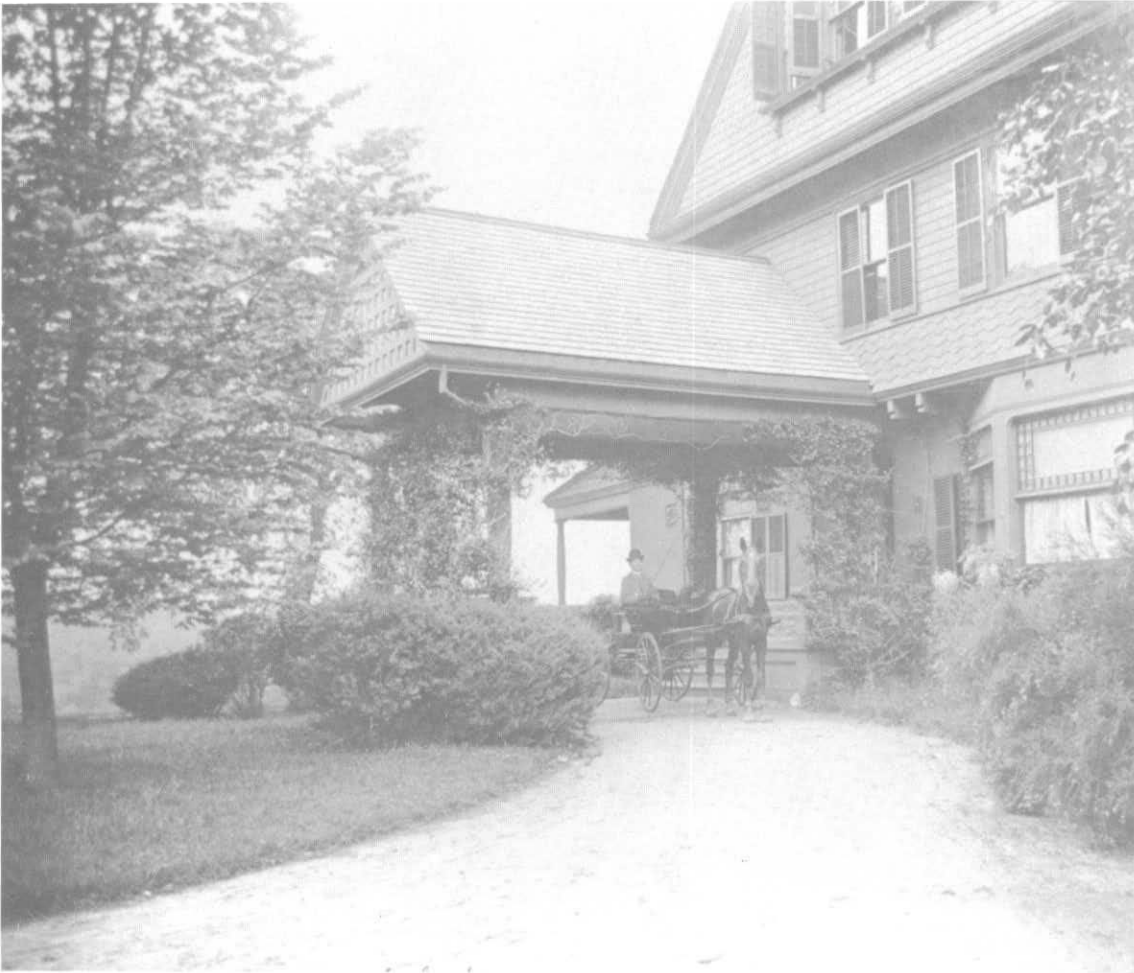
FIGURE 1.42: Vines growing on porte-cochere, 1905. (SAHINHS, no. 1123A, Box 6).

Fiveleaf Akebia (*Akebia quinata*) grew on the porte-cochere and verandah and, until 1905, Boston Ivy (*Parthenocissus tricuspidata*) completely covered the north facade of the house (see figure 1.41, 1.42, 1.43).<sup>127</sup> It seems that the vines (on the north facade) were removed when the north room was added in 1905 (see figure 1.19). Soon after the completion of the North Room, vines were planted at the base of the walls and allowed to cover the new addition (see figure 1.44). In 1922 the addition was engulfed in wisteria (*Wisteria* sp.) (see figure 1.45).

Wisteria (*Wisteria* sp.) grew from below the bay window outside the library (see figure 1.42). Roosevelt referred to this vine late in the period (1911) in a letter to his sister Anna Roosevelt Cowles (Bamie). He wrote, "...I am dictating this at my desk at Sagamore, and just outside the window the wisteria is blooming in masses on the vine that Edith planted with the special purpose of my being able to see it."<sup>128</sup>

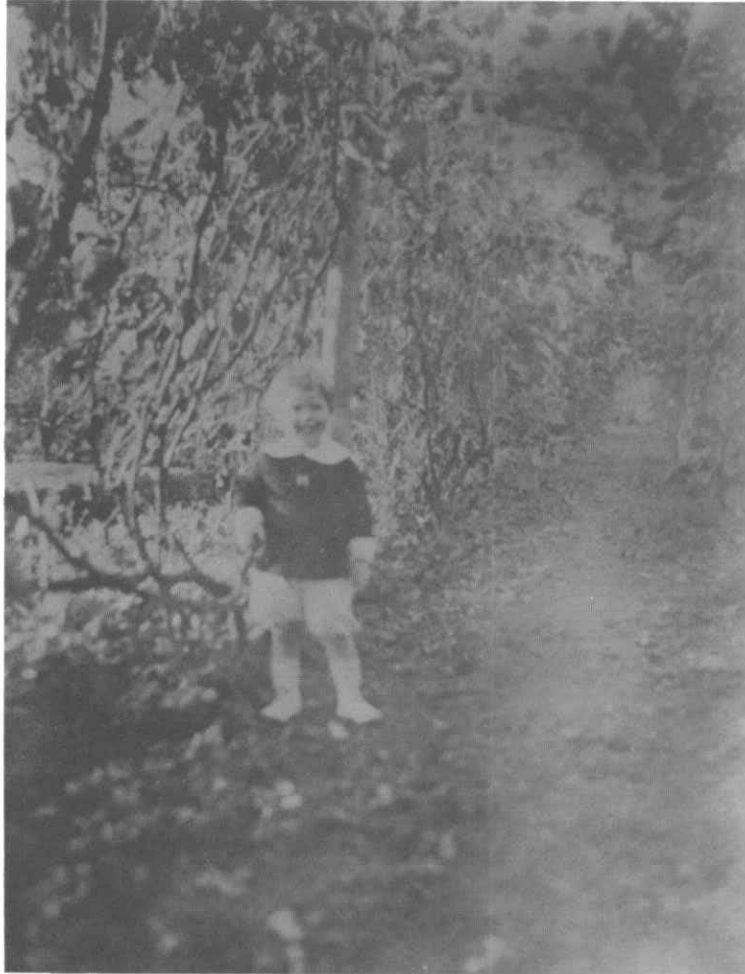
**FIGURE 1.51:** Richard Derby Jr. standing beneath grape arbor at Sagamore Hill, c. 1918. (SAHINHS, Family photo album no. 7644).

Vegetables were grown in the eastern two-thirds of the garden and were separated by a double arbor of grapes. Concord grapes grew south of the path, and Niagara, Catawba, and a third type, possibly Delaware, north of the path (see figure 1.51).<sup>139</sup>

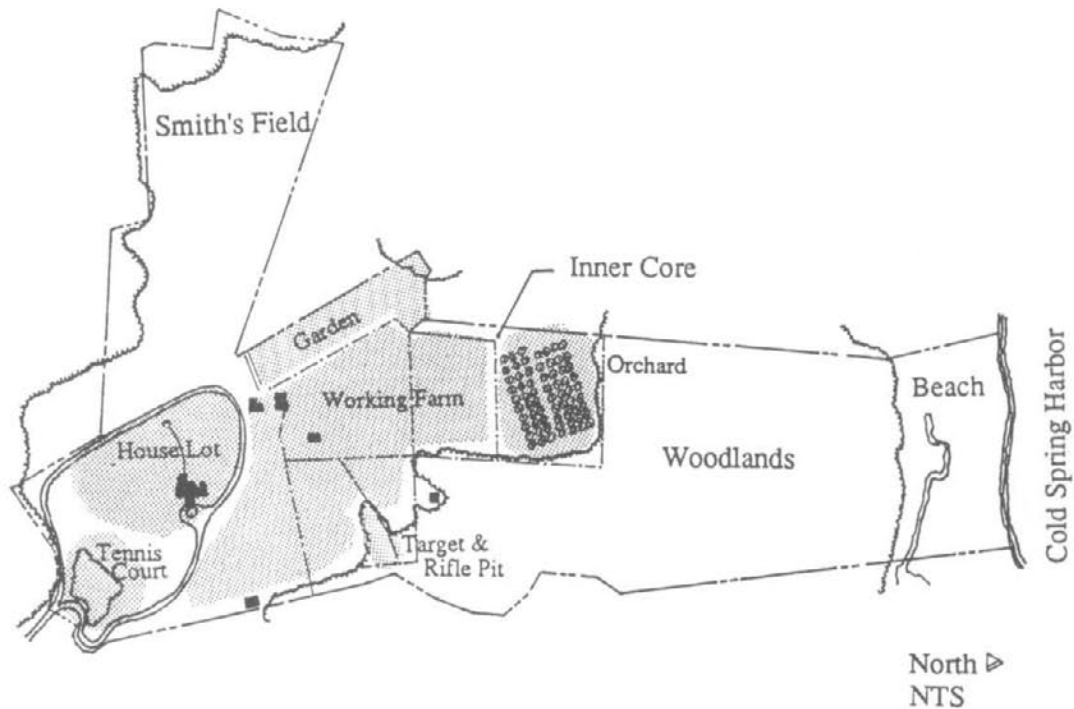
**FIGURE 1.53:** Diagram showing the spatial organization of the property during Theodore Roosevelt's stewardship. (Bellavia, 1993. SUNY CESF).

The three-dimensional organization of physical and visual forms define the character of the historic landscape. The landscape elements discussed thus far make up the base plane, vertical plane and overhead plane that create spaces in the landscape. The spatial organization of the site is the relationships between these spaces. Sagamore Hill was divided into four major spaces defined primarily by use; the inner core (including the house lot, working farm, flower and vegetable garden, orchard, tennis court, and target and rifle pit), woodlands, beach, and Smith's Field (see figure 1.53).

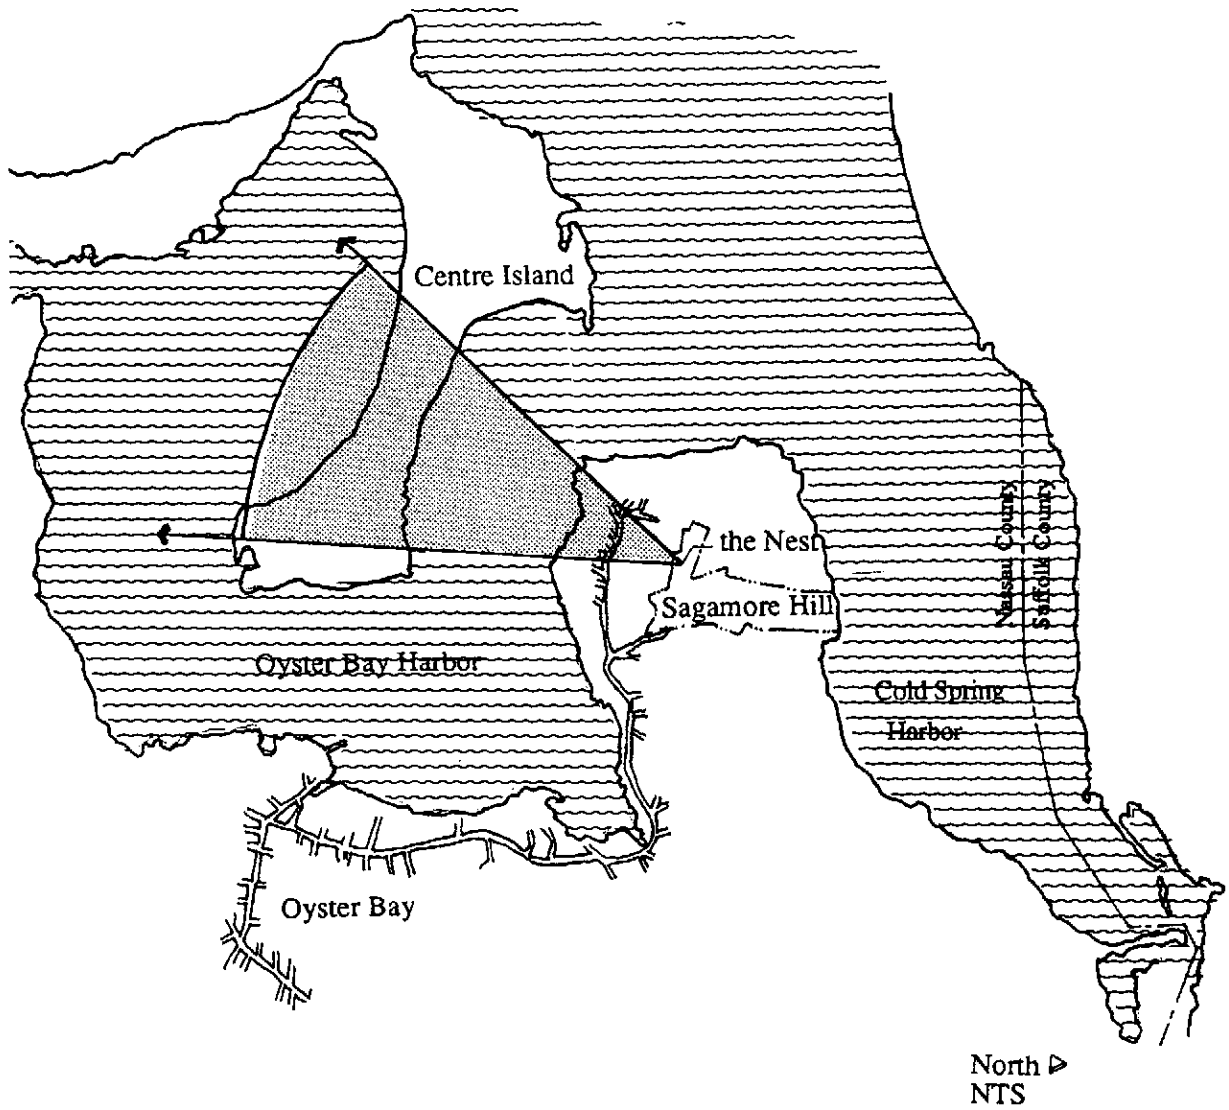
FIGURE 1.54: Diagram showing viewshed from the "Nest" to Oyster Bay Harbor and Long Island Sound. (Bellavia, 1993. SUNY CESF).

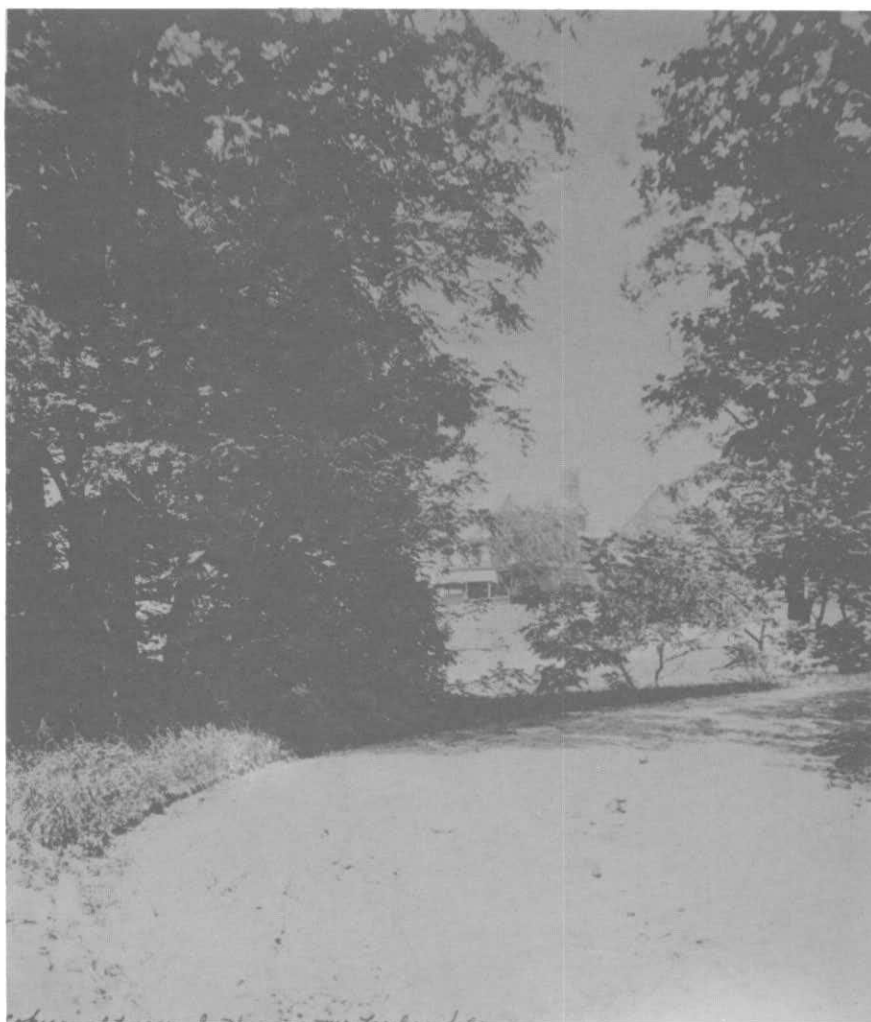
**FIGURE 1.55:** View of Sagamore Hill from carriage road, 1905. (SAHINHS, no. 1071, Box 5).

The carriage road was compacted soil that varied in width (see figure 1.55). According to one source, it was "...only about twelve feet wide at a certain place...."<sup>166</sup> The last 150'–200' of the road was perpendicular to the south facade of the house and terminated in a circular drive that went under the porte-cochere (see figure 1.35, Inner Core: Theodore Roosevelt Stewardship). The area underneath the porte-cochere was paved with brick laid in a herringbone pattern (see figure 1.58).

There also was a significant view to the house from the approach on the main entrance drive from the southwest (see figures 1.55, 1.56). "It [the house] is approached by a steep, winding roadway, which takes the visitor through a dense wood before revealing to him the house itself..."<sup>162</sup> In 1905, a reporter wrote, "...now it [the road] reaches back at a higher elevation; until finally there comes into view a house on a hilltop, swept by salt breezes."<sup>163</sup> This view was changed in 1911 when a new entrance road was built. No information regarding the new view of the house was found during the research for this report.

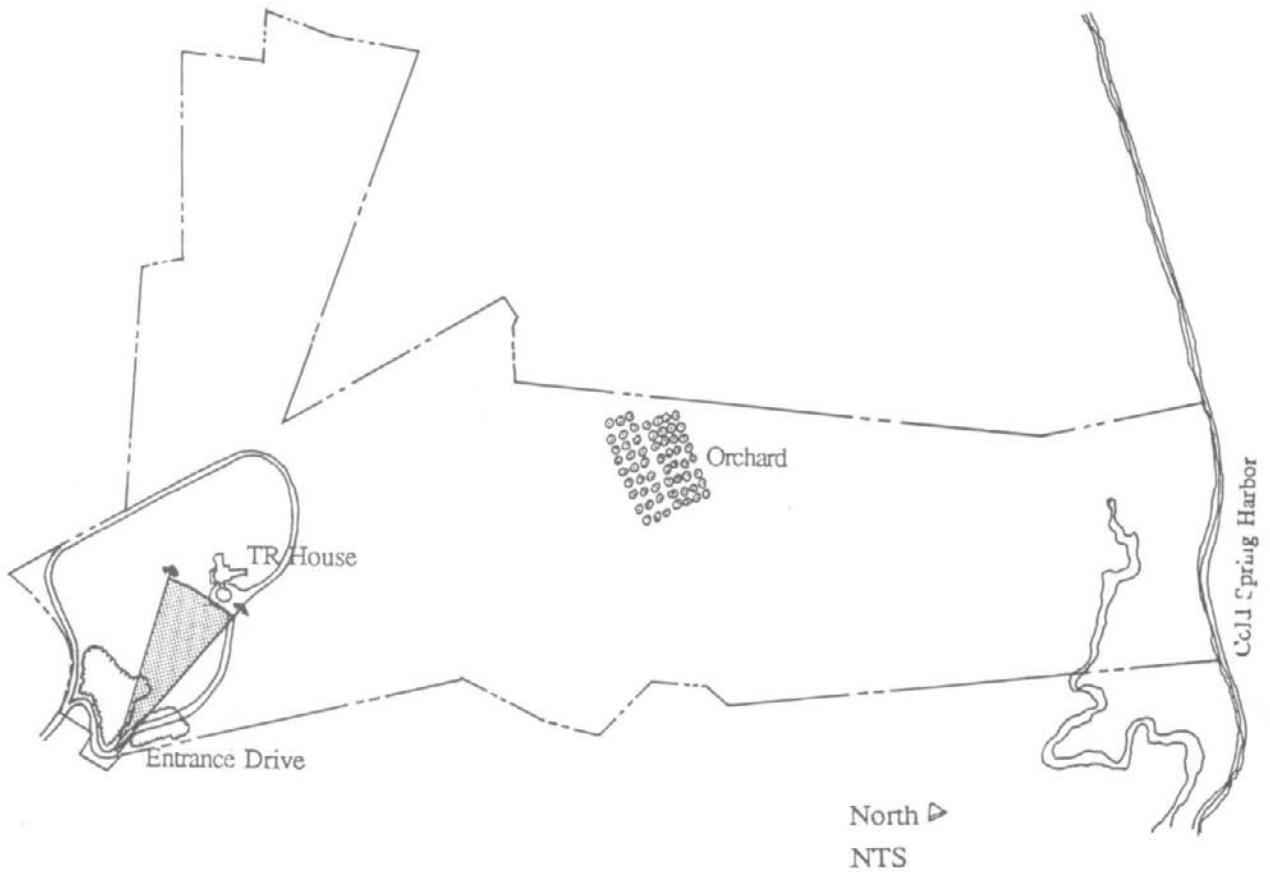
**FIGURE 1.56:** Diagram showing viewshed from entrance drive to Sagamore Hill. (Bellavia, 1993. SUNY CESF).

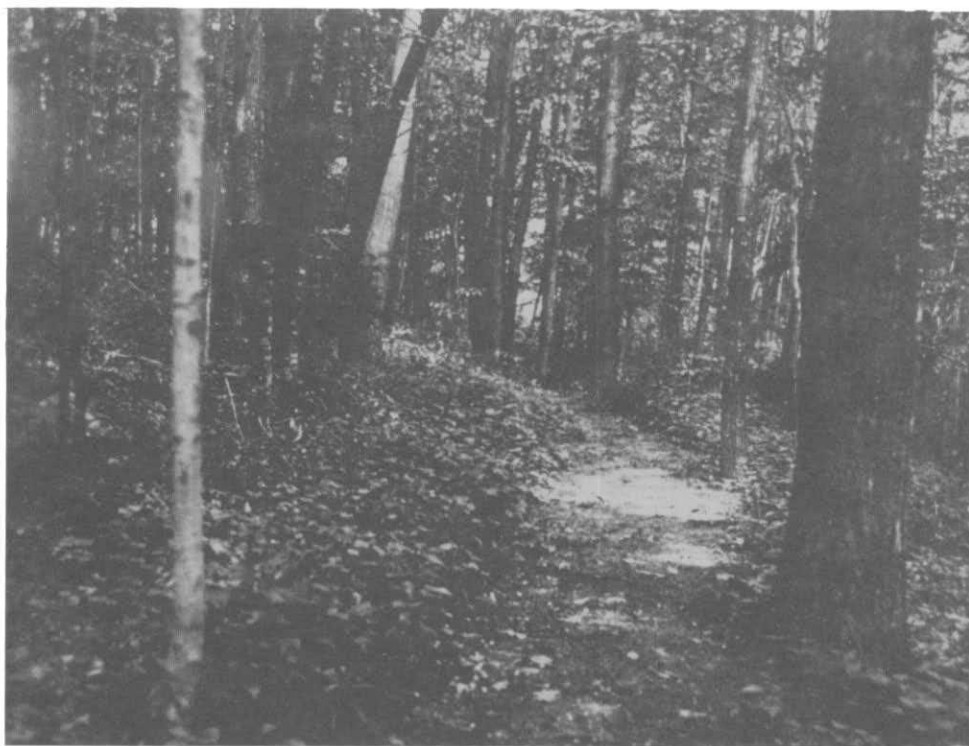
**FIGURE 1.57:** Path to Cold Spring Harbor , n.d. (SAHINHS, no. 1141, Box 6).

There were trails and farm roads located in the outer acreage of the estate. These were the less frequented routes and therefore were narrow and simple in design and materials, just compacted soil. The farm roads originated in the inner core (and are discussed in that section). There were trails that led to the beach and to the "Nest". These were narrow, compacted soil paths that varied in width (see figure 1.57). The general locations of these paths are shown on the period plan.<sup>164</sup>

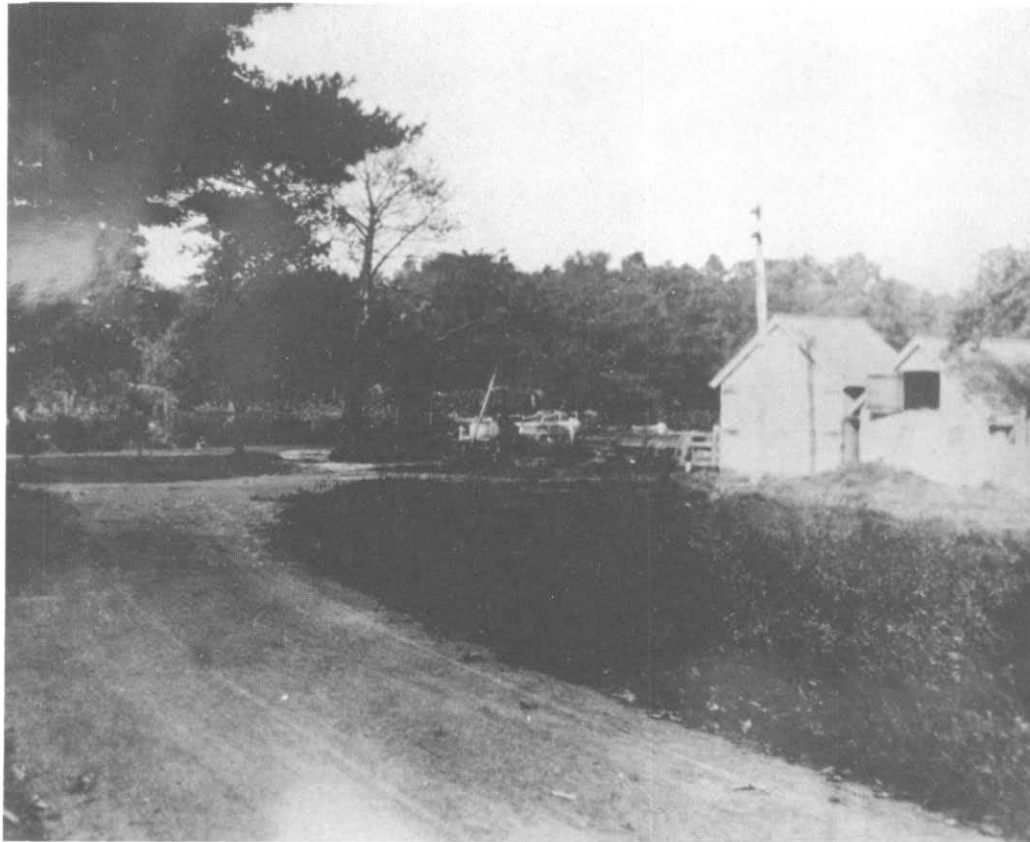
**FIGURE 1.59:** View toward garden, path in middleground in center of photo, c. 1925. (SAHINHS, no. 1104, Box 6).

Fences – There were many fences at Sagamore Hill that separated the fields, pastures, orchard, and woodland (see Overall Site: Theodore Roosevelt Stewardship). Their main function was to control the livestock.<sup>171</sup> There were several different types, but perhaps the most frequently used fence was the post and rail. The post and rail fence, such as the one seen in figure 1.61, was constructed of four wooden rails with posts approximately every 10'. It was used to delineate pastures from plowed fields. This fence type enclosed the field where the new barn was located (see figure 1.61). It also was used north of the carriage house, then northeast alongside the garden and enclosed the pasture west of the orchard (see figure 1.59).

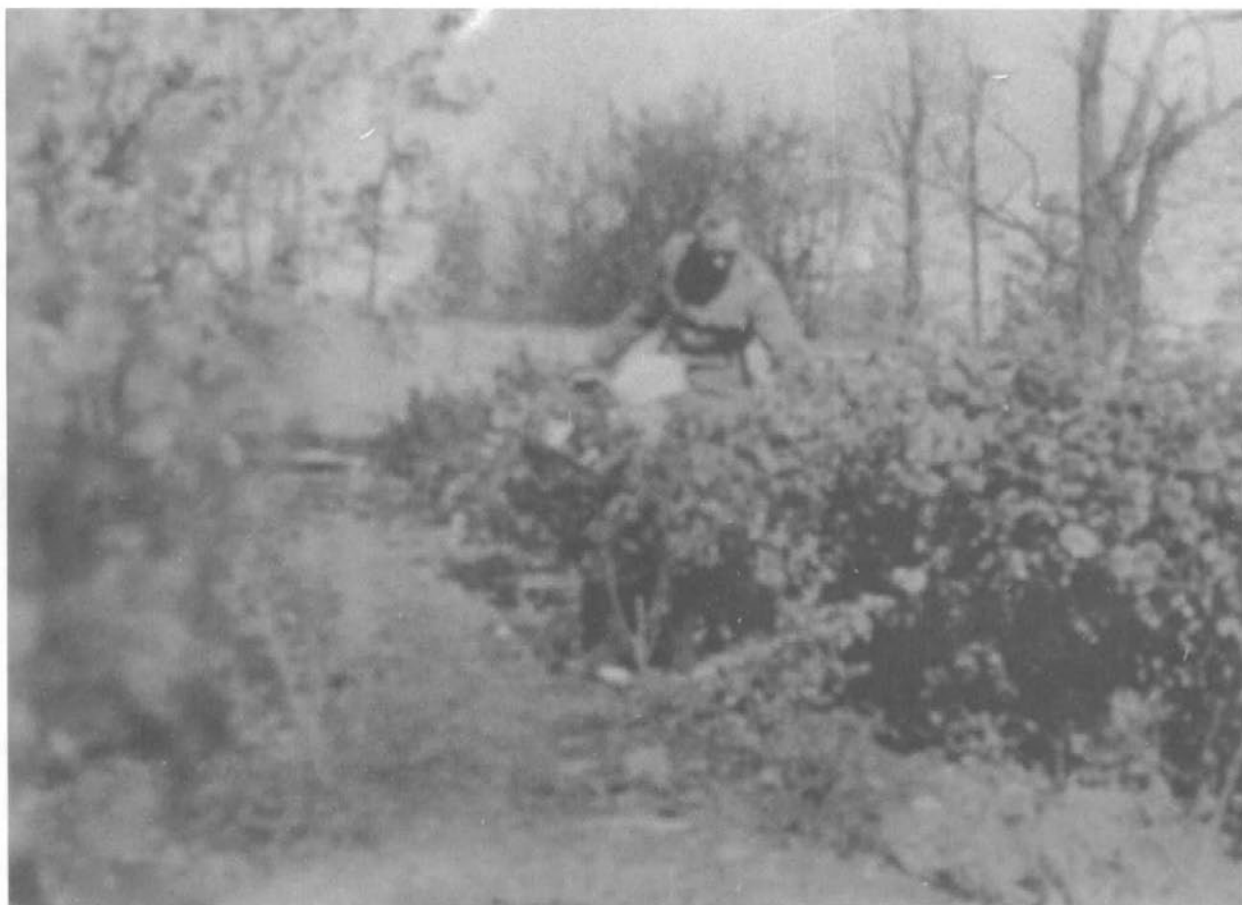
**FIGURE 1.60:** Richard Derby Sr. in vegetable garden at Sagamore Hill, paths between rows of vegetables, c. 1917. (SAHINHS, Family photo album no. 7644).

There were additional paths in the garden; these paths were approximately 4' wide, less formal, and compacted soil. They were located under the grape arbor and between rows of vegetables (see figure 1.51, 1.60).

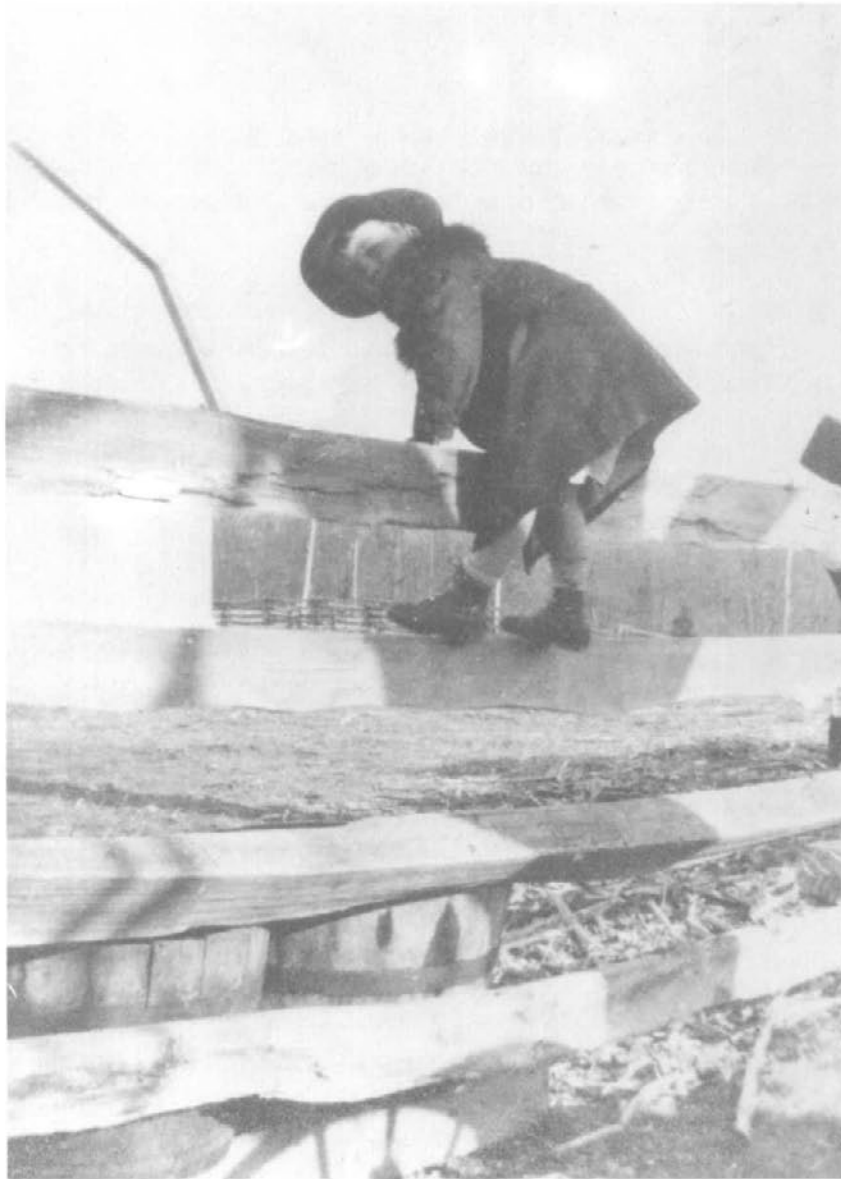
**FIGURE 1.61:** Post and rail fence at Sagamore Hill, new barn in background on left side of photo, water tubs in foreground, c. 1918. (Theodore Roosevelt Collection, Harvard College Library. By permission of the Houghton Library, Harvard University).

Water Tub – A round wooden water tub approximately 24" high was located in the garden east of the arbor in circa 1918 (see figure 1.67). A spigot supplying running water was located above it.<sup>177</sup> At least two similar water tubs were located on the west side of the new barn along the split-rail fence (see figure 1.61).

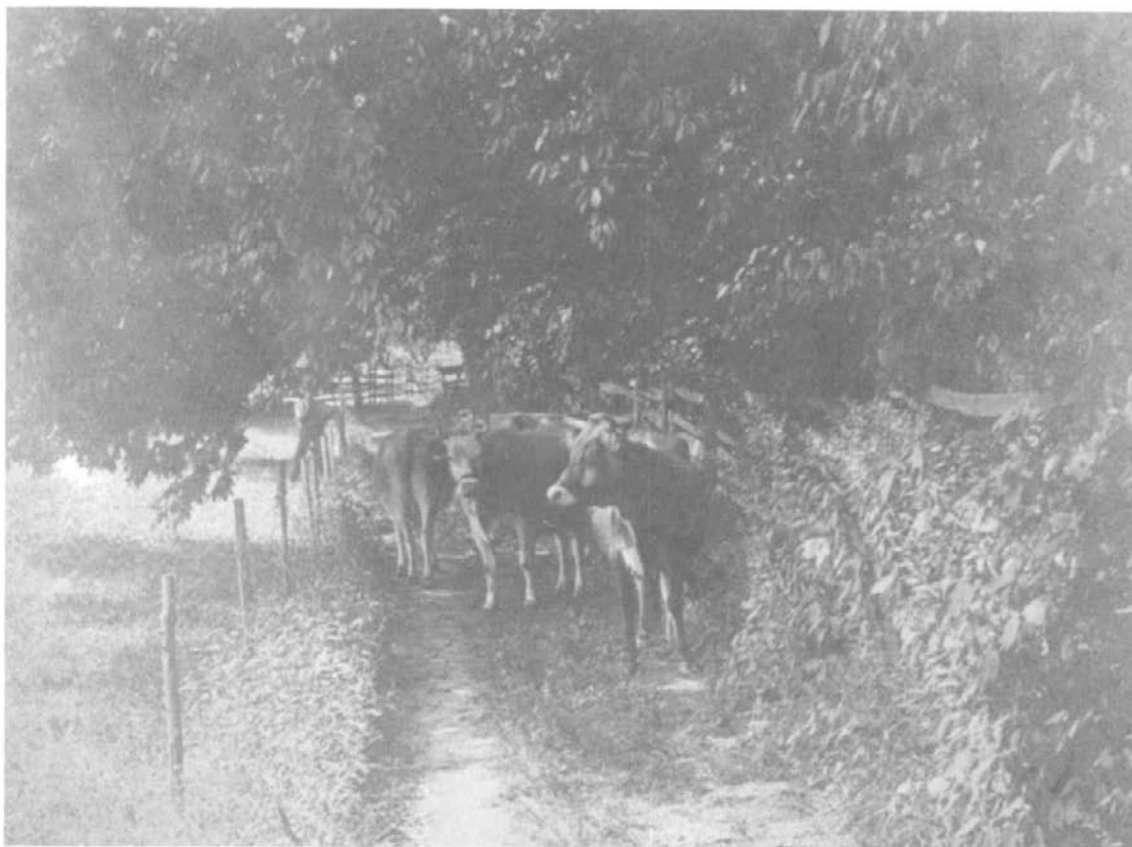
**FIGURE 1.62:** Cows on path to orchard, post and rail fence on right side, post and wire on left side, 1907. (SAHINHS, no. 1111, Box 6).

Another fence type was post and wire; made of posts and a top rail with four single strands of horizontally strung twisted wire spaced evenly apart (see figure 1.29).<sup>172</sup> One of the roads was fenced on one side with post and rail and on the other with post and wire (see figure 1.62). Some of the wire fencing was erected in 1904, but it is unclear at which location.<sup>173</sup> The fence located behind the old farm barn, running east to west, was a simpler fence, having posts with a single top rail (see figures 1.13, 1.14).

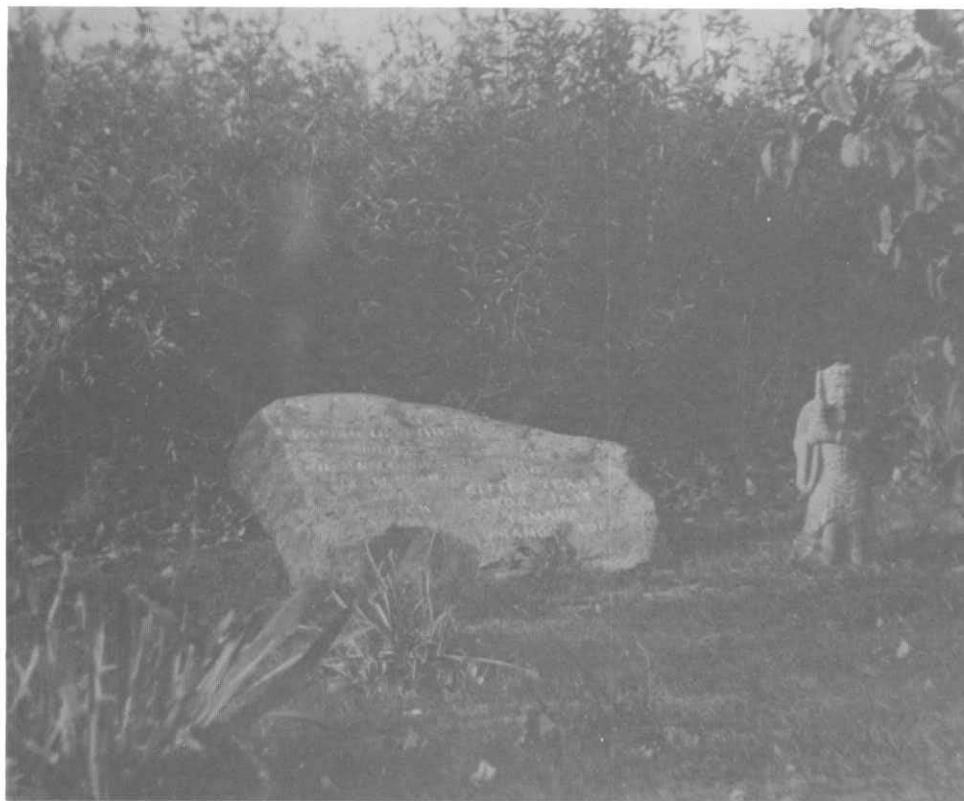
FIGURE 1.64: Pet cemetery stone at Sagamore Hill, n.d. (SAHINHS, no. 3901, Box 9).

Pet Cemetery Stone – The pet cemetery where the Roosevelt children buried their pets was located north of the house and just south of the service road. A stone with the pets' names carved in it marked the grave area. The inscription on the stone was:

There was an oriental stone monument located approximately 1' from the cemetery stone (see figure 1.64).

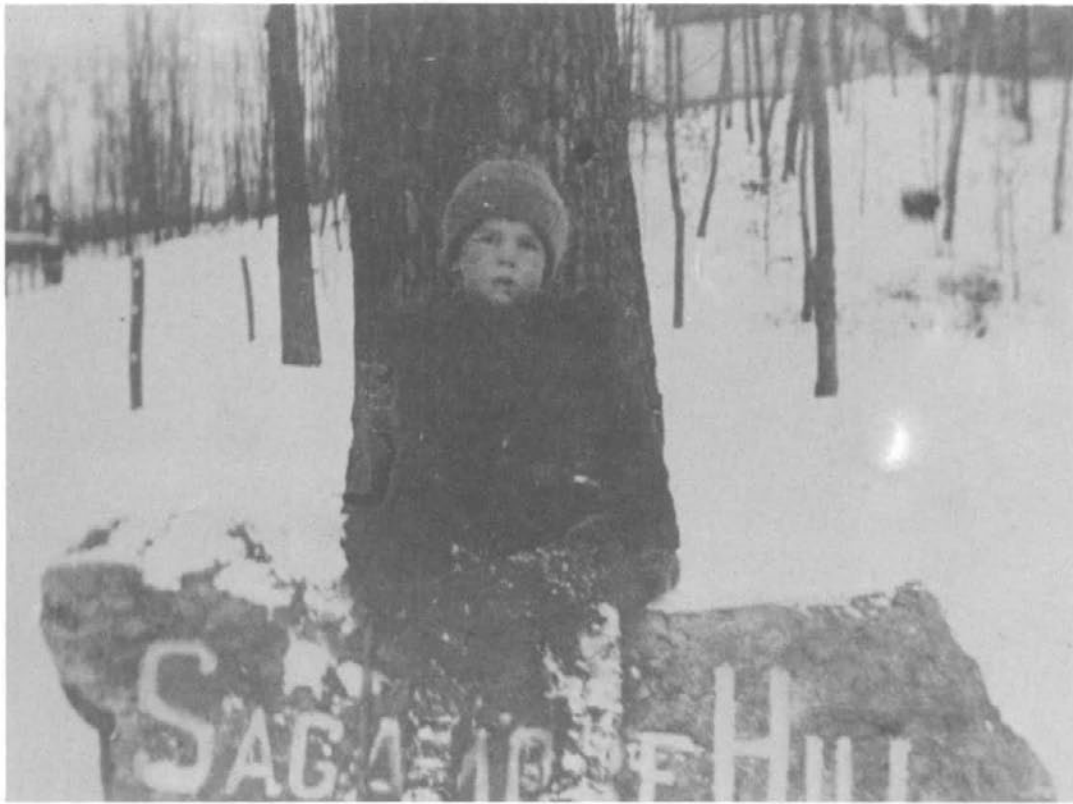
**FIGURE 1.65:** Richard Derby Jr. standing in front of Sagamore Hill rock, c. 1919. (SAHINHS, Family photo album no. 7644).

Sagamore Hill Rock – A rock of unknown location, with the words "Sagamore Hill" carved in it with the letters painted white was present during this period (see figure 1.65).
