# CULTURAL LANDSCAPE REPORT

## FOR SAGAMORE HILL

### NATIONAL HISTORIC SITE

Site History, Existing Conditions, and Analysis

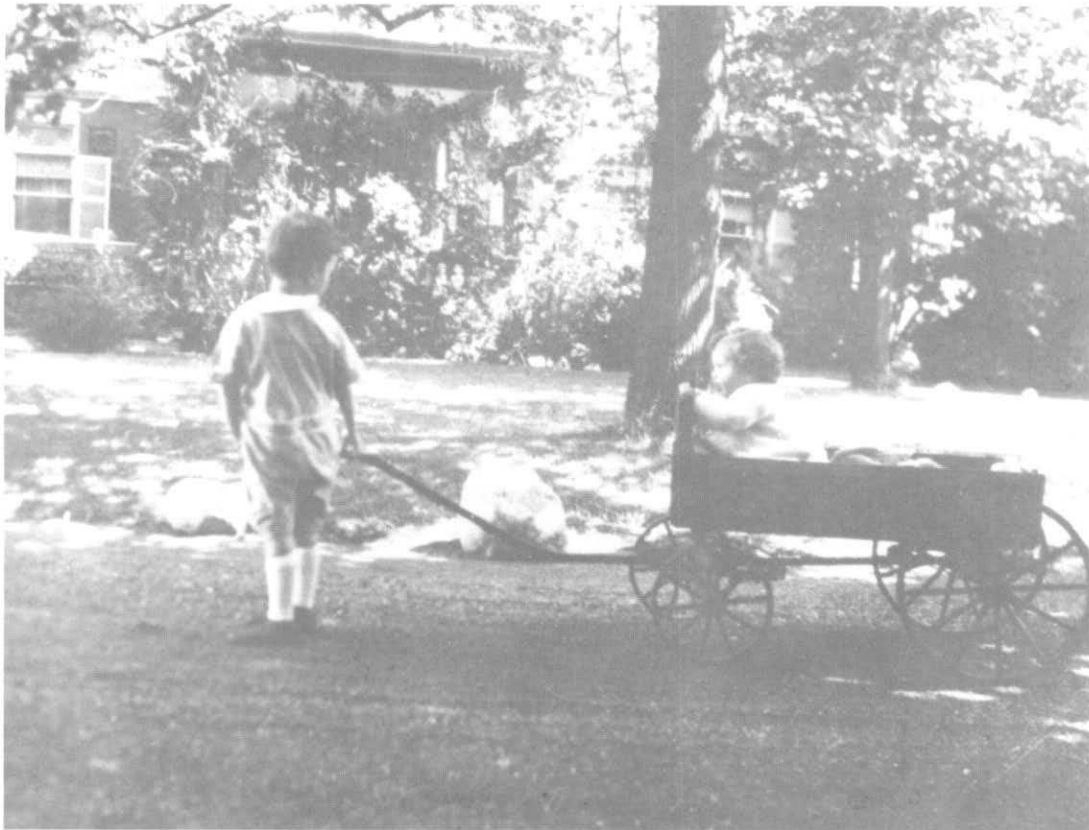
**FIGURE 1.66:** Richard Derby Jr. on circular drive in front of Sagamore Hill, c. 1918. (Theodore Roosevelt Collection, Harvard College Library. By permission of the Houghton Library, Harvard University).

Rocks Around Circular Drive – Toward the end of the period, circa 1918, rocks were located around the circular drive (see figure 1.66). They were spaced evenly apart, approximately 5' on center.

Rocks Around Circular Drive – Rocks were located along the circular driveway during the period (see figures 1.39, 3.7). The rocks on the outside perimeter of the circle were small and spaced only 1–6" apart (see figure 3.4). The rocks around the perimeter of the interior circle were larger and spaced between 5–15' apart. Similar or possibly the same rocks existed in Period One (see figure 1.66).

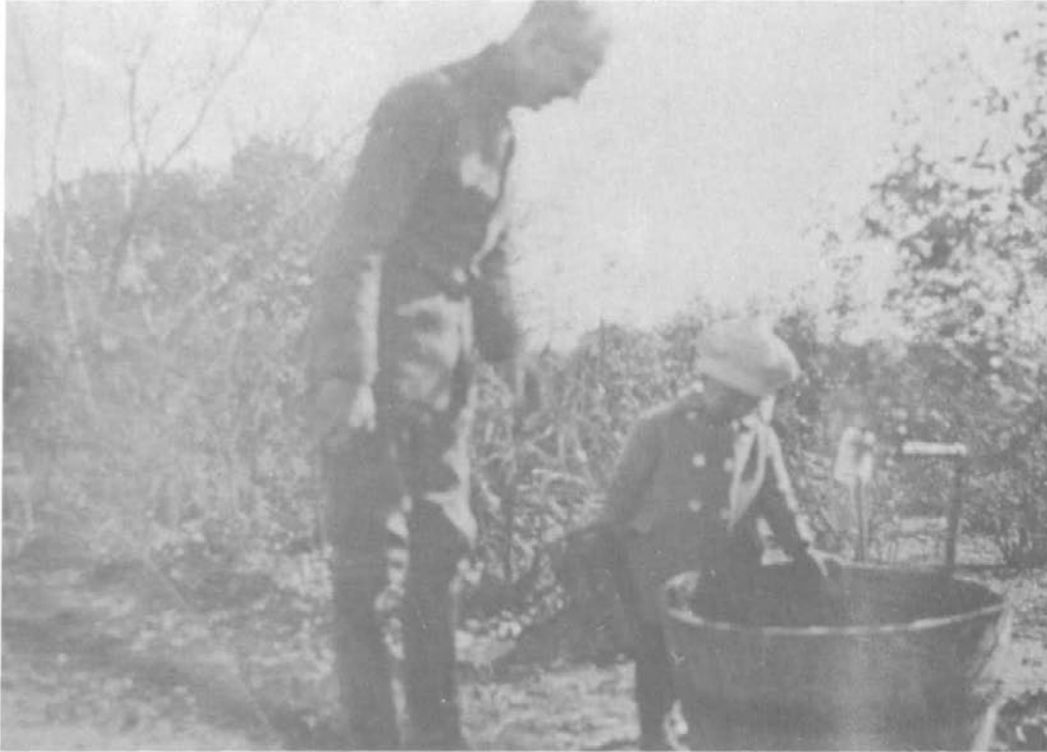
**FIGURE 1.67:** Richard Derby Sr. and Jr. in garden near water tub, c. 1918. (SAHINHS, Family photo album no. 7644).

Water Tub – A round wooden water tub approximately 24" high was located in the garden east of the arbor in circa 1918 (see figure 1.67). A spigot supplying running water was located above it.<sup>177</sup> At least two similar water tubs were located on the west side of the new barn along the split-rail fence (see figure 1.61).

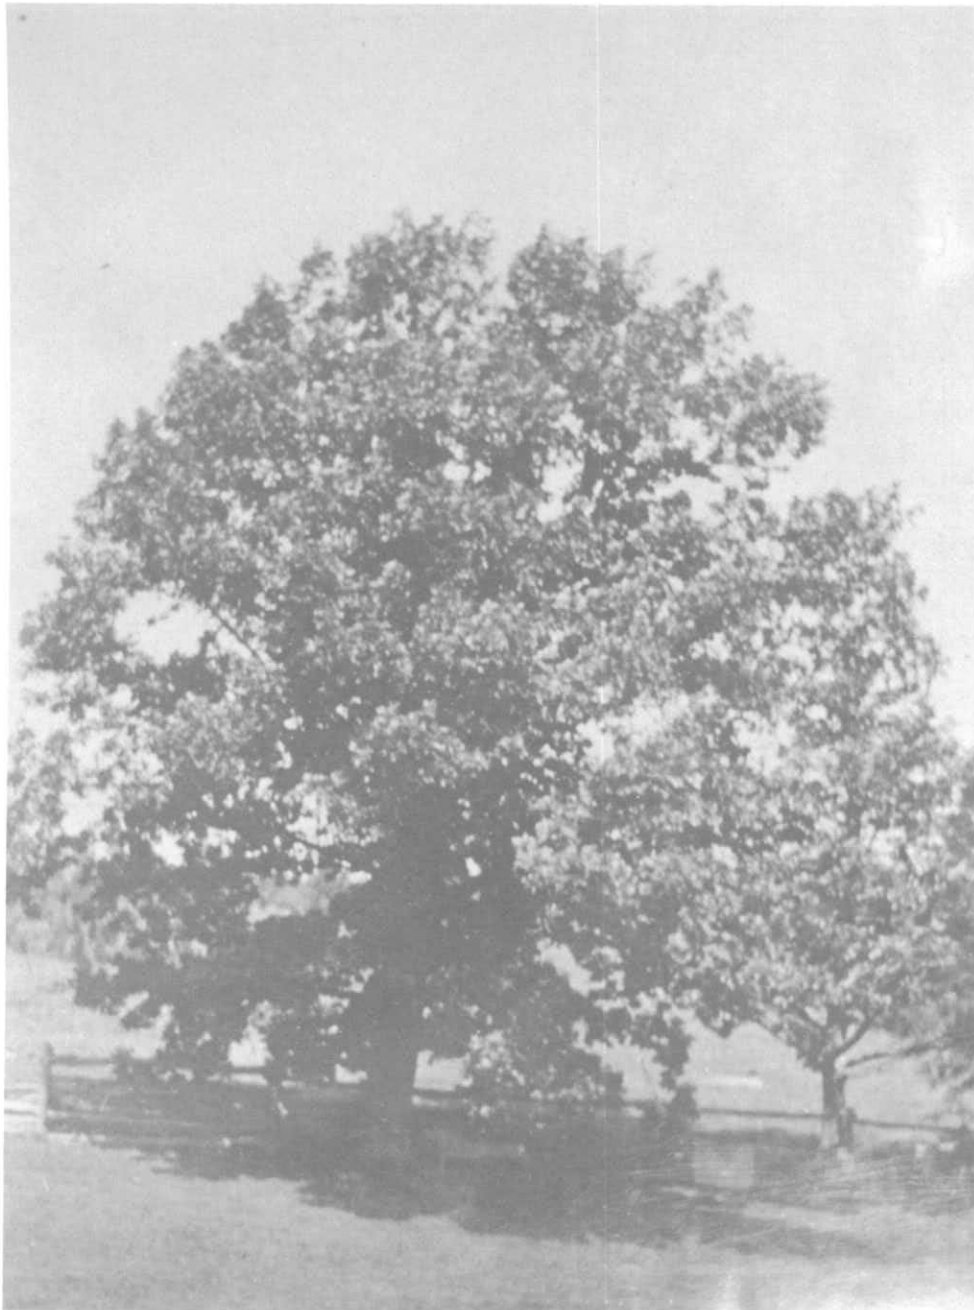
**FIGURE 1.68:** White bench underneath oak tree at Sagamore Hill, n.d. (SAHINHS, no. 1138, Box 6).

White Bench – There was a white bench located under a large white oak tree (see figure 1.68). The bench was white marble, given to the Roosevelts by Oscar Straus.<sup>178</sup> Although this location remains undetermined, the same bench also was seen located near the North Room and covered with wisteria (*Wisteria* sp.) vines.<sup>179</sup>

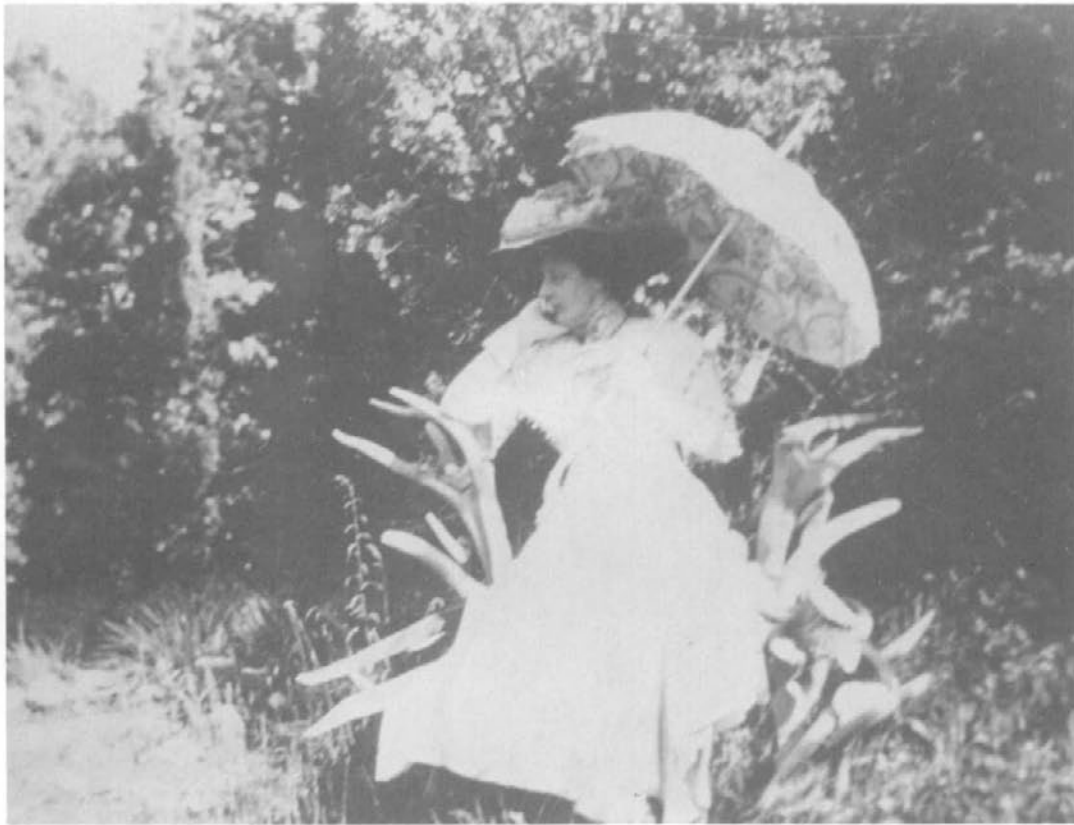
FIGURE 1.69: Mrs. Roosevelt in elkhorn chair, c. 1904. (SAHINHS, no. 9342, Box 14).

Elkhorn Chair – The elkhorn chair was placed in a variety of locations at different times, including out in the landscape and on the verandah by the front door (see figure 1.69). It also was used by the Secret Service men during Theodore Roosevelt's Presidency. After being exposed to many winters, it became "twisted and snarled up" and put in the dump heap.<sup>180</sup>

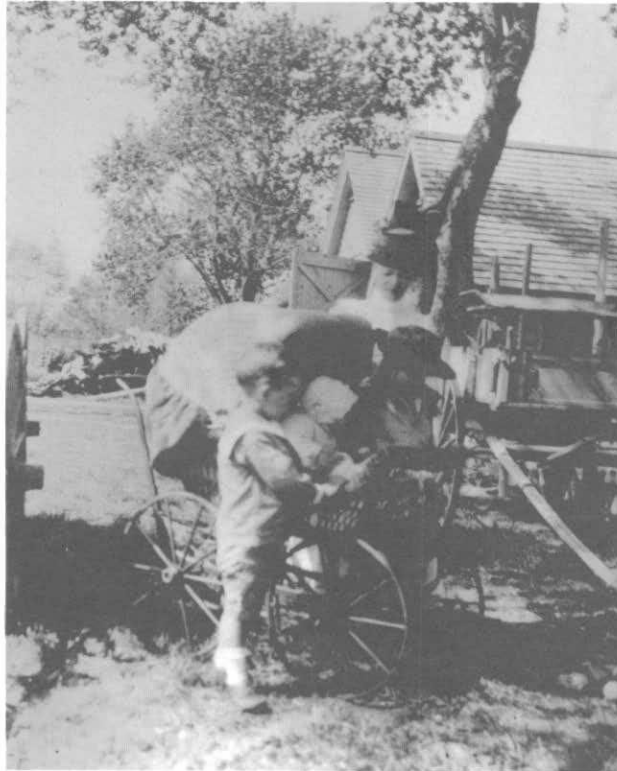
**FIGURE 1.70:** Richard Derby Jr. southwest of chicken coop and carriage house, c. 1918. (Theodore Roosevelt Collection, Harvard College Library. By permission of the Houghton Library, Harvard University).

Other miscellaneous objects were located on the site during this period, including woodpiles, and several objects whose functions are unknown. One woodpile was located northwest of the carriage house and appeared to be a pile of fence rails (see figure 1.70). There were, undoubtedly, piles of wood that Theodore Roosevelt had chopped for the fireplaces, but no specific location is known. Unidentified objects can be seen in an early 1900's photo underneath the tree on the northwest corner of the North Room; in a 1905 photo on the east side of the lodge; in an unidentified location in circa 1918 (see figures 1.47, 1.71).<sup>186</sup> There were four wooden posts approximately 4–5' high stuck in the ground and forming a square, with two cross members on at least two sides connecting the posts. A row of posts about 10' high was located in front of the carriage shed and chicken coop and tool shed. The row ran along the west facades of the buildings for more than 100' (see figure 1.22). Use and the length of time it remained there is unknown.

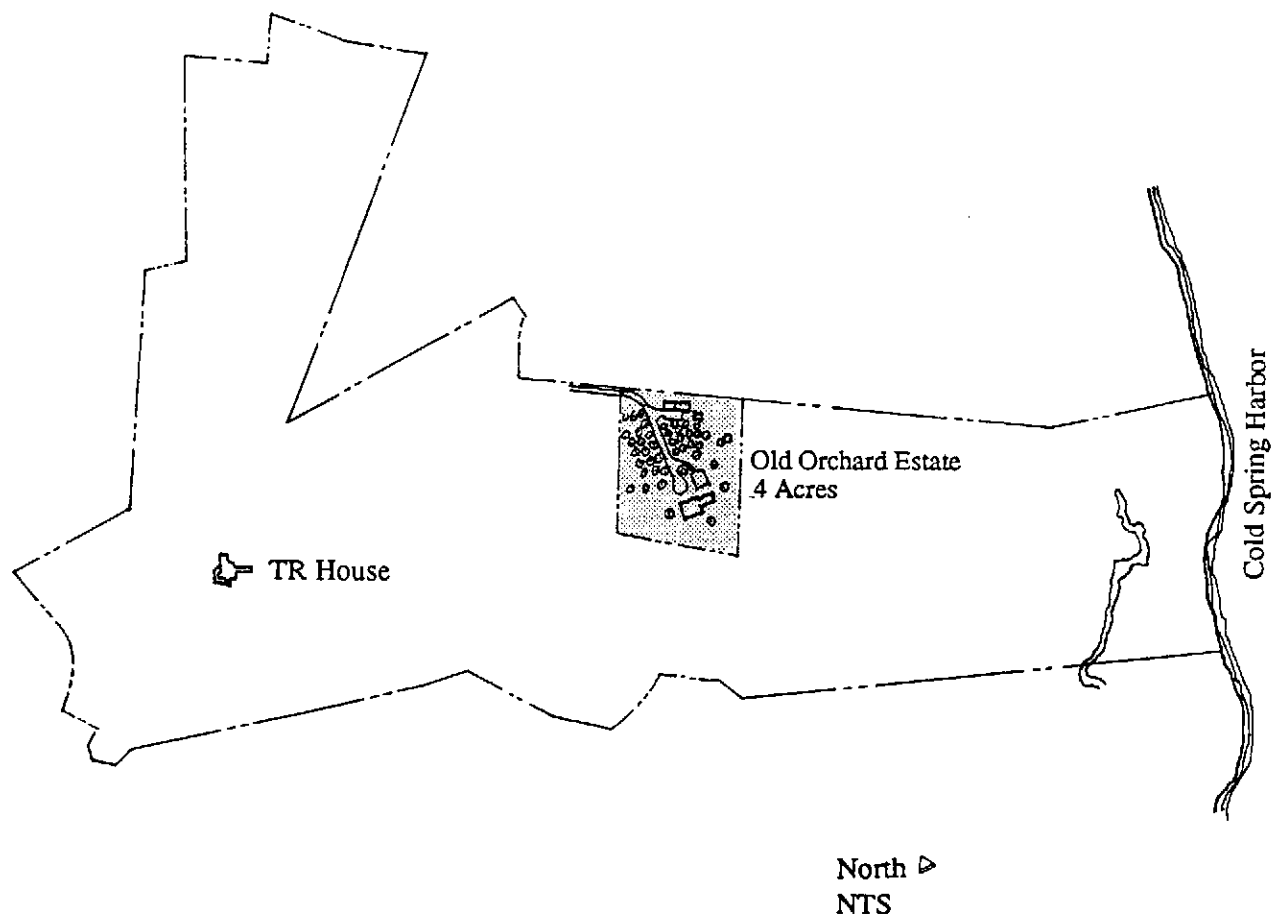
FIGURE 2.1: Map showing lot given to Eleanor B. Roosevelt in 1945. (Bellavia, 1993. SUNY CESF).

The boundaries of the site changed in this period when Mrs. Roosevelt gave a four-acre lot of land to Theodore Roosevelt, Jr. in the area of the old orchard (see figure 2.1). Although Theodore Roosevelt, Jr. and his wife built a house and two other buildings on this parcel in 1938, the land transfer did not occur officially until 1945, approximately one year after Theodore, Jr.'s death.<sup>190</sup> The original plans were for him and his wife to inherit Sagamore Hill upon the death of Mrs. Roosevelt; but, before that could happen, they became tired of living in apartments, and Mrs. Roosevelt agreed to let them build in the area of the orchard. Sagamore Hill thus consisted of approximately 83 acres from this transfer in 1945 until the end of this period of history.

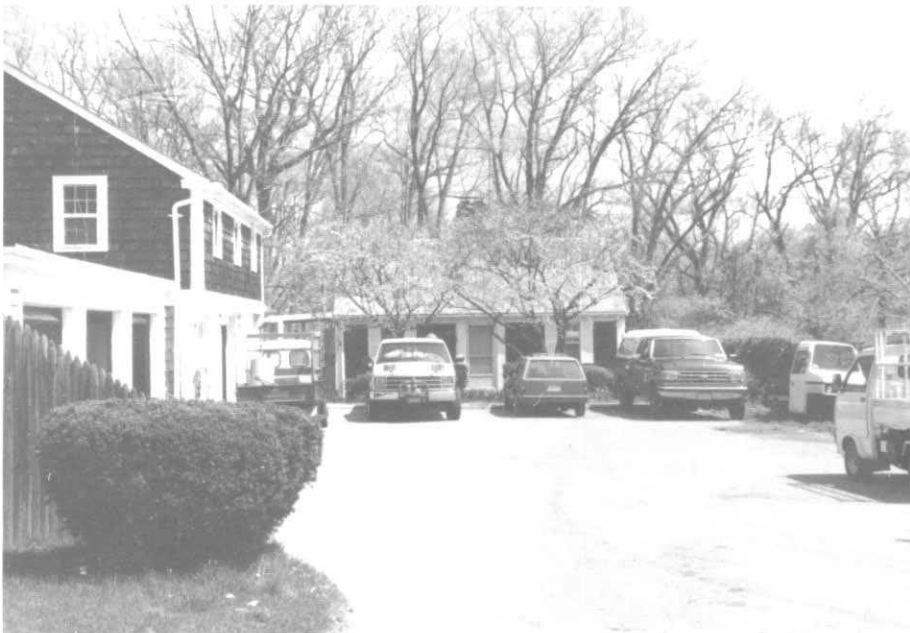
**FIGURE 2.4:** Foreman's Cottage, 1993. (Photograph by author).

Foreman's Cottage – The foreman's cottage, constructed in 1938, was the home of the head groundskeeper for the Old Orchard estate. It was located approximately 250' north of Old Orchard; the front of the building faced west (see Inner Core: Mrs. Roosevelt Stewardship). It was a one and one-half story, rectangular block approximately 50'x35' and clad with wood shingles painted brown (see figure 2.4).

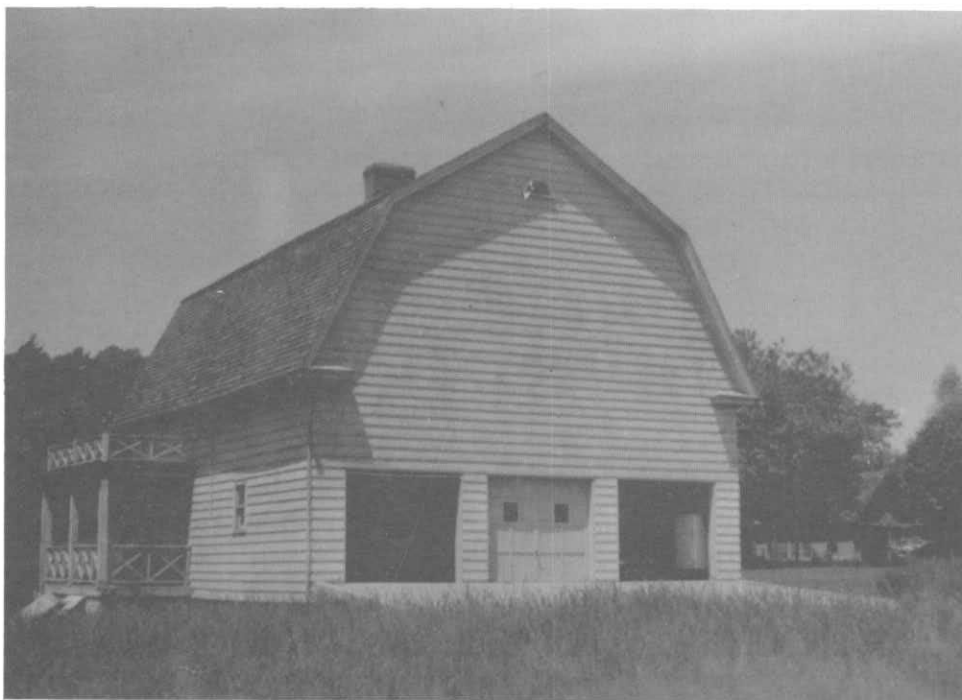
**FIGURE 2.6:** New barn converted to three-car garage and residence, 1950. (SAHINHS, TRA Materials, Box 5, Folder 2, GAIC "G").

New Barn – The new barn was converted to a three car garage and servants' living quarters after the stable and lodge burned. A living room and kitchen were located on the first floor, and two bedrooms and one bath on the second floor. Almost half of the cubic (foot) area of the new barn was unused during Period Two.<sup>195</sup> The alterations included: a partition separating the 32' x 18' dwelling section from the 32' x 24' garage, a 14' x 16' basement under the dwelling, a porch on the south side, and a brick chimney for the boiler and kitchen coal stove replacing the cupola (see figure 1.21, 2.6).<sup>196</sup>

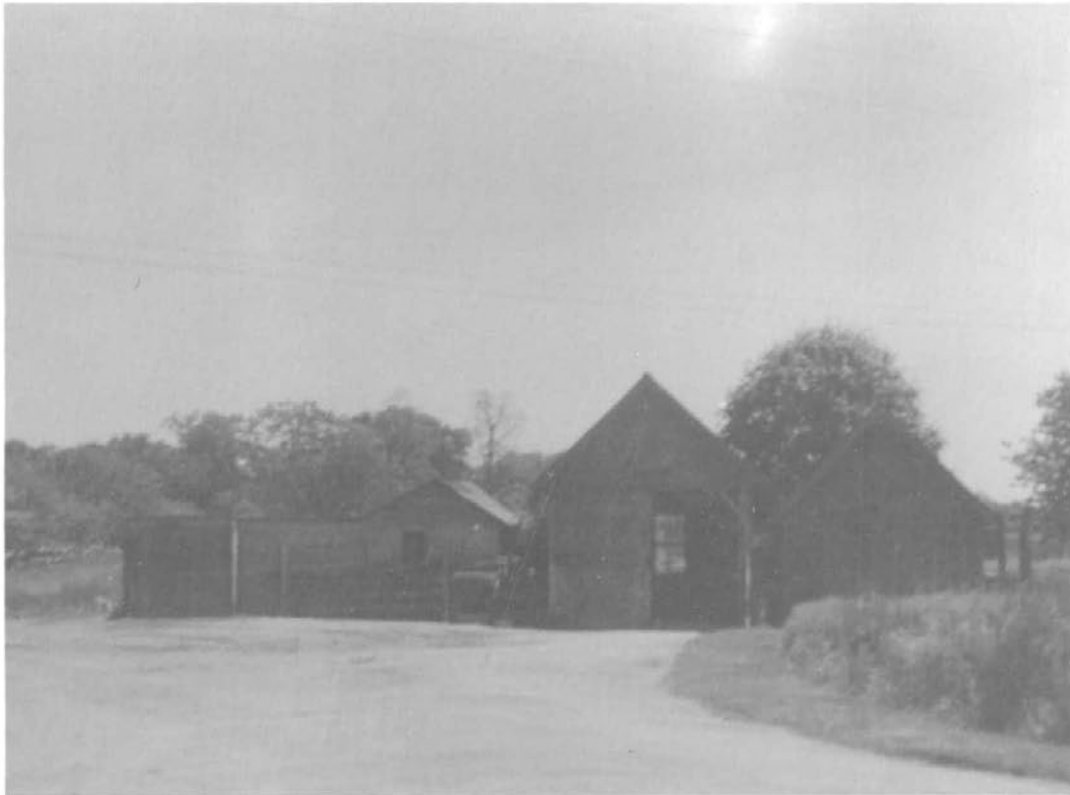
**FIGURE 2.7:** Cow shed near carriage house, 1950. (SAHINHS, TRA Materials, Box 5, Folder 2, GAIC "K").

In the early part of the TRA stewardship, a large portion of the site was tall meadow grasses, not regularly maintained (see figures 2.7, 2.8, 3.6, 3.10). The lawn was cut regularly immediately around the house, and along some of the roads (see figures 2.7, 3.7). These conditions can be observed on photographs taken in 1950, before the site was opened for public visitation. The lawn was presumably routinely maintained throughout the property after the opening in 1953.

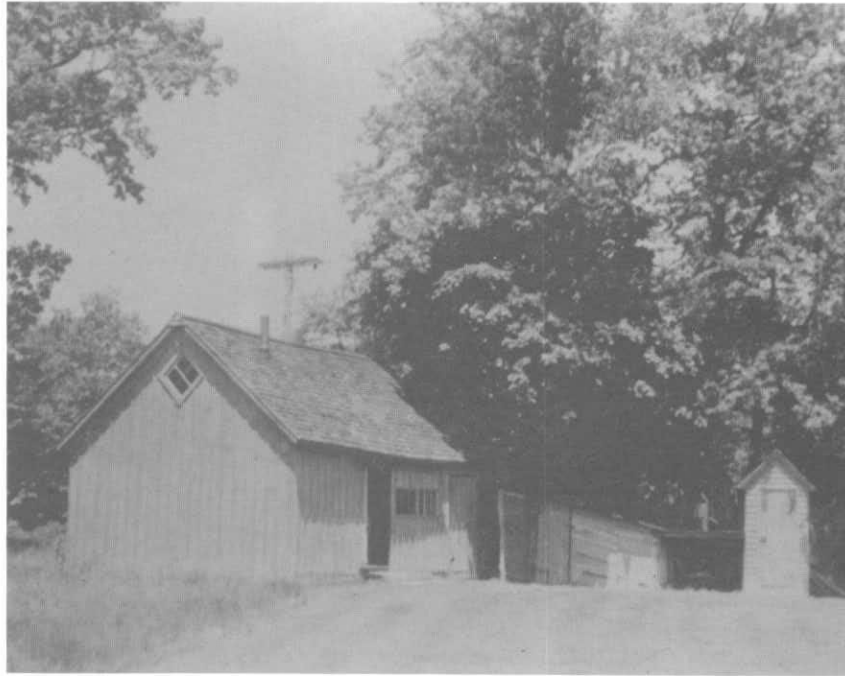
FIGURE 2.8: Sheds near Gardener's shed, 1950. (SAHINHS, TRA Materials, Box 5, Folder 2, GAIC "L").

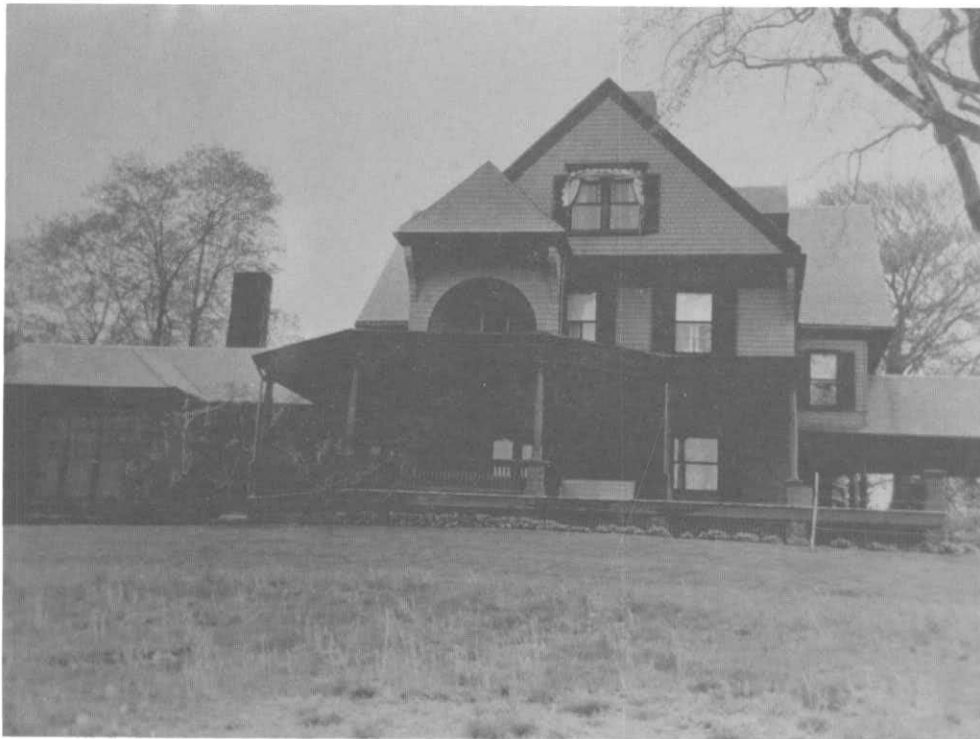
**FIGURE 2.9:** Sagamore Hill west elevation, *Hosta* along base of verandah, c. 1948. (SAHINHS, no. 1077, Box 5).

The barberry (*Berberis* sp.) on the south side of the porte-cochere in Period One, and the yew (*Taxus* sp.) on the southwest corner of the house, were removed by the early part of this period (circa 1922). In circa 1948 hosta (*Hosta* sp.) were located along the base of the verandah on all sides (see figure 2.9). They were approximately 8" high and spaced unevenly. No other information regarding shrubs existing in period two was found during the research for this report.

In 1922 wisteria (*Wisteria* sp.) covered the north room and was located on two posts at the northwest side of the verandah (see figure 1.45). The Fiveleaf Akebia (*Akebia quinata*) located on the porte-cochere during period one was removed by circa 1922 (see figure 1.41, 1.42, 2.9).

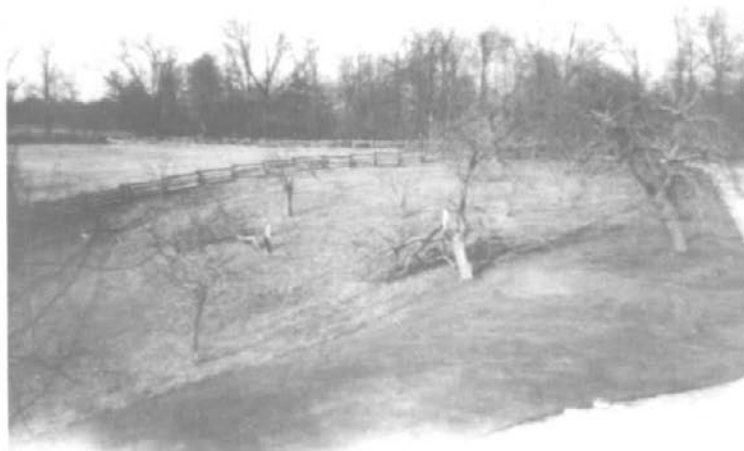
**FIGURE 2.10:** Old Orchard ice storm, c. 1940. (Courtesy of the Library of Congress).

A significant change occurred in the orchard in Period Two. The construction of Old Orchard in 1938 required the removal of an undetermined number of apple trees, and an ice storm destroyed some of the remaining trees late in the period (exact date unknown, see figures 2.10, 2.11). When Theodore, Jr. and his wife built Old Orchard in 1938, this area no longer functioned as part of the Sagamore Hill farm. An assumption can be made that from this time the apple orchard was no longer strictly managed.

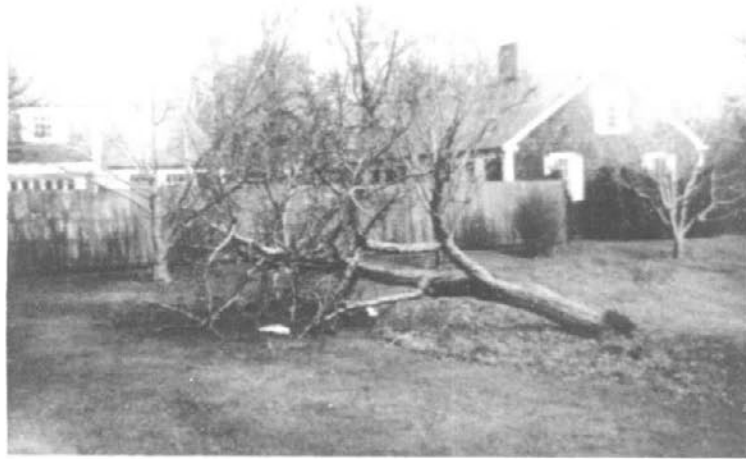
**FIGURE 2.11:** Old Orchard ice storm, fence in background, c. 1940. (Courtesy of the Library of Congress).

New fences were constructed by the foreman's cottage and garage on the Old Orchard estate. The fences ran east-west and north-south and enclosed the parking lot adjacent to the buildings (see Inner Core: Mrs. Roosevelt Stewardship, Appendix G: Aerial Photographs). They were approximately 6' high and were constructed of abutting, 3-4" vertical wood boards, pointed on top. The fence was not painted, but allowed to weather naturally. The fences served to screen the outbuildings and service area from the Old Orchard mansion (see figures 2.11).

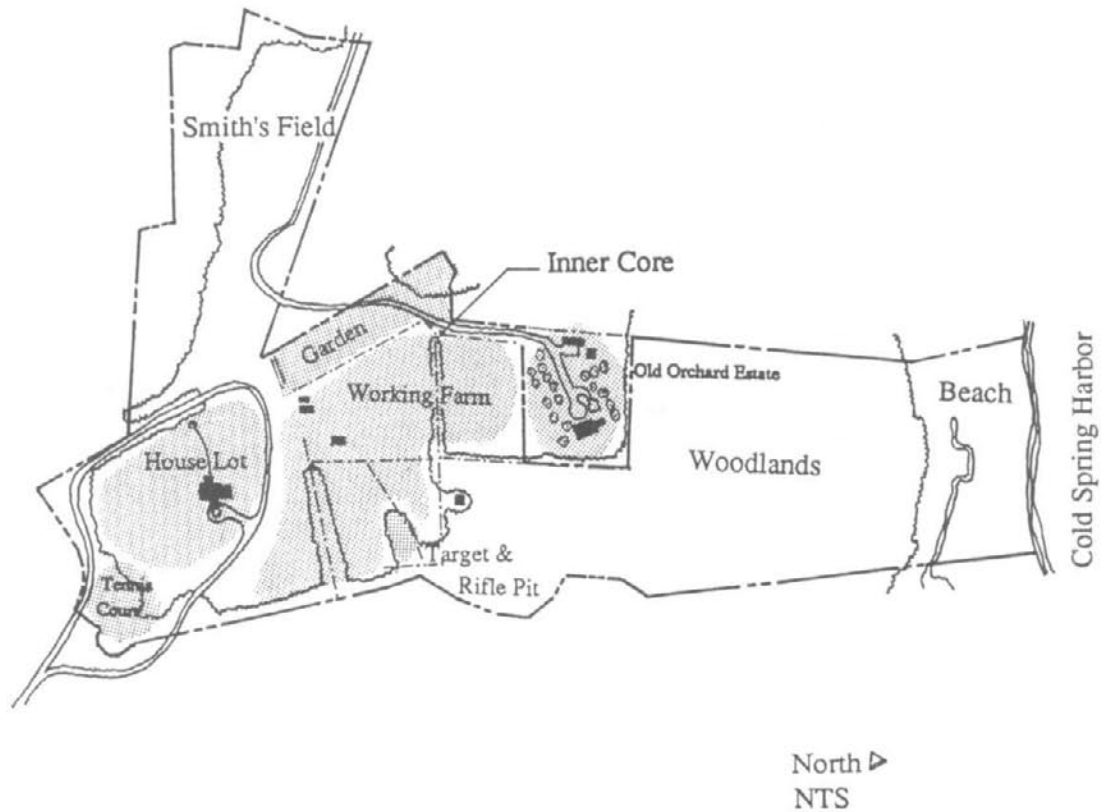
**FIGURE 2.12:** Diagram showing the spatial organization of the property during Mrs. Roosevelt's stewardship. (Bellavia, 1993. SUNY CESF).

Smith's Field – The only change in the spatial organization of the outer acreage was in the Smith's Field area. The increase in vegetation cover in the northern two sections (that became one section in this period) made the space appear smaller as the sense of enclosure increased. The adjacent fields to the east were no longer cultivated, and vegetation grew along the property boundary on the east side, creating an edge that did not exist during Period One.

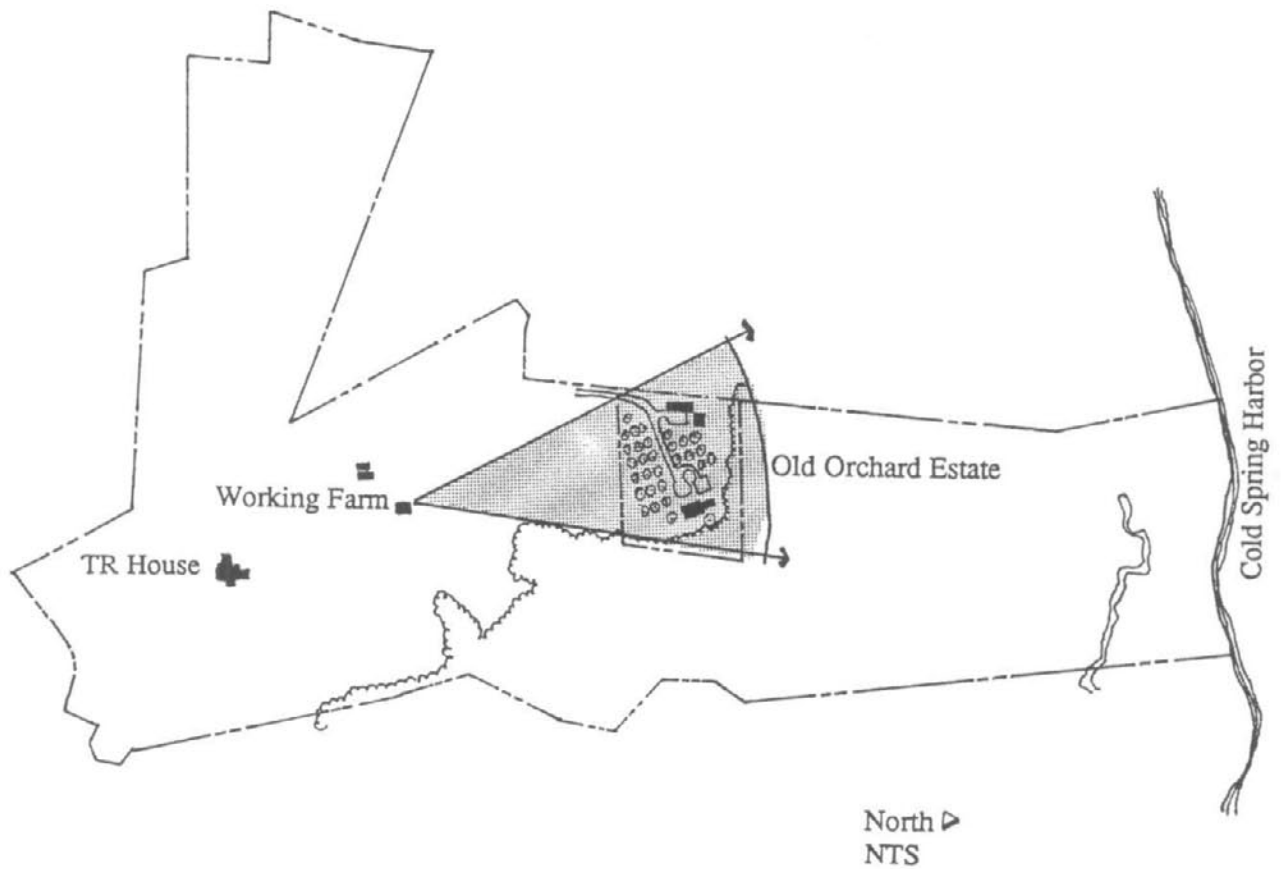
**FIGURE 2.13:** Diagram showing viewshed from Sagamore Hill to Old Orchard estate. (Bellavia, 1993. SUNY CESF).

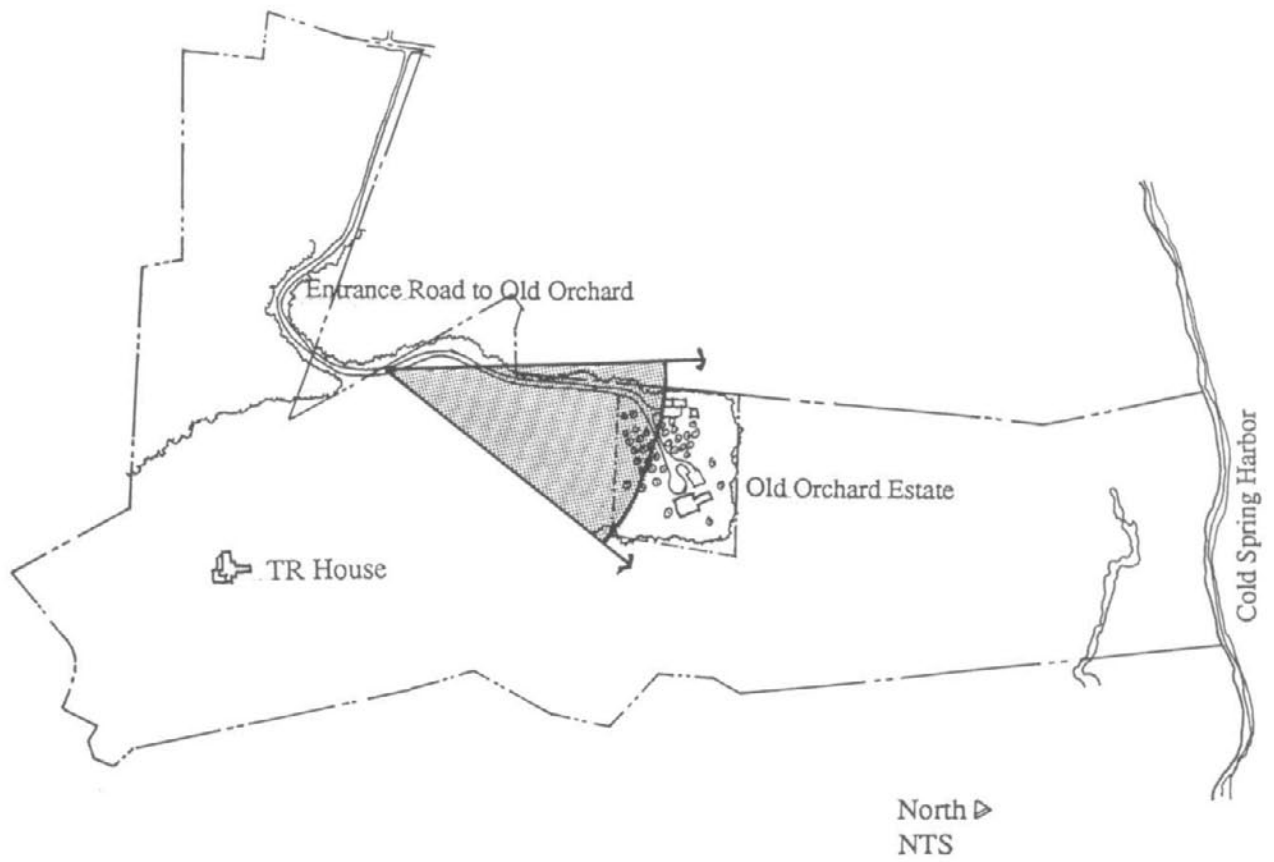
**FIGURE 2.15:** Diagram showing viewshed from new road to Old Orchard. (Bellavia, 1993. SUNY CESF).

A new view existed from the road leading to Old Orchard. The view was across the open pasture; the focal point was the Old Orchard mansion (see figure 2.15).

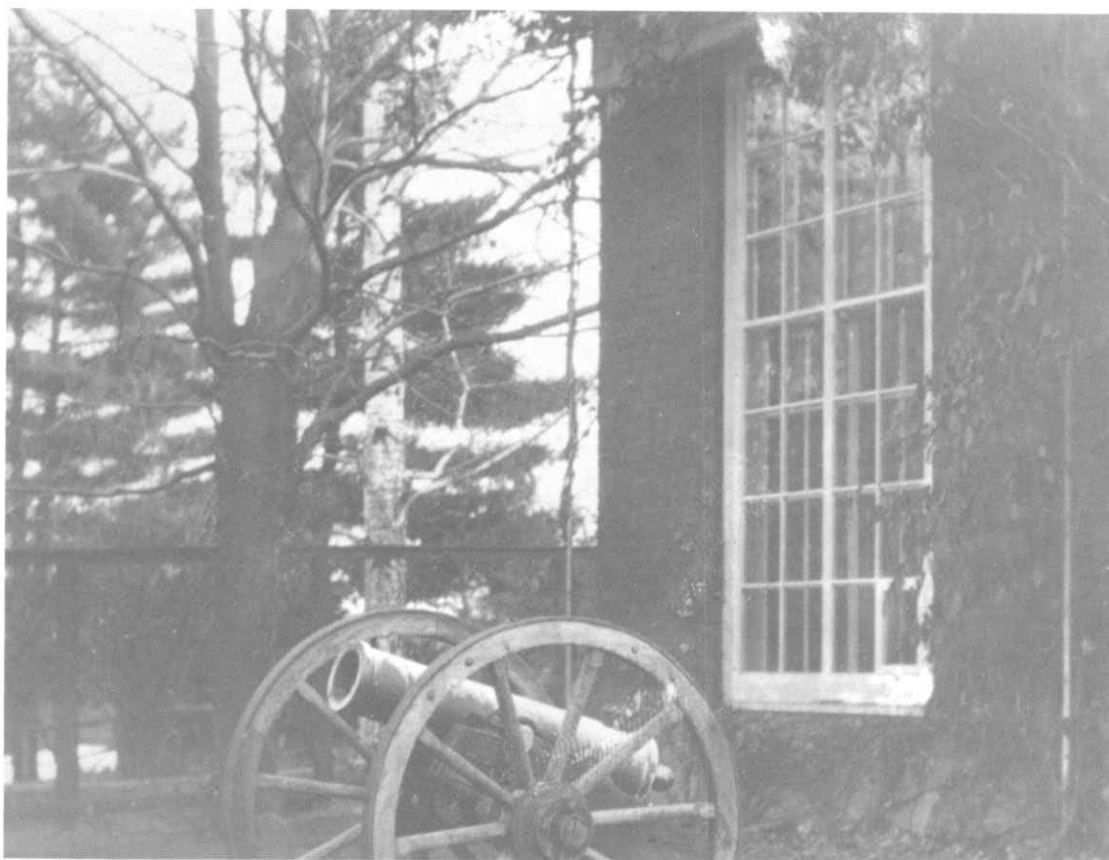
**FIGURE 2.16:** Northeast corner of North Room, cannon and fence in foreground, c. 1922. (SAHINHS, no. 9303, Box 14).

Cannon – A cannon was located 5' north of the north room in 1922 and remained throughout the period (see figure 2.16, 2.17). Materials, size, color and origin are unknown.

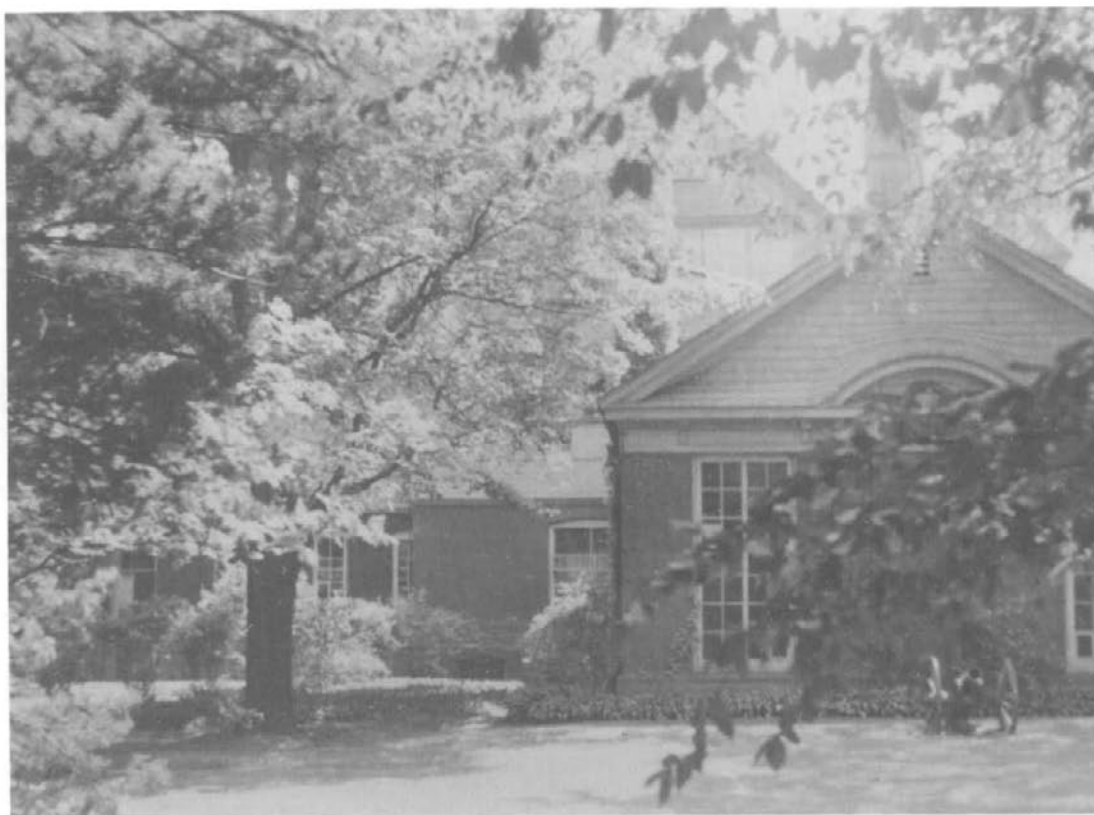
**FIGURE 2.17:** Cannon north of North Room, 1950. (SAHINHS, TRA Materials, Box 5, Folder 2, GAIC "E").

Wisteria (*Wisteria* sp.) vines covered all but the windows of the North Room in 1950 (see figure 3.9). The same vine was located on the brick wall of the porte-cochere, and on the northwest portion of the verandah (see figures 1.39, 3.10). An unidentified vine, possibly an ivy, was located on north and east walls of the North Room (see figure 2.17). The same vine was located on the east side of the house near the ice house (see figure 3.3).

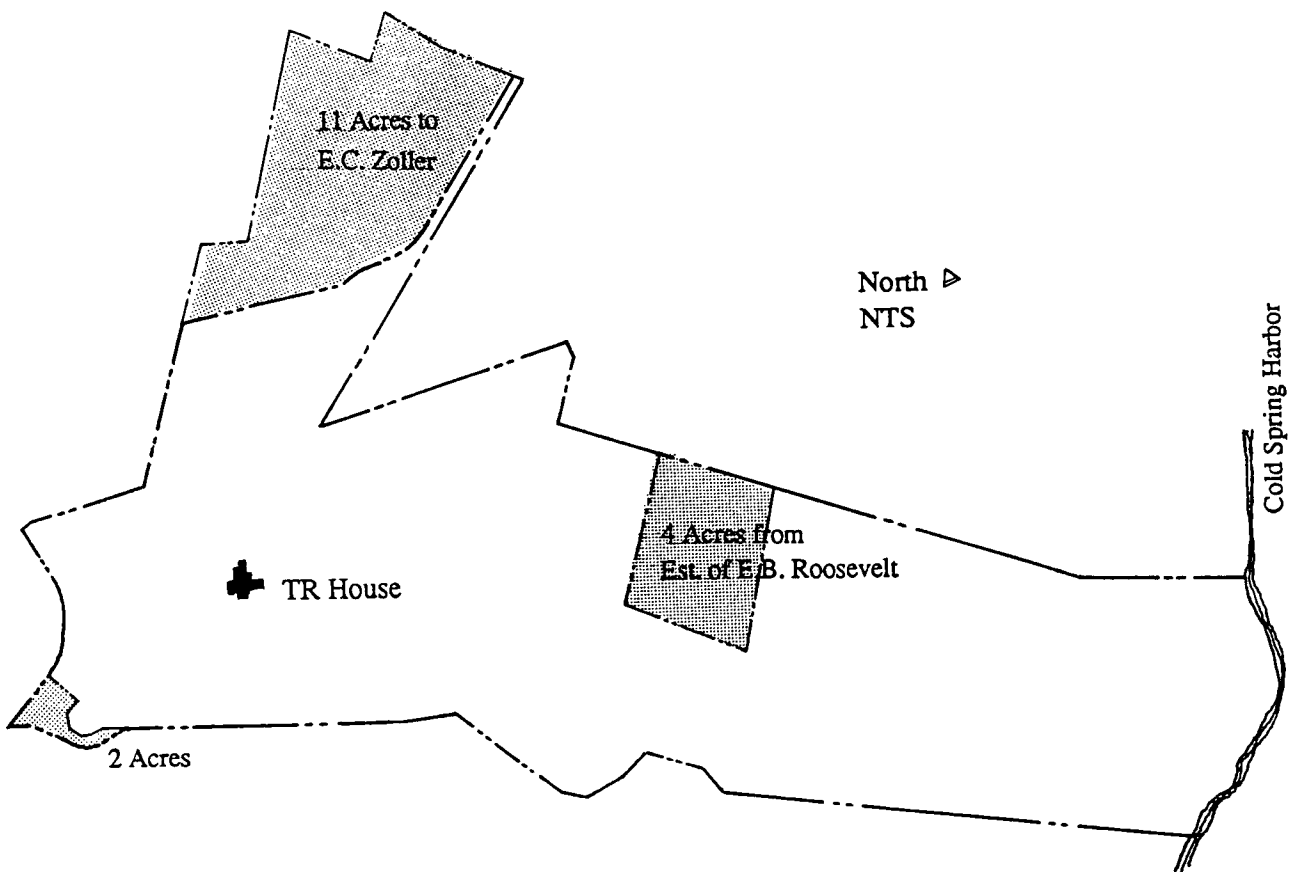
**FIGURE 3.1:** Map showing acreage sold and acquired during the TRA Stewardship. (Bellavia, 1993. SUNY CESF).

In 1950, when the TRA bought Sagamore Hill, the property boundaries were the same as at the end of the previous period of history. The property consisted of approximately eighty-three acres. In 1957 Dr. Phillip A. Zoller began renting two acres of land in the northeast portion of Smith's Field.<sup>212</sup> On August 1, 1961 the Theodore Roosevelt Association sold the north eleven acres of the fifteen acres called Smith's Field to Eleanor C. Zoller, leaving approximately seventy-two acres owned by the Association in 1961 (see figure 3.1). The portion sold included the area where "the Nest" was located.

The Theodore Roosevelt Association bought two lots of approximately four acres surrounding and including Old Orchard in 1963 shortly before it donated Sagamore Hill (and the Theodore Roosevelt Birthplace in Manhattan) to the National Park Service (see figure 3.1). The parcel included the same acreage deeded to Eleanor B. Roosevelt in 1945.

The Association also acquired a small lot, approximately two acres, east of Sagamore Hill and adjacent to the southwest corner of the property (see figure 3.1). The exact date of this acquisition was not located during the research for this report. However, it occurred between 1952 and 1963 since the lot belonged to John K. Roosevelt in 1952, and was later included in the Association's donation to the National Park Service in 1963.<sup>213</sup> The donation included approximately seventy-eight acres (see figure 3.1).

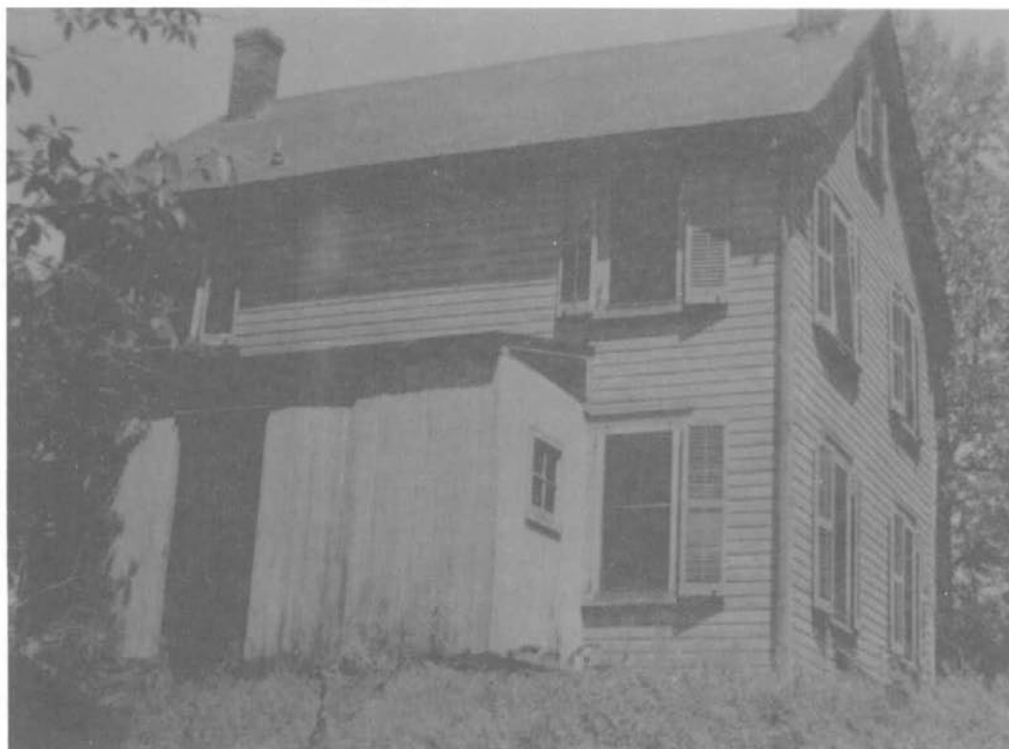
**FIGURE 3.2:** The Gray Cottage, 1950. (SAHINHS, TRA Materials, Box 5, Folder 2, GAIC "H").

The Gray Cottage – The gray cottage was in very poor condition when the Association acquired Sagamore Hill (see figure 3.2). In January 1956 they appropriated \$5,000 to "rehabilitate" the house and rented it to Mr. H. Townsend, a person with no association to the Roosevelts. The rental agreement included upkeep of the property and expenditure of \$500 per year on improvements to be paid by the tenant.<sup>221</sup>

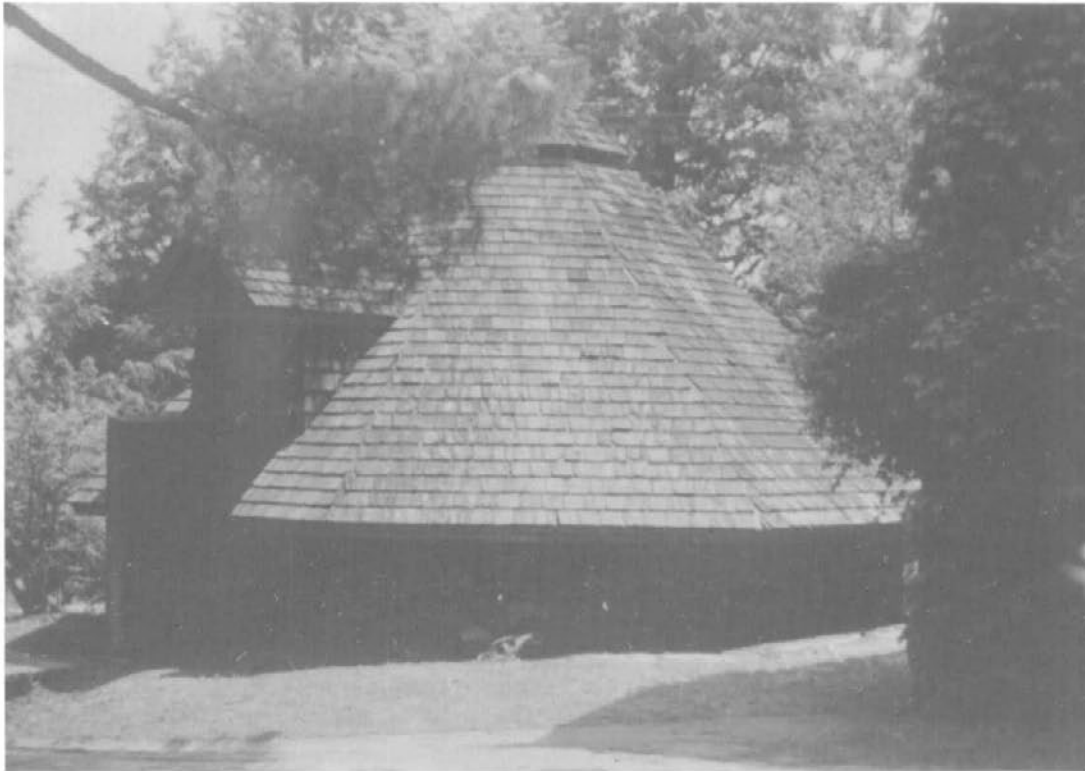
FIGURE 3.3: The ice house, 1950. (SAHINHS, TRA Materials, Box 5, Folder 2, GAIC "I").

Ice House – The interior of the ice house was altered in 1951 to provide restroom facilities. The women's room was located on the south side of the building and the men's room on the north (see figure 3.3, 3.4). In 1956, after the construction of a new souvenir shop with restroom facilities, these restrooms were no longer used, but the fixtures remained in the building.

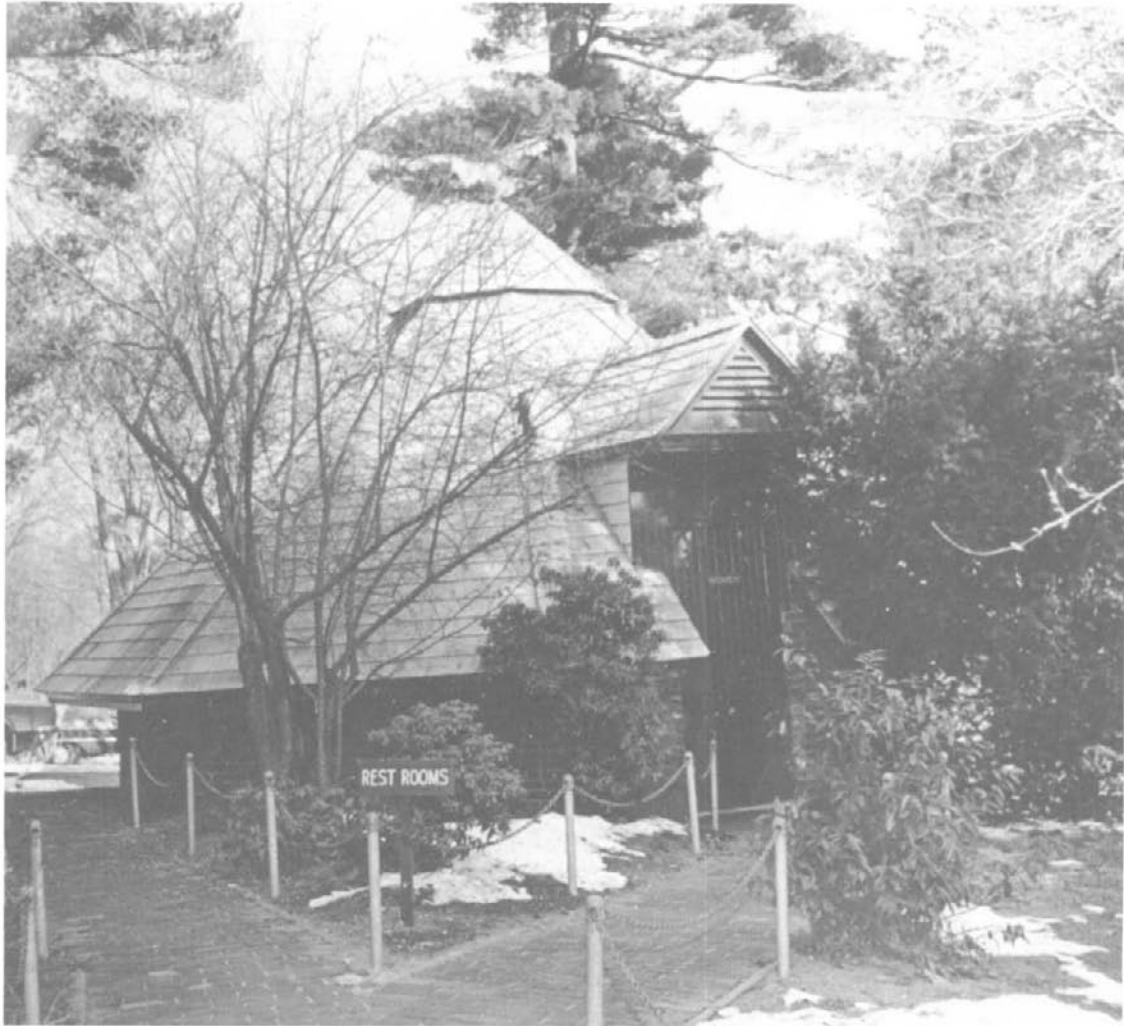
FIGURE 3.4: The ice house, c.1960. (SAHINHS).

Signage – A small sign was located east of the house identifying the restroom location in the ice house (see figure 3.4). The sign plaque, 12"x6", and post were wood and stood 2–3' high. An assumption was made that other signage on the site was made of the same material and simplistic design.

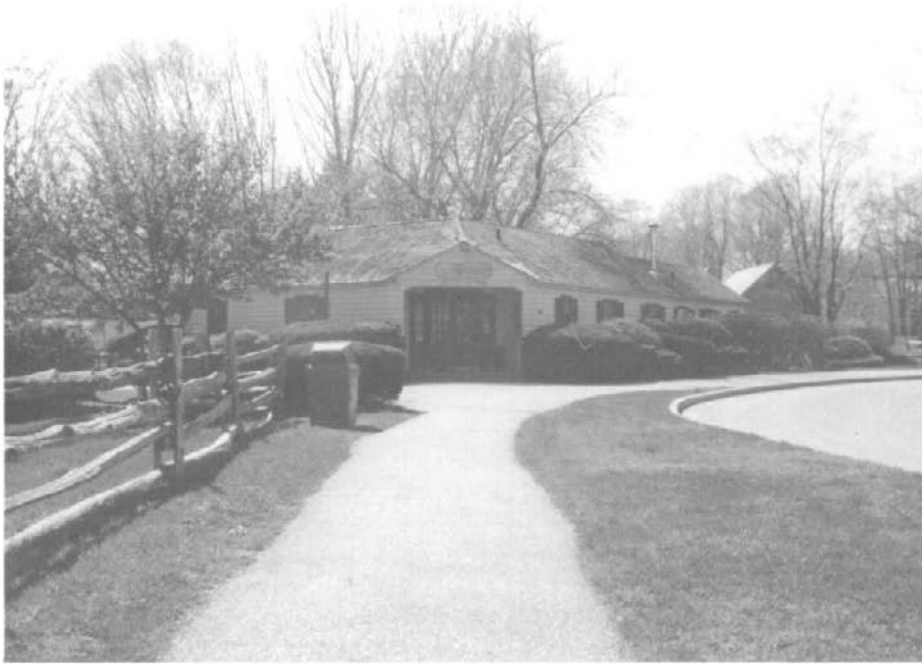
**FIGURE 3.5:** The souvenir shop, 1993. (Photograph by author).

Souvenir Shop – The souvenir shop, constructed in 1956, was designed by architect Piers Brookfield (see figure 3.5).<sup>227</sup> It was located southeast of the chicken coop and tool shed, approximately 5' off the southeast corner (see Inner Core: TRA Stewardship). It included a small snack bar, gift shop, and restroom facilities. The shop was a one-story, wood-frame building; the front was oriented to the northeast, visible from the parking lot. The building was L-shaped, 60'x20' on the long side, and 40'x20' on the short side. The color of the building during this period is unknown.
