# CULTURAL LANDSCAPE REPORT

## FOR SAGAMORE HILL

### NATIONAL HISTORIC SITE

Site History, Existing Conditions, and Analysis

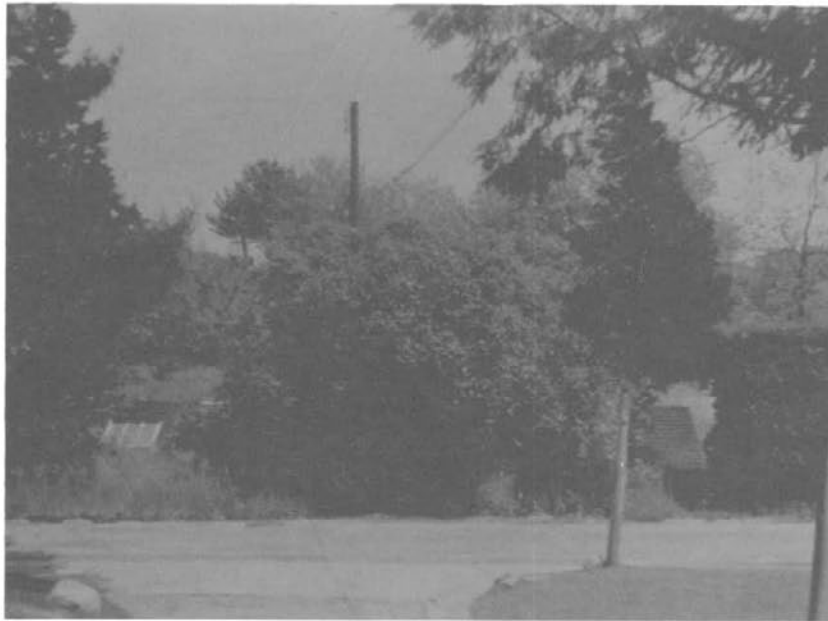
**FIGURE 3.6:** The pump house, utility pole in middleground, 1950. (SAHINHS, TRA Materials, Box 5, Folder 2, GAIC "J").

A water line ran from the pump house north to the garden; lines branched from this main line to the new barn and Gray Cottage. A direct line went from the pump house to the house.<sup>232</sup> A system of hydrants and pumps was installed on the property in 1951 for fire protection and was presumably tied into this water line system.

In the early part of the TRA stewardship, a large portion of the site was tall meadow grasses, not regularly maintained (see figures 2.7, 2.8, 3.6, 3.10). The lawn was cut regularly immediately around the house, and along some of the roads (see figures 2.7, 3.7). These conditions can be observed on photographs taken in 1950, before the site was opened for public visitation. The lawn was presumably routinely maintained throughout the property after the opening in 1953.

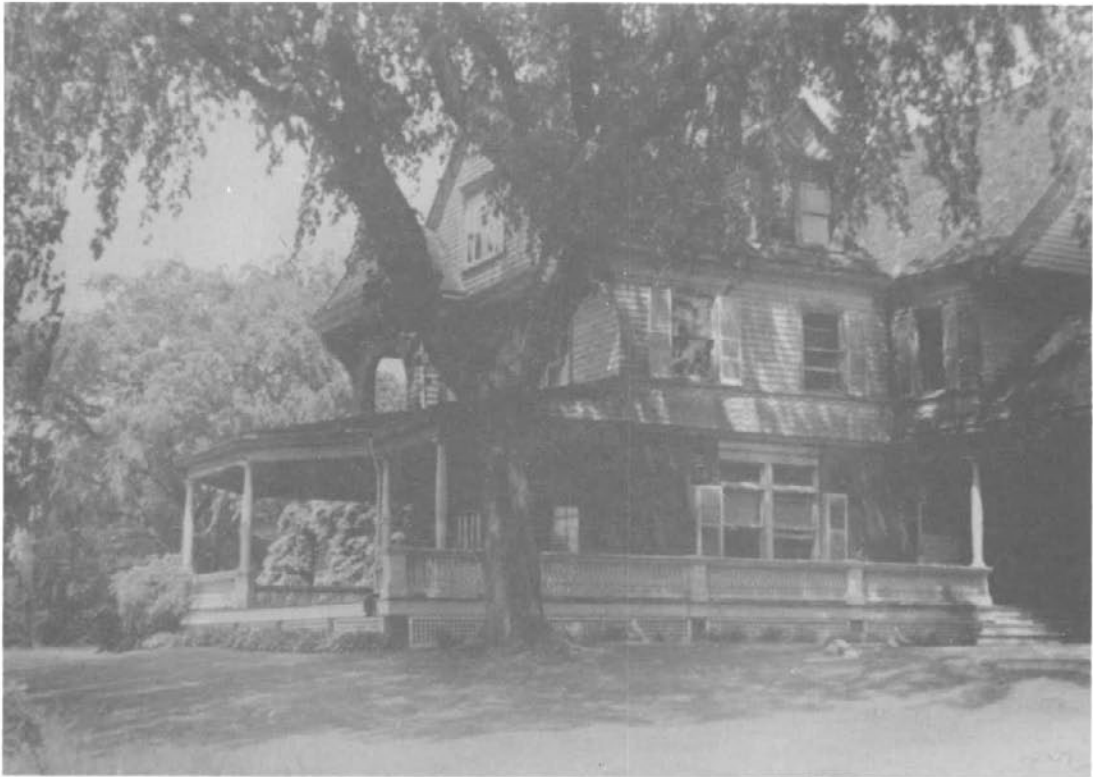
**FIGURE 3.7:** Weeping elm on southwest corner of verandah, 1950. (SAHINHS, TRA Materials, Box 5, Folder 2, GAIC B”).

Rocks Around Circular Drive – Rocks were located along the circular driveway during the period (see figures 1.39, 3.7). The rocks on the outside perimeter of the circle were small and spaced only 1–6" apart (see figure 3.4). The rocks around the perimeter of the interior circle were larger and spaced between 5–15' apart. Similar or possibly the same rocks existed in Period One (see figure 1.66).

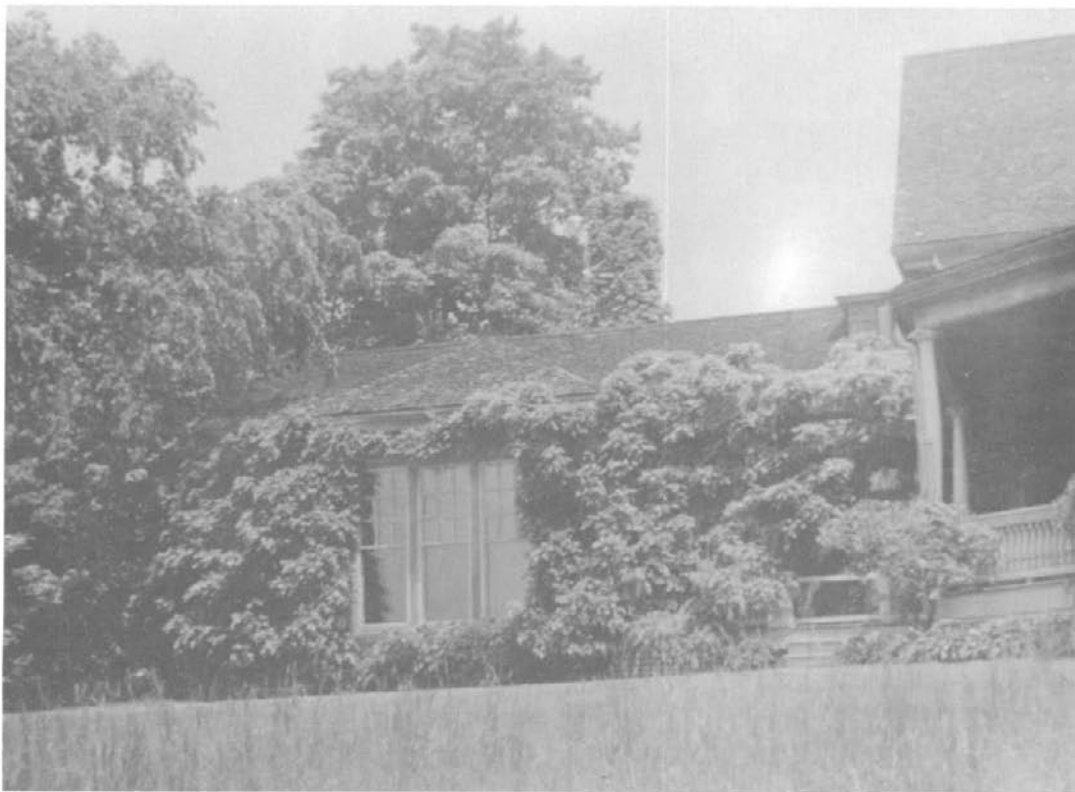
**FIGURE 3.9:** North room covered with wisteria vines, 1950. (SAHINHS, TRA Materials, Box 5, Folder 2, GAIC "D").

Wisteria (*Wisteria* sp.) vines covered all but the windows of the North Room in 1950 (see figure 3.9). The same vine was located on the brick wall of the porte-cochere, and on the northwest portion of the verandah (see figures 1.39, 3.10). An unidentified vine, possibly an ivy, was located on north and east walls of the North Room (see figure 2.17). The same vine was located on the east side of the house near the ice house (see figure 3.3).

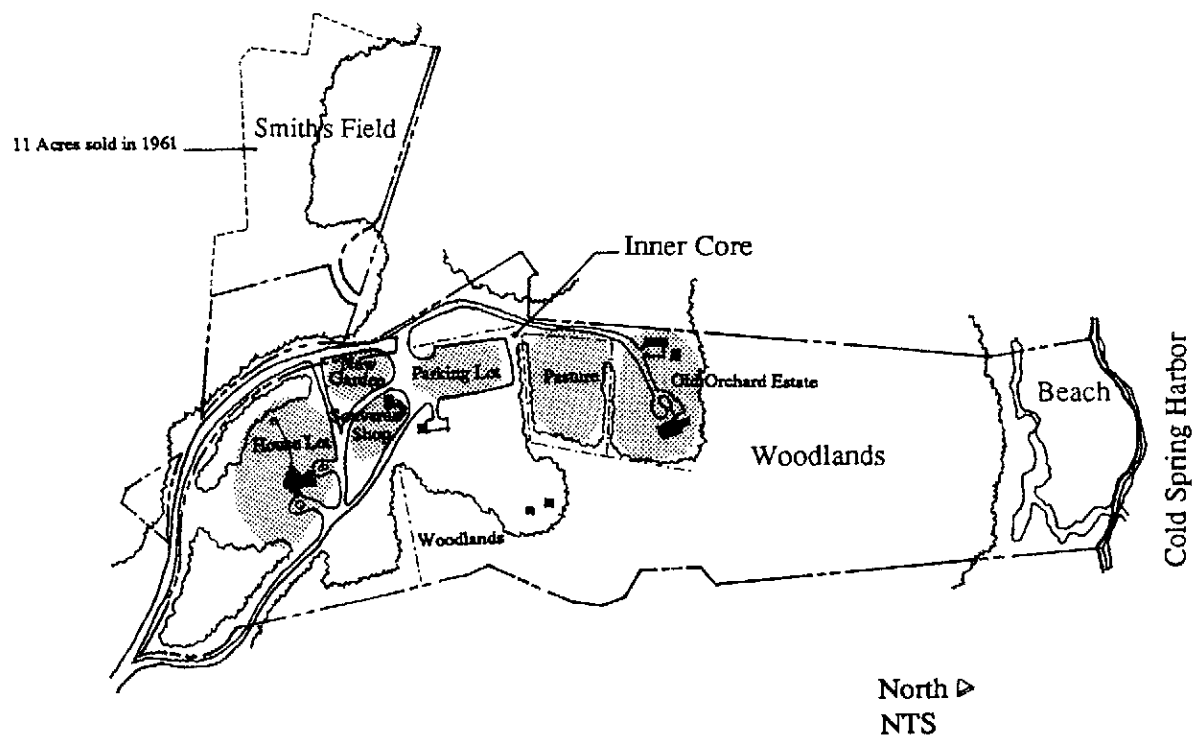
FIGURE 3.11: Diagram showing the spatial organization of the property during the TRA stewardship. (Bellavia, 1993. SUNY CESF).

The change in land use from a working farm/country home to a house museum/national shrine resulted in a significant change in the spatial organization of the inner core during this period of Sagamore Hill history. The core no longer consisted of the house lot, working farm, garden, and orchard but rather the house lot, souvenir shop (and picnic area), new garden, and parking lot (see figure 3.11).

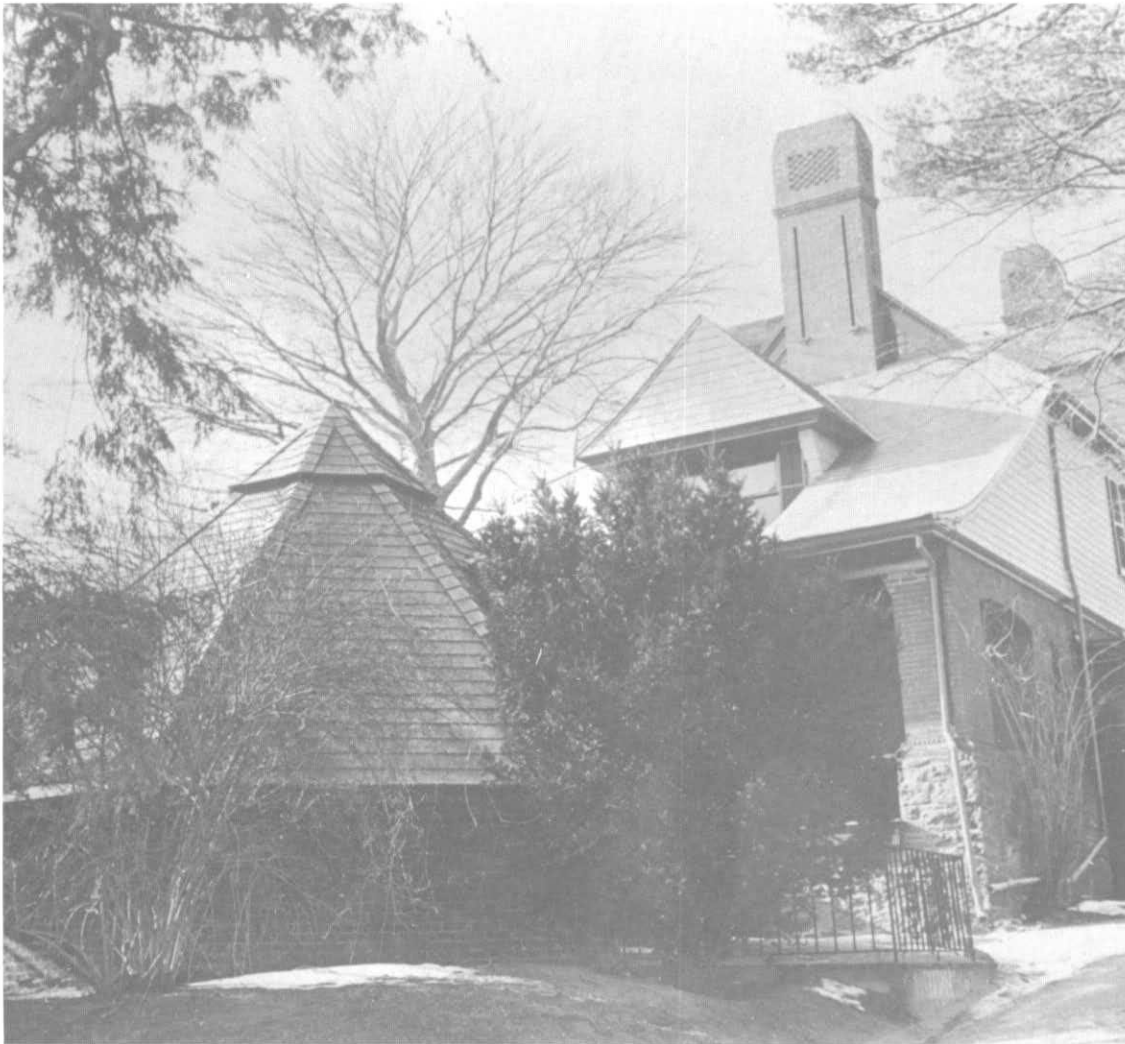
FIGURE 3.12: Wrought iron fence near restrooms, c. 1960. (SAHINHS).

Fences – Two new fence types were introduced during this period. In circa 1951, a metal post and chain fence was located along the circular entry drive on the south side of the house and along the walkway to the restrooms in the former ice house. The posts were approximately 3' high and were spaced evenly at 4–5' intervals; a chain connected the posts (see figure 3.4). A similar fence, 10–12" high, enclosed the Quentin Memorial. A black wrought-iron fence, approximately 2 1/2' high, was installed on the north side of the restrooms (former ice house) in 1959 (see figure 3.12).<sup>245</sup> It had top and bottom horizontal rails, and 1/4"x1/4" posts spaced 4" apart. A post and rail fence, approximately 4 1/2' high, the same type historically located throughout the site, was located on the north, east, and south of the garden in circa 1954 (see Overall Site: TRA Stewardship).

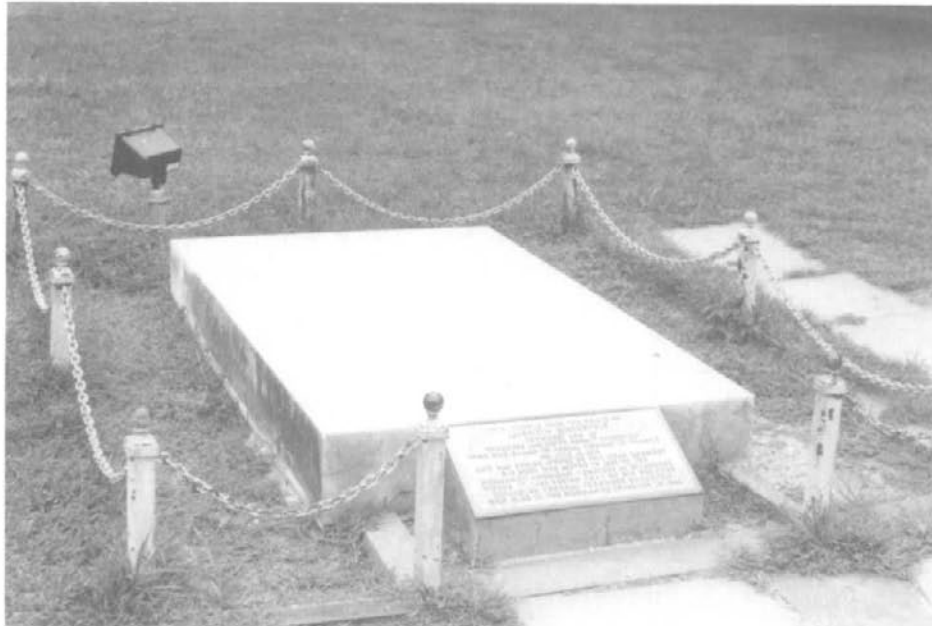
**FIGURE 3.13:** Memorial to Quentin Roosevelt, 1993. (Photograph by author).

Quentin's Memorial – Quentin Roosevelt, Theodore Roosevelt's youngest son, was killed in aerial combat during WW1 in France in 1918. In 1955 his body was moved from Chamery to San Laurent, France, and placed next to the grave of his brother, Theodore Roosevelt, Jr., who died in combat in WW2 in 1945. In May 1956 Quentin Roosevelt's grave marker from Chamery was brought to Sagamore Hill. It was placed at the base of the flag pole on the west lawn southwest of the house and was dedicated at a Memorial Day service on May 30, 1956 (see figure 3.13). In July, 1959, a foundation for the plaque was installed, and flagstone was set around the perimeter of the memorial (outside the post and chain fence).

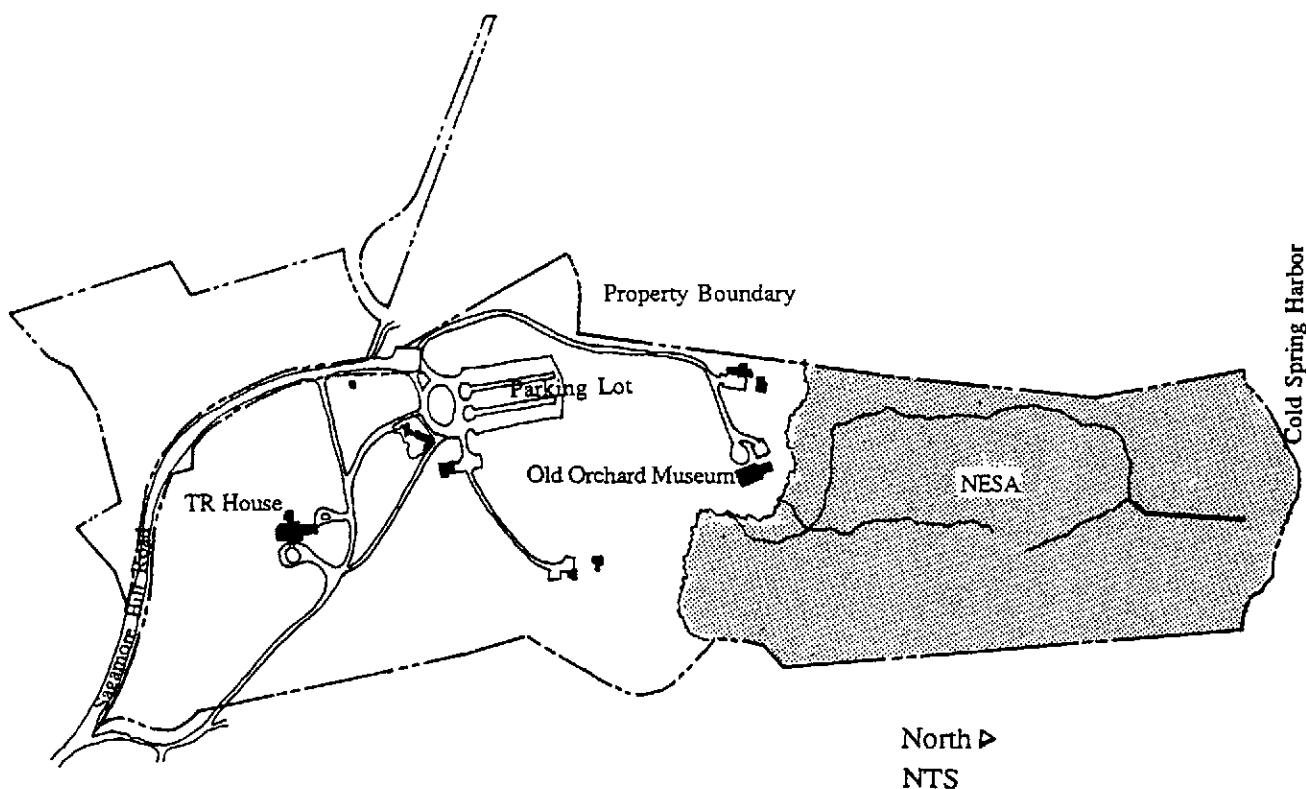
FIGURE 4.1: Natural Environmental Study Area (NESA). (Bellavia, 1993. SUNY CESF).

Natural – A thirty-two acre Natural Environmental Study Area (NESA) was designated at Sagamore Hill in 1968 (see figure 4.1).<sup>248</sup> A trail, approximately one mile long, was laid out in the woodlands behind Old Orchard and a room was set aside inside the building for environmental study. The Natural Environmental Study Area included the salt marsh and creek, freshwater pond, and the beach, which were the habitat of a variety of birds, water fowl, and mammals.<sup>249</sup> Theodore Roosevelt was known as the "Conservation President," and therefore the NPS designated this area for individuals sharing the former President's interests and ideals. The trail was used for guided tours by staff from the Theodore Roosevelt Bird Sanctuary (located on Cove Road, Oyster Bay). Current use of the study area is limited due to the threat of Lyme Disease, spread by deer ticks, on Long Island. Understory vegetation has become overgrown, increasing the threat of contracting the disease and further inhibiting the use of the trail.

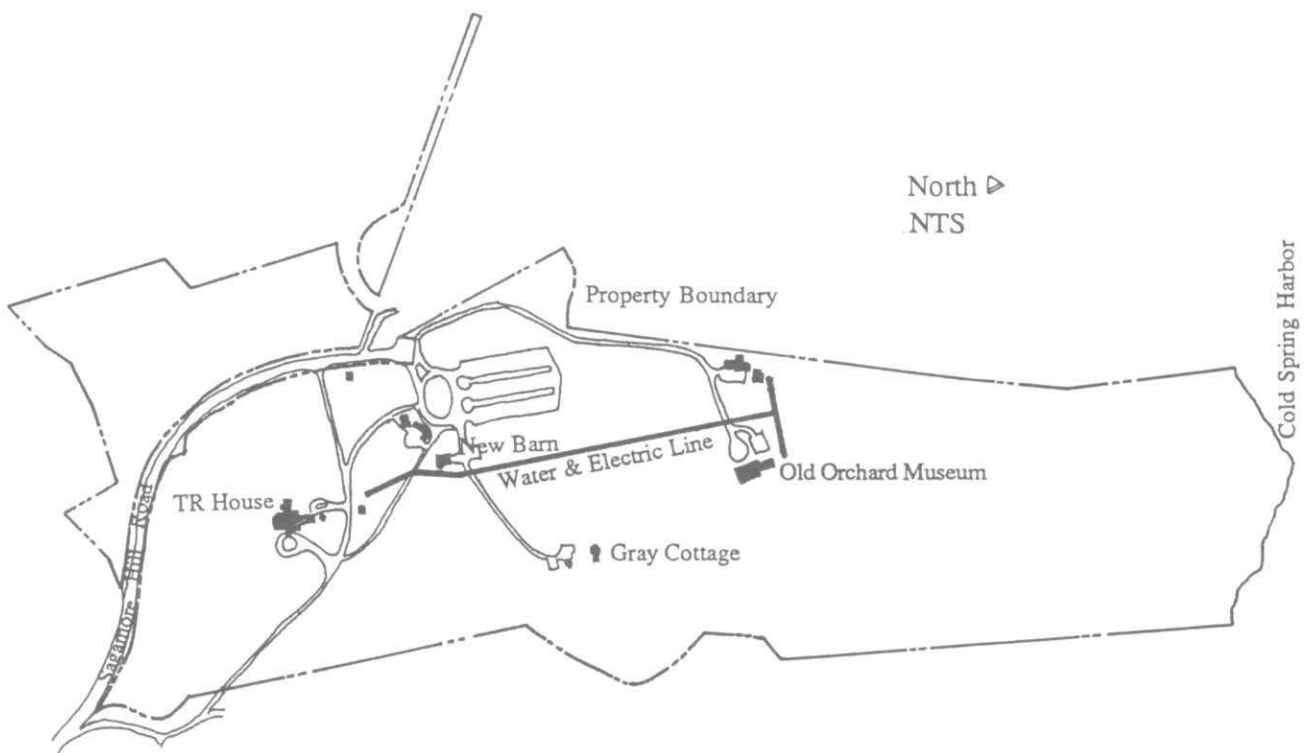
**FIGURE 4.21:** Water and electric lines installed in the 1980s. (Redrawn from DeCesare, Archeological Collections Management, figures 1 and 2).

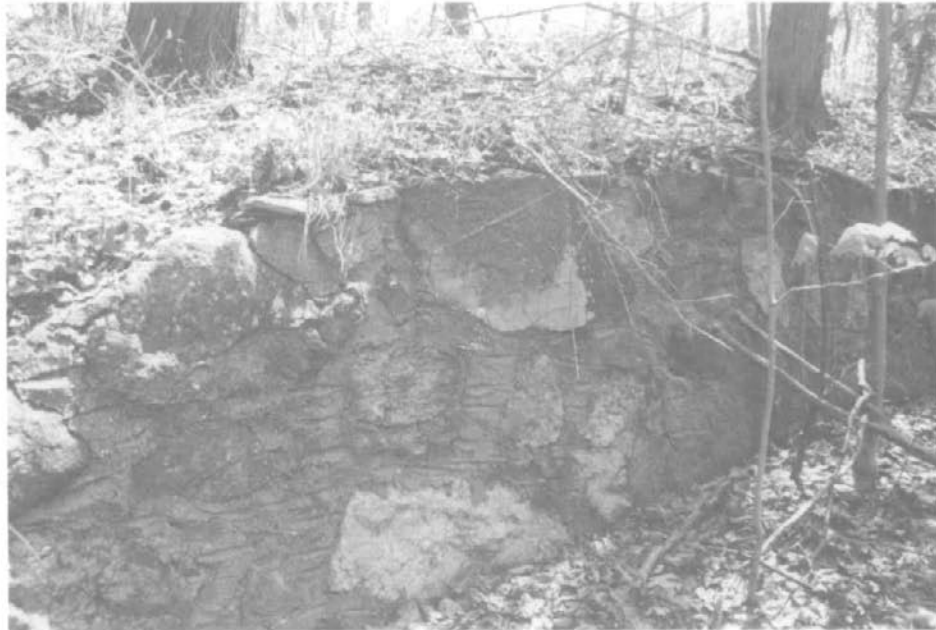
**FIGURE 4.26:** Stone and mortar wall near carriage road, 1993. (Photograph by author).

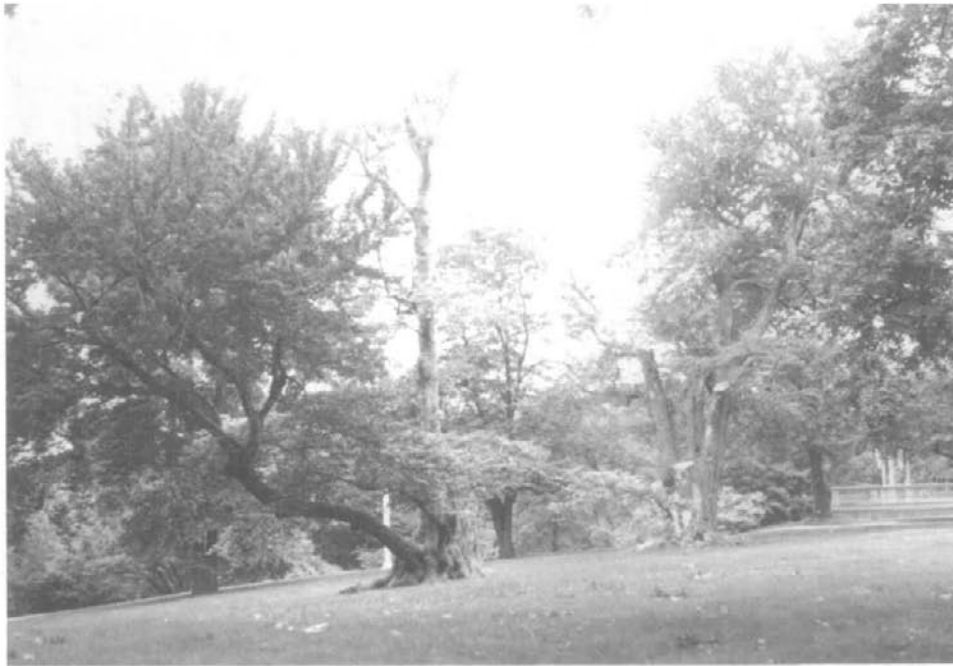
**FIGURE 4.30:** Hazardous beech trees south of circular drive, 1993. (Photograph by author).

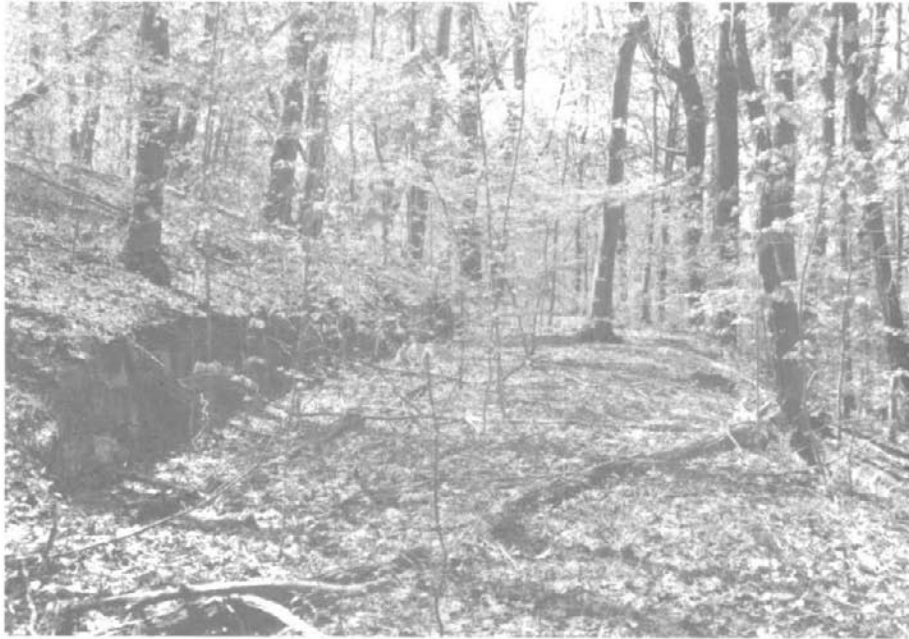
**FIGURE 4.45:** Southwest corner of property, 1993. (Photograph by author).

Southwest Corner – This sub-space, including the carriage road, the 1911 road, and the tennis court, is overgrown with vegetation (see figure 4.45). The shape of the area is irregular. The 1911 macadam road forms the edge on the south-east side, Sagamore Hill Road on the south-west, and where the woodland ends and the lawn begins forms the edge on the north. The dense tree canopies enclose the area overhead and, until recently, visitors were neither inclined nor directed to wander into this sub-space. In 1993, a path following the boundaries of the carriage road was cleared for visitor circulation.<sup>287</sup> The path is enclosed on by dense vegetation and varied topographical changes on both sides. The tennis court is also defined and enclosed by vegetation and varied topography.

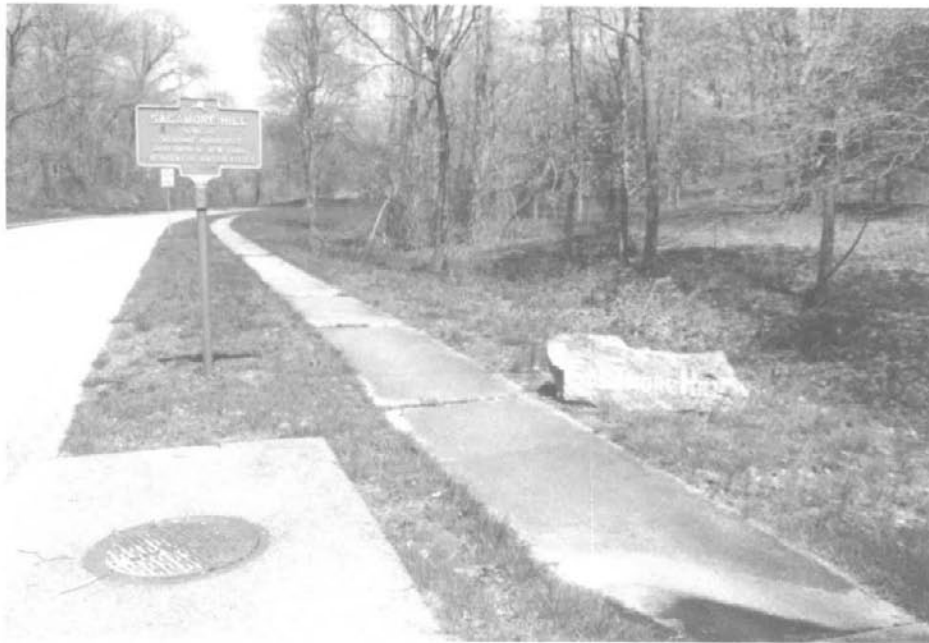
**FIGURE 4.47:** Sagamore Hill Road, 1993. (Photograph by author).

Sagamore Hill Road is the entrance to the site today, and has been throughout the NPS stewardship. It is 24' wide, with a 13' right-of-way on both sides. A 4' concrete sidewalk is located on the south side of the road (see figure 4.47). The asphalt road is maintained by Nassau County. This road meets the service road and also leads to the parking lot. The service road, originating just to the west of the gardener's shed, is approximately 12' wide and is used by pedestrians and maintenance vehicles. It leads to the service entrance of the house and terminates at the circular drive. From the circular drive, the original paved entrance road extends to the southwest to Sagamore Hill Road. The original entrance road is not accessible to vehicular traffic (see Inner Core: Existing Conditions). However, pedestrians walk on this road to reach the carriage road that leads to the tennis court. Both the carriage road and the tennis court were made accessible to visitors in 1993. The carriage road is located in the woodland southwest of the house. Its width is variable, but averages approximately 8' wide. The road is mulched.

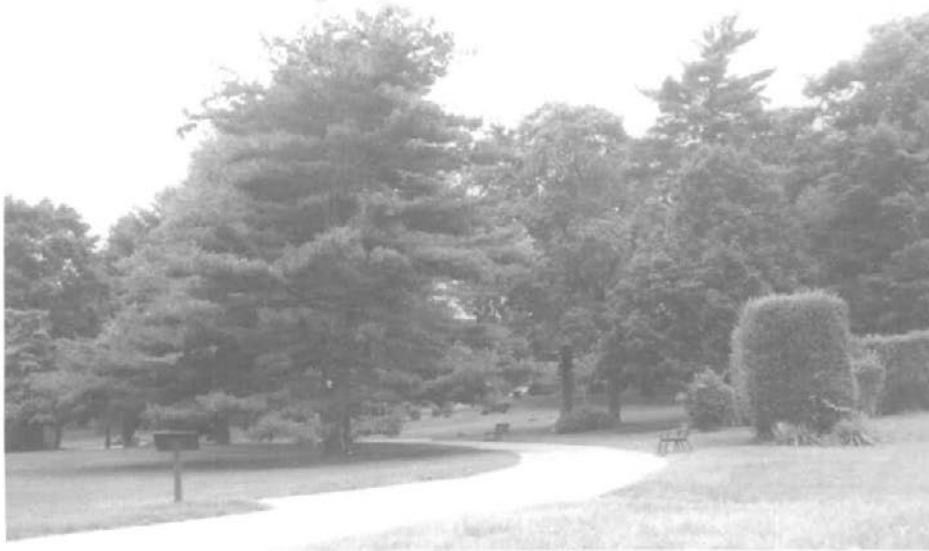
**FIGURE 4.48:** Pedestrian path north of carriage house, 1993. (Photograph by author).

Visitors park in the parking lot east of the souvenir shop and continue their visit on foot. Two pedestrian paths, both originating from the parking lot, lead to the house. One is located north of the carriage house, and one south of the souvenir shop (see figures 4.35 and 4.48). These are 10' wide asphalt paths. The grade on both is minimal. However, the grade on the west end of both paths increases to 11% and greater. A brick walkway leads the visitor from the circular driveway to the ice house (see figure 4.49). It is a common bond pattern, approximately 4' wide. A 6' wide gravel walkway originating on the west side of the house continues north where it terminates at the pet cemetery (see figure 4.50, Inner Core: Existing Conditions). These are the major pedestrian paths on the site. However, most visitors wander off the paths to examine the grounds.

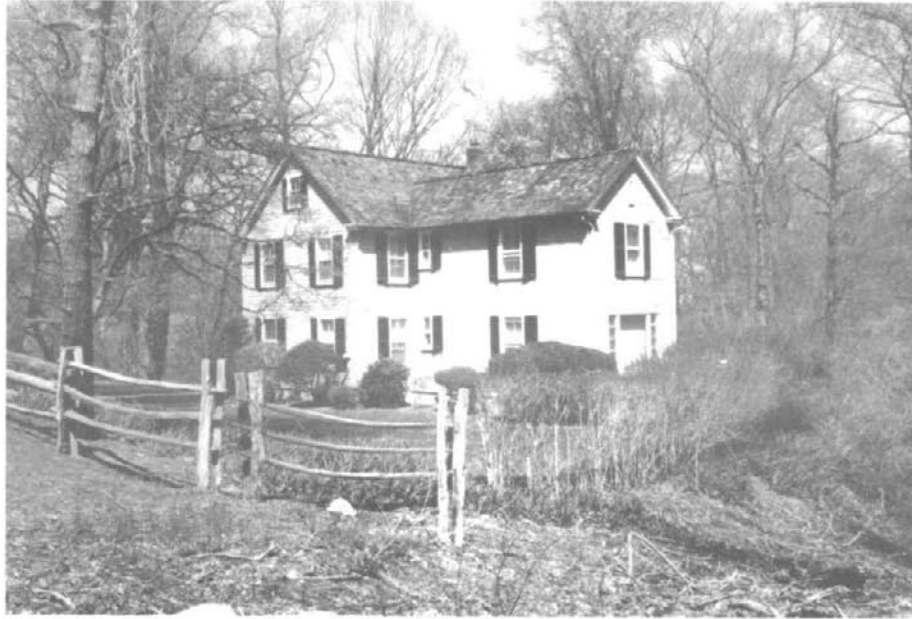
**FIGURE 4.51:** Three-rail-split-rail fence west of the Gray Cottage, 1993. (Photograph by author).

Fences – The fences located in the outer acreage are typically wood split rail. They have three or four rails (both types exist), and posts located approximately 10' apart (see figure 4.51). This type of fence is located along the north property boundary, the north boundary on the beach, 40' west of the Gray Cottage, and along the property boundary north of Sagamore Hill Road. Scattered remnants of the same fence types are located in the woodlands.

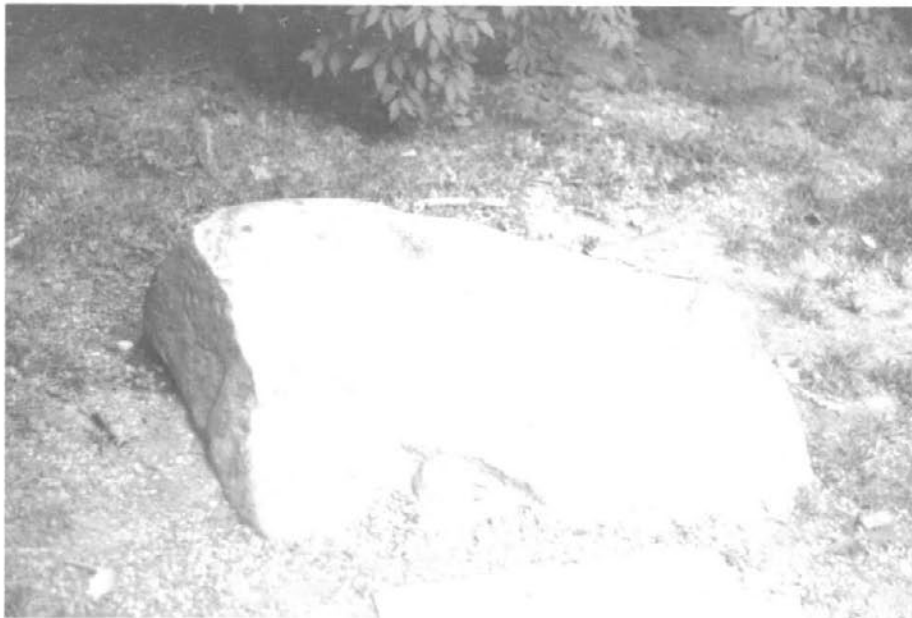
**FIGURE 4.52:** Pet Cemetery Stone, 1993. (Photograph by author).

Pet Cemetery Stone – The extant pet cemetery stone is located in its historic location approximately 200' north of the Theodore Roosevelt house (see figure 4.52).

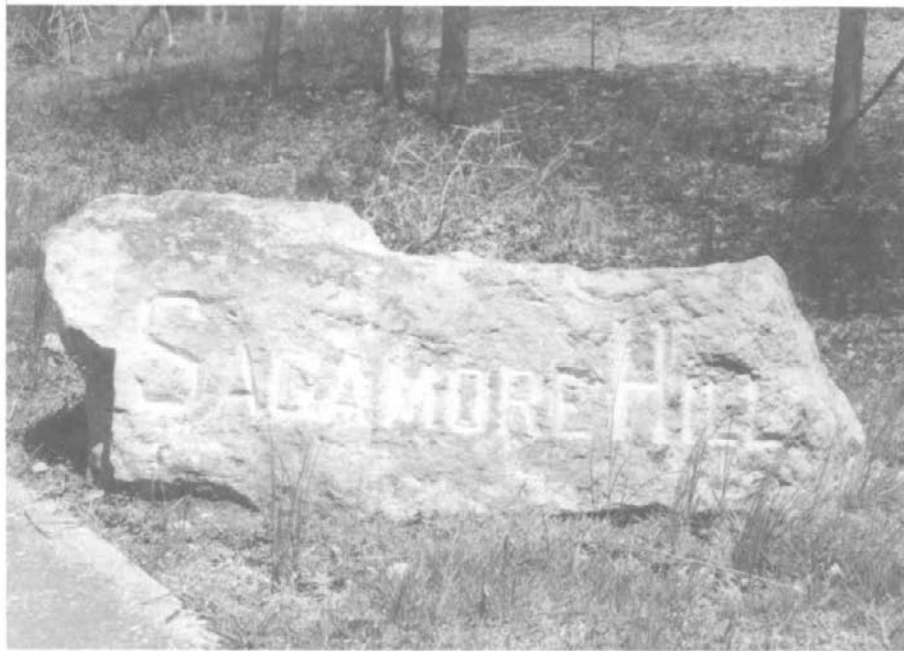
**FIGURE 4.53:** Sagamore Hill Rock, 1993. (Photograph by author).

Sagamore Hill Rock – The extant Sagamore Hill Rock is located along Sagamore Hill Road at the entrance to the site (see figure 4.53).

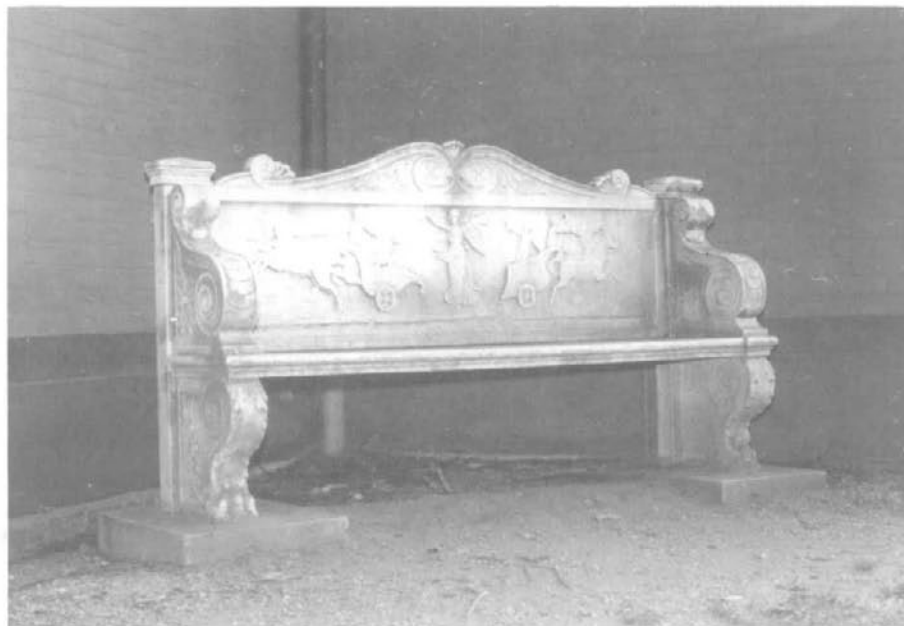
**FIGURE 4.54:** White Bench outside North Room, 1993. (Photograph by author).

White Bench – The white marble bench, a gift from Oscar Strauss during Theodore Roosevelt's stewardship, is located outside the north room (see figure 4.54). The bench is approximately 5' long and 2' high.

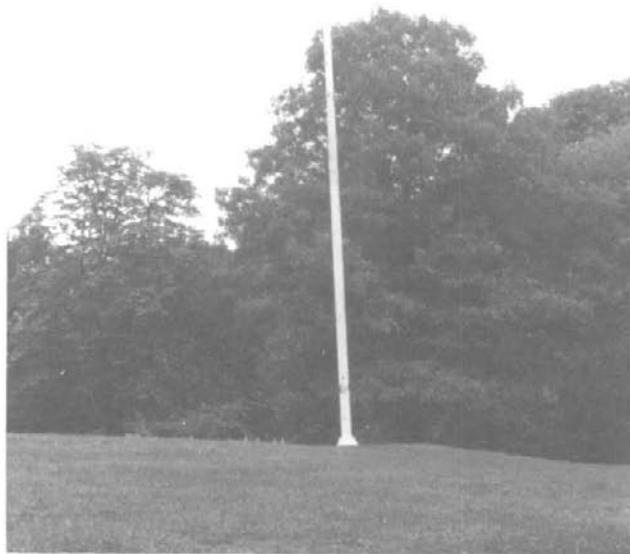
**FIGURE 4.55:** Flagpole on lawn southwest of house, 1993. (Photograph by author).

Flag Pole – A white flag pole, from the TRA period, is located several feet west of the Quentin Memorial (see figure 4.55).

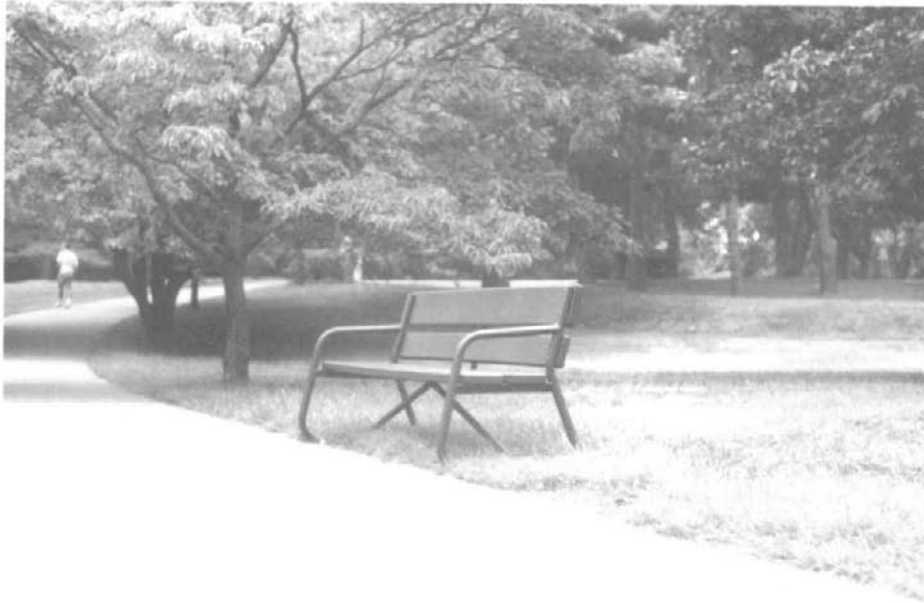
**FIGURE 4.56:** Typical green wooden benches located along pedestrian paths , 1993.  
(Photograph by author).

Benches – Three types of benches were installed during the NPS stewardship. Green wooden benches with metal frames, including arm rests, approximately 5' long are located along the pedestrian paths (see figure 4.56). Brown benches, similar in size and design to the green benches, but without arm rests, are located on the perimeter of the parking lot (see figure 4.57). The third type of bench is located in the memorial rose garden. It is a teakwood bench approximately 5' long (see figure 4.37). All of the benches are moveable.

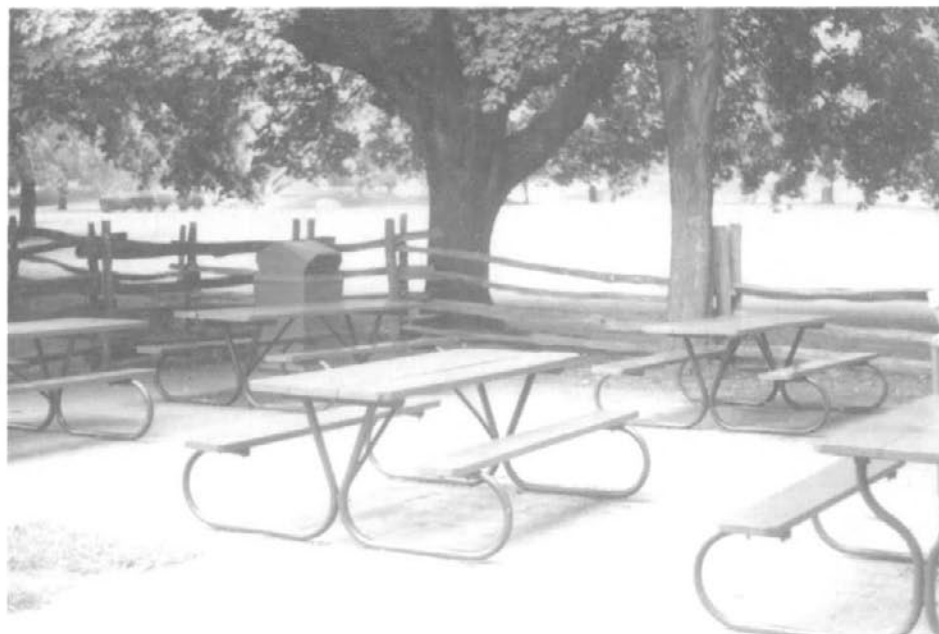
FIGURE 4.58: Typical picnic table at Sagamore Hill, 1993. (Photograph by author).

Picnic Tables – Picnic tables are located in the picnic area west of the souvenir shop. They are green wooden tables with metal frames (see figure 4.58). The tables are approximately 6' long.

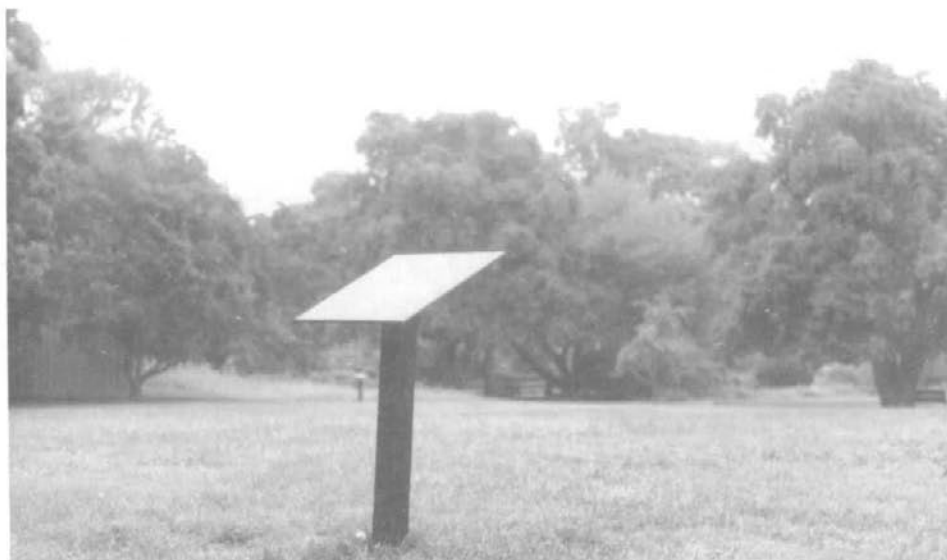
FIGURE 4.59: Typical interpretive sign at Sagamore Hill, 1993. (Photograph by author).

Signs – There are currently five different types of signs at the site. Interpretive signage, as well as information plaques, are located throughout the site. The interpretive signs are typically one or two brown metal posts and a metal platform with a picture(s), with embossed text on them (see figure 4.59). The posts are 2 1/2' high and the interpretive plaque is set on top at an angle. Other informative and directional signs are 5' high, made of 4"x4" wooden posts and 1 1/2'x2' wooden rectangular sign, with a peak on top (see figure 4.60). A third type, of which there is only one, is located on Sagamore Hill Road. It is approximately 5' high, made of a pipe and heavy metal plaque (see figure 4.47). A wooden sign, painted brown, located at the entrance to the parking lot, indicates that Sagamore Hill is a National Historic Site under the auspices of the Department of Interior, National Park Service (see figure 4.61). The sign is 8' long and 4' high. Other small signs, approximately 3 1/2' high, have a wooden replica of the National Park Service seal on top and are located north and south of the Old Orchard Museum.

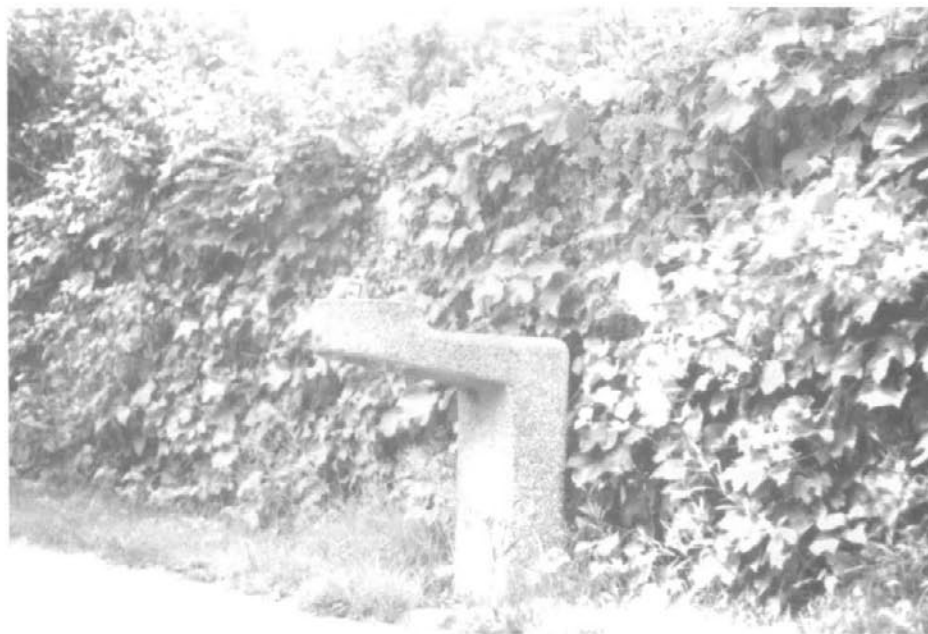
FIGURE 4.62: Typical water fountain, 1993. (Photograph by author).

Drinking Fountains – There are several drinking fountains located on the site. They are approximately 3' high, made of exposed aggregate concrete (see figure 4.62). They function during the summer months.

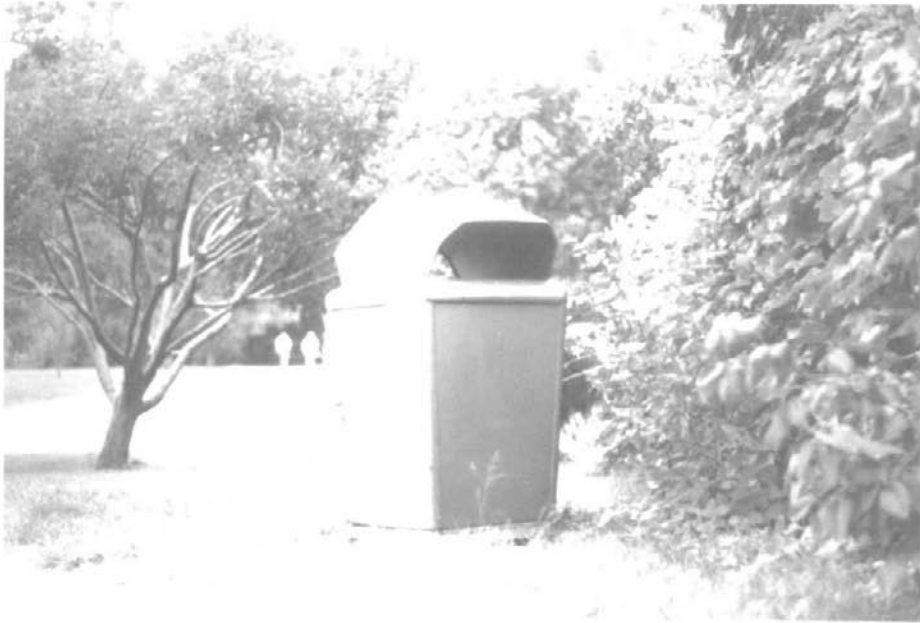
FIGURE 4.63: Typical trash receptacle at Sagamore Hill, 1993. (Photograph by author).

Trash Receptacles – Green trash receptacles are located throughout the inner core of the site. A large number are located in the parking lot and picnic area. They are moveable, metal rectangular cans approximately 2'x2'x4' high (see figure 4.63).

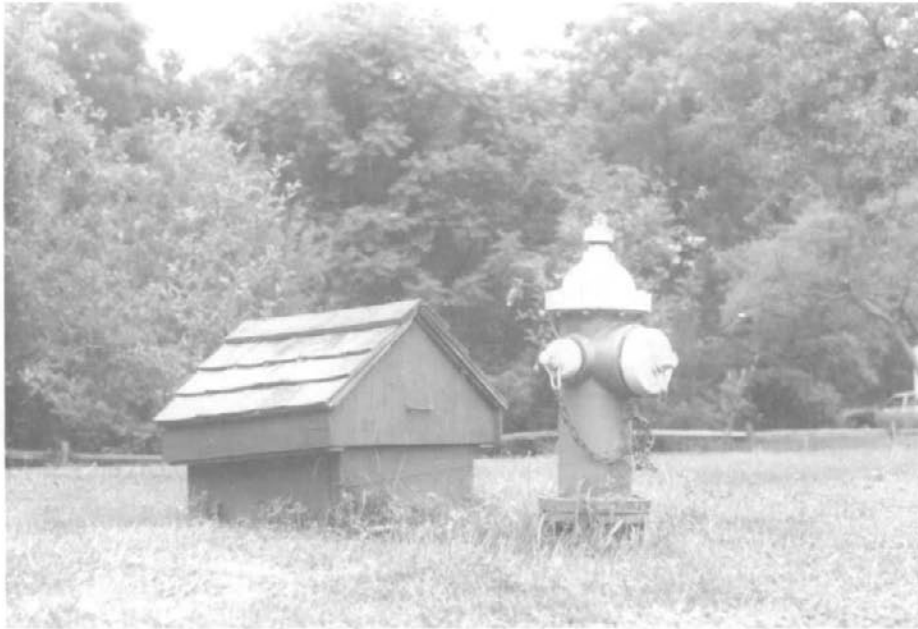
**FIGURE 4.64:** Typical hydrant and hose house, 1993. (Photograph by author).

Hydrants & Hose Houses – Fire hydrants, 2 1/2' high, painted red and white, are located throughout the site and function as part of the fire suppression system. Associated with each hydrant is a small "doghouse" that is used to store hoses (see figure 4.64). These hose houses are approximately 2' high, 2' wide, and 3' long. The wood shingled, gable roofs are natural color and the remainder painted red.

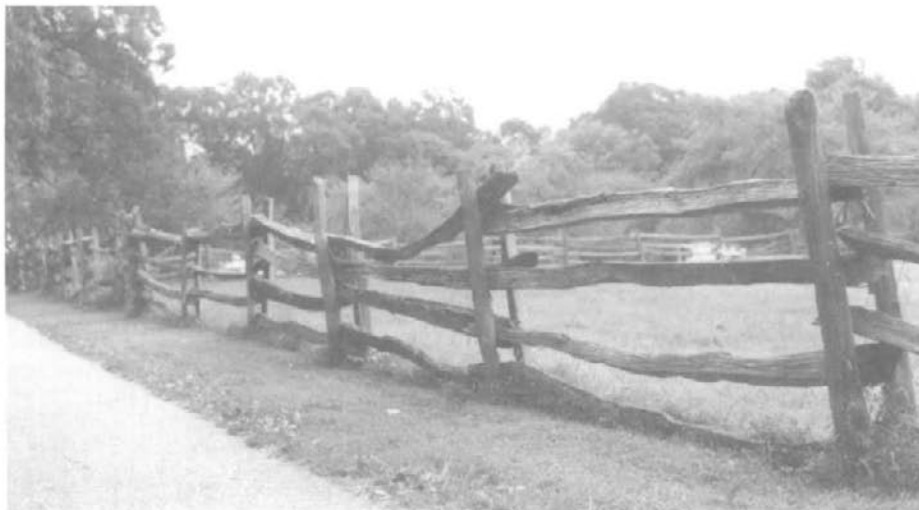
**FIGURE 4.65:** Four-rail-split-rail fence around pasture, 1993. (Photograph by author).

Fences – There are many fence types located in the inner core. Many of them are locust wood, split-rail and only differ by the number of rails. Three-rail fences are located around the flower garden, parking lot, and alongside the road to the Gray Cottage. Four-rail fencing surrounds the pasture east of the parking lot, the picnic area, and the New Barn (see figure 4.65). A single-rail fence is located along the north side of the 1911 entrance road (see figure 4.66). A two-rail fence is located east of the carriage shed and chicken coop (see figure 4.60). Other wooden fences include a 6', light brown picket fence separating the maintenance facilities from the Old Orchard Museum, and another separating the employee parking lot from the entrance to the museum. Two other fences are post and chain. One is 1' high and surround Quentin Roosevelt's grave stone and memorial (see figure 3.13). Another is located along the path to the ice house and along the northeast side of the circular driveway (see figures 3.4, 4.67). It is approximately 2 1/2' high. A black wrought iron fence is located on the north side of the ice house (see

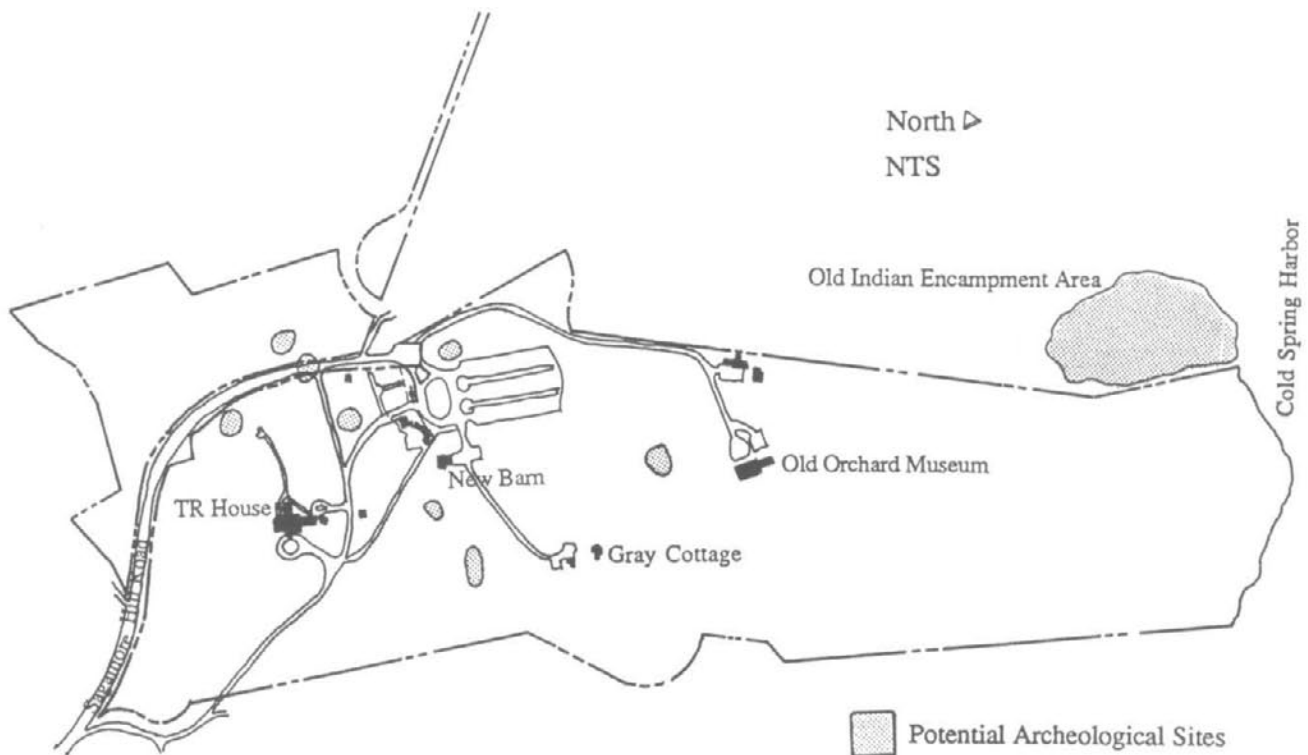
**FIGURE 4.68:** Potential archeological sites. Redrawn from DeCesare, *Archeological Collections Management*, figure 2. 1993. (Bellavia, SUNY CESF).

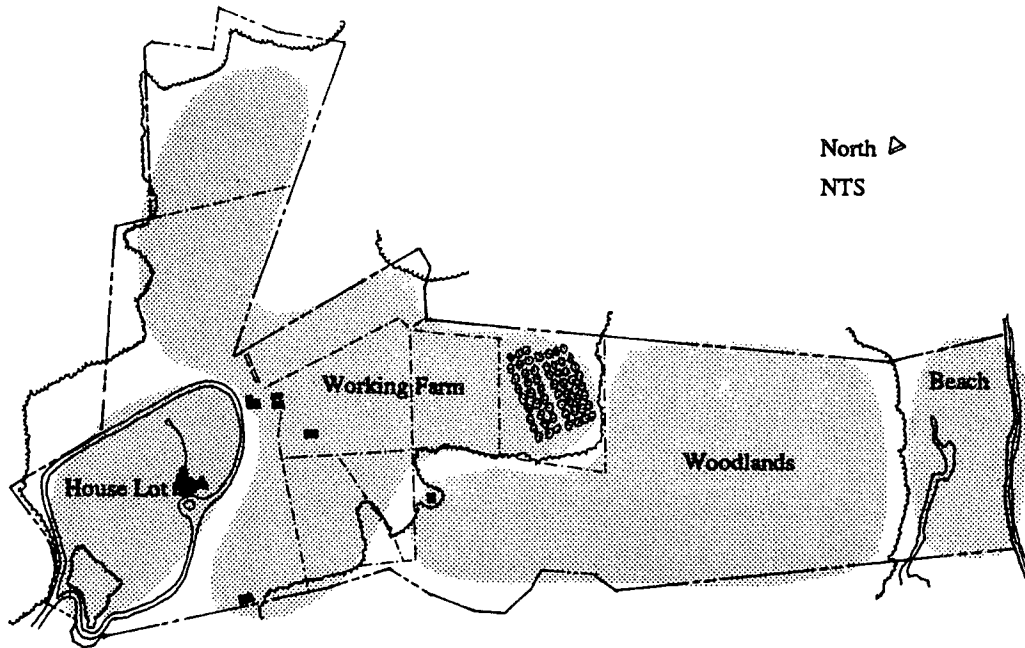
FIGURE 5.1: Diagram showing the spatial organization during the period of significance. (Bellavia, SUNY CESF).
