# CULTURAL LANDSCAPE REPORT

## FOR SAGAMORE HILL

### NATIONAL HISTORIC SITE

Site History, Existing Conditions, and Analysis

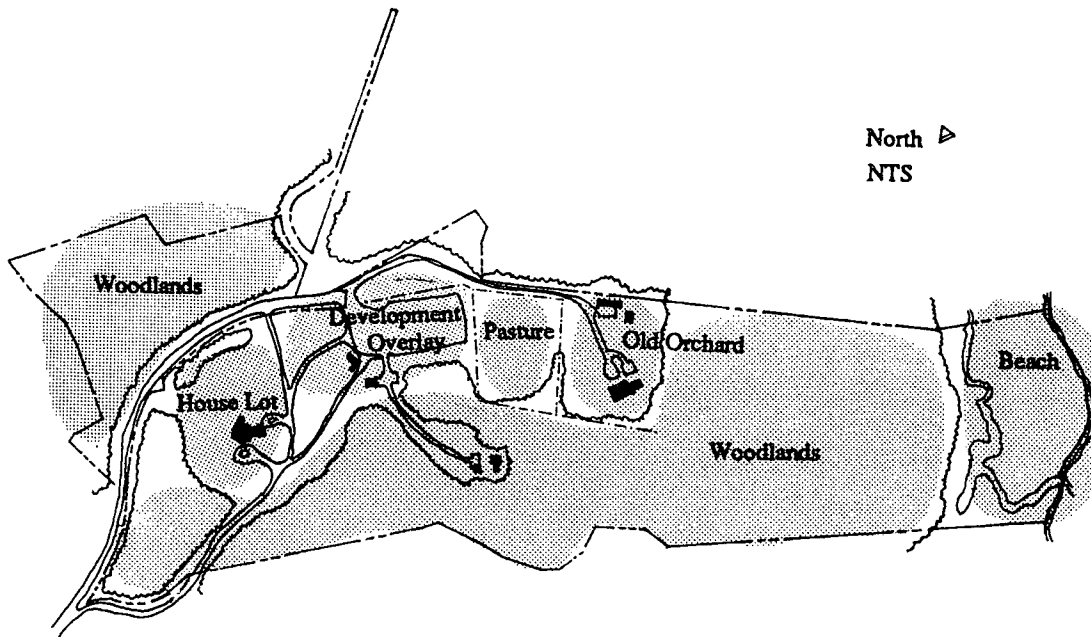
FIGURE 5.2: Diagram showing the spatial organization in 1993. (Bellavia, SUNY CESF).

**Existing Condition:** Basic spatial organization exists. Changes in the spatial organization of the site are due to increased vegetation types and amount of cover, and overlays of development that occurred prior to the NPS stewardship. Successional woodlands surround the house and make the property feel more enclosed. Ornamental vegetation species have been introduced. The construction of the Old Orchard estate, and the parking lot, county road, and souvenir shop modified the organizing principals of the orchard and the inner core, particularly the working farm (see figure 5.2).
